# ANDERSON MIDDLE SCHOOL

**BERKLEY SCHOOLS**  
**Comprehensive Academic Spaces, Facilities and Technologies Needs Assessment**

**Anderson Middle School**

| Address: 3205 Catalpa, Berkley, Michigan<br>Bldg. Area: 95,908 GSF<br>No. of Floors: 2<br>Year Built: 1956<br>Evaluation Date: January 2014 | <b>Item No. Codes</b><br>AB: Accessibility Improvement/Building Code<br>AD: Academic/Space Deficiencies<br>BE: Building Exterior<br>BI: Building Interior<br>BS: Building System<br>ES: Electrical System<br>MS: Mechanical System<br>PS: Plumbing System<br>SC: Site Circulation<br>SE: Specialty Equipment/Other<br>IT: Technology | | <b>Building Deficiencies Priorities by Category</b><br><div style="display: flex; justify-content: space-around;"> <div style="background-color: yellow; padding: 5px;"> <b>Consequences of the Problem</b><br/> 1. Hazards<br/> 2. Interruption<br/> 3. Deterioration<br/> 4. Utility<br/> 5. Energy </div> <div style="background-color: lightgreen; padding: 5px;"> <b>Need</b><br/> 1. Critical<br/> 2. Urgent<br/> 3. Necessary<br/> 4. ADA<br/> 5. Desirable </div> <div style="background-color: orange; padding: 5px;"> <b>Frequency of Use</b><br/> 1. Constant<br/> 2. Frequent<

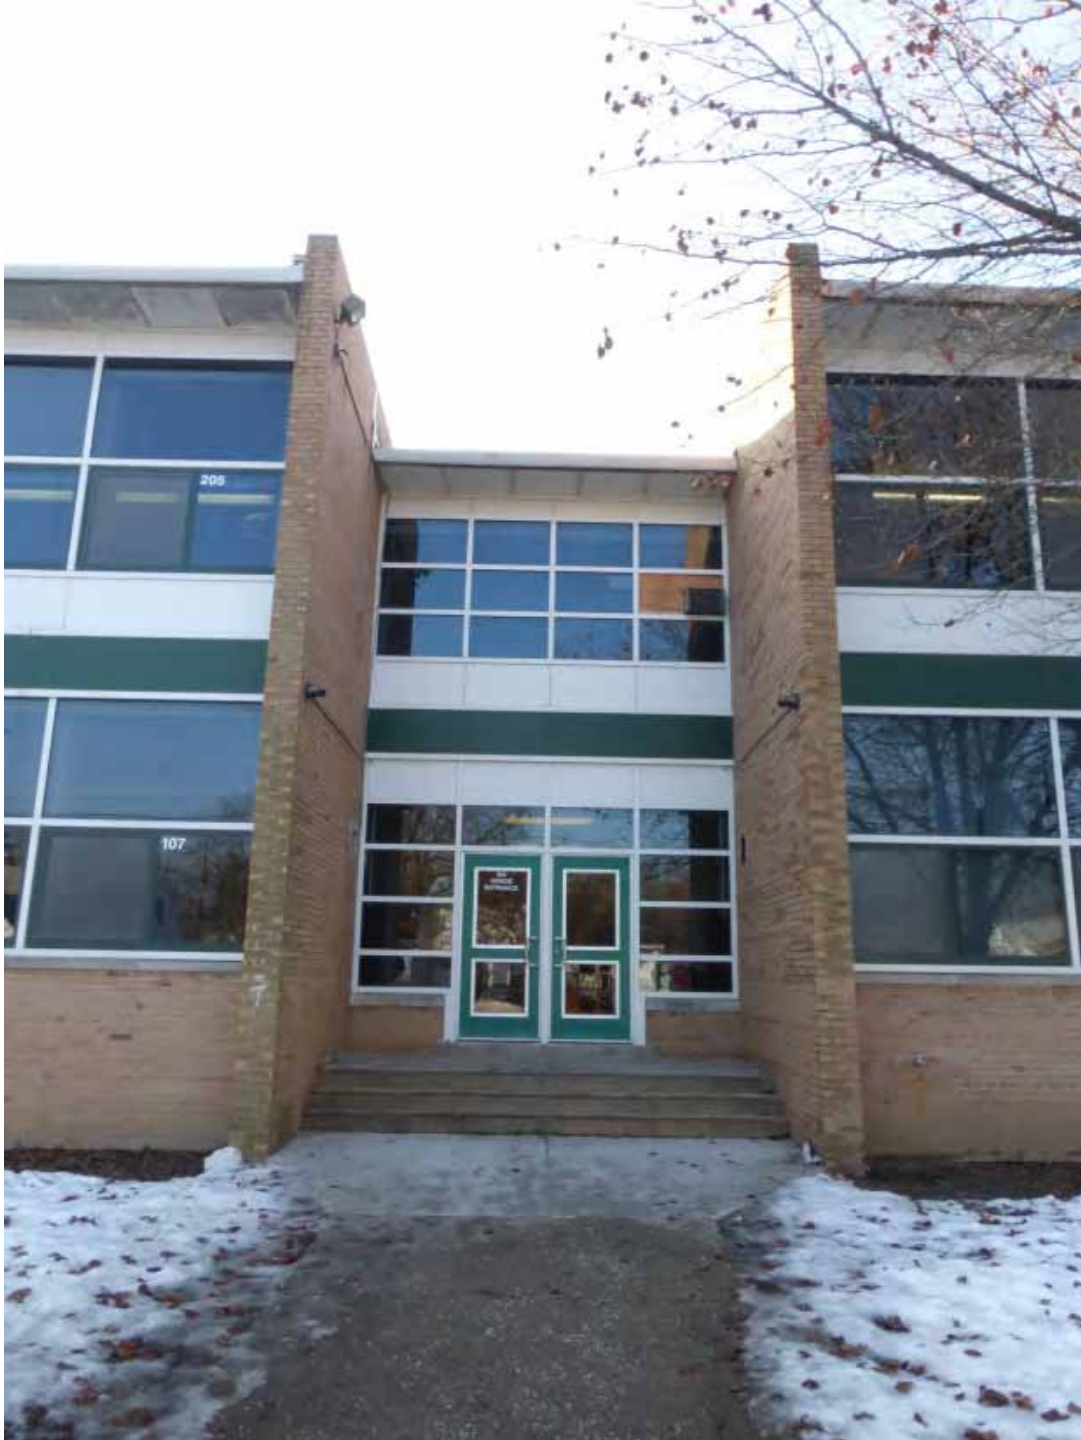
AB-4A

| No. | Item/Description | Location | Photo No. | Cons. | Need | Freq. | Score | Energy | Notes | Action | Qty. | Unit | Architectural | | Mechanical | | Electrical | | 2014 Project Cost |
|--|---|--|---|---|---|---|---|---|---|--|---|---|---|---|---|---|---|---|---|
| AB-4 | Handrails at Stairs | Girl's Locker Room, Gym Balcony, Exercise Room, Northeast Building Entrance, Locker Room Exits to Exterior | AB-4A<br>AB-4B<br>AB-4C | 1 | 4 | 2 | 7 | | Handrails missing (required on both sides of stairs). | Add handrails. | 75 | LF | \$ 50.00 | \$ 3,750 | | | | | \$ 5,655 |

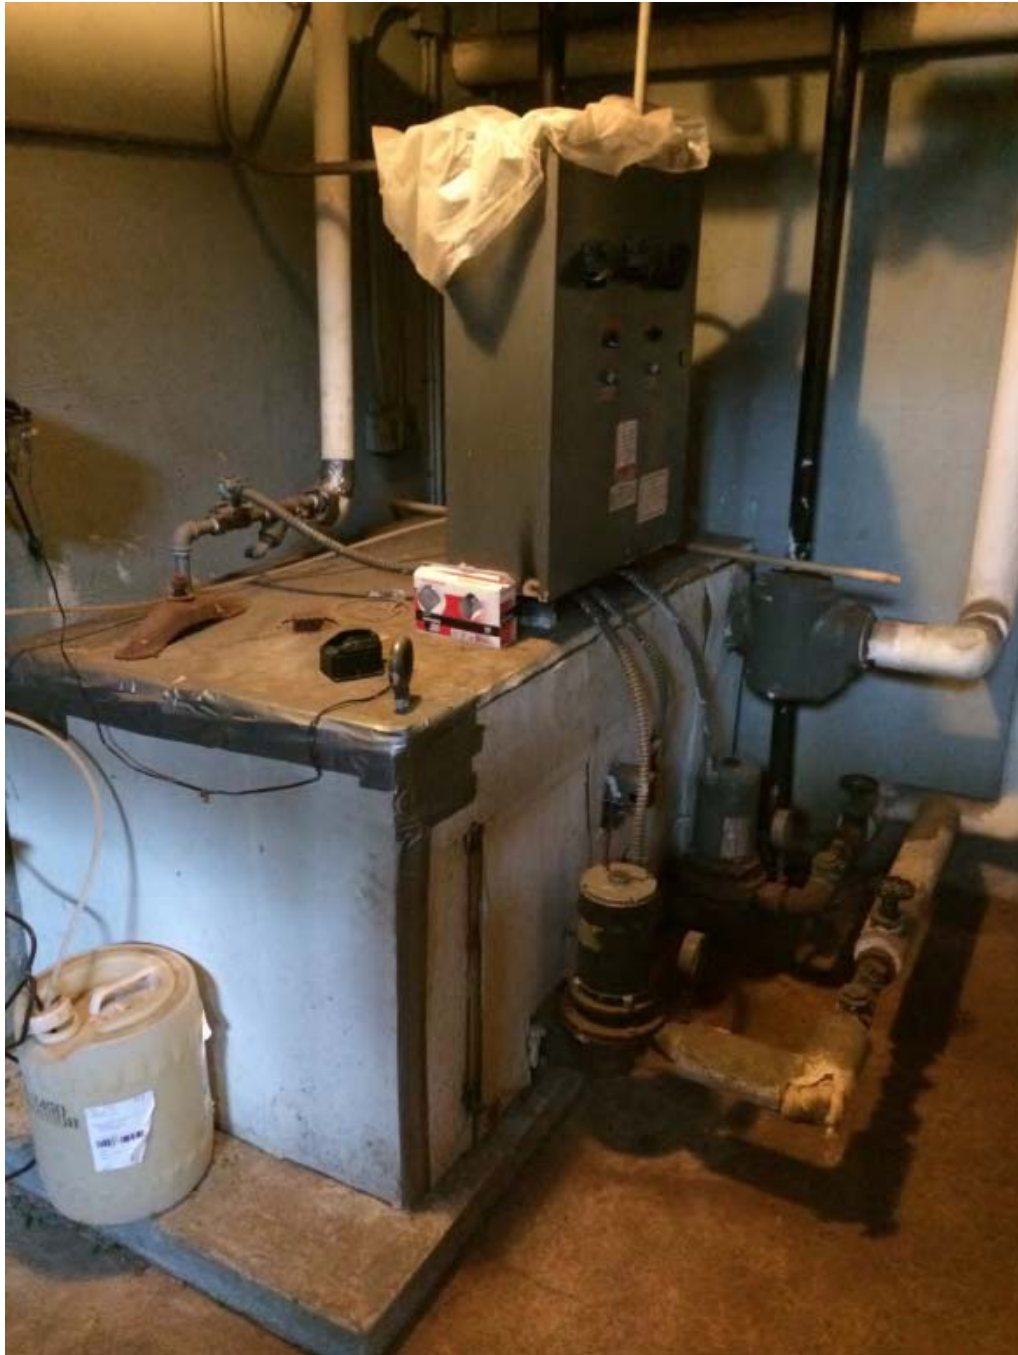
| No. | Item/Description | Location | Photo No. | Cons. | Need | Freq. | Score | Energy | Notes | Action | Qty. | Unit | Architectural | | Mechanical | | Electrical | | 2014 Project Cost |
|--|---|--|---|---|---|---|---|---|---|--|---|---|---|---|---|---|---|---|---|
| MS-3 | Domestic Water Heater (HTR-2) | Boiler Room | MS-3 | 3 | 3 | 1 | 7 | X | Existing Lochinvar water heater is beyond its useful life. | Replace with like and kind; 399 MBH unit. | 1 | LS | | | \$ 7,300.00 | \$ 7,300 | | | \$ 11,008 |
