# NORUP INTERNATIONAL SCHOOL

**BERKLEY SCHOOLS**  
**Comprehensive Academic Spaces, Facilities and Technologies Needs Assessment**

Address: 14450 Manhattan, Oak Park, Michigan Bldg. Area: 89,603 GSF No. of Floors: 2 Year Built: 1956 Evaluation Date: January 2014	<b>Item No. Codes</b> AB: Accessibility Improvement/Building Code AD: Academic/Space Deficiencies BE: Building Exterior BI: Building Interior BS: Building System ES: Electrical System MS: Mechanical System PS: Plumbing System SC: Site Circulation SE: Specialty Equipment/Other IT: Technology		<b>Building Deficiencies Priorities by Category</b> <div style="display: flex; justify-content: space-around;"> <div style="background-color: yellow; padding: 5px;"> <b>Consequences of the Problem</b>            1. Hazards            2. Interruption            3. Deterioration            4. Utility            5. Energy         </div> <div style="background-color: lightgreen; padding: 5px;"> <b>Need</b>            1. Critical            2. Urgent            3. Necessary            4. ADA            5. Desirable         </div> <div style="background-color: orange; padding: 5px;"> <b>Frequency of Use</b>            1. Constant

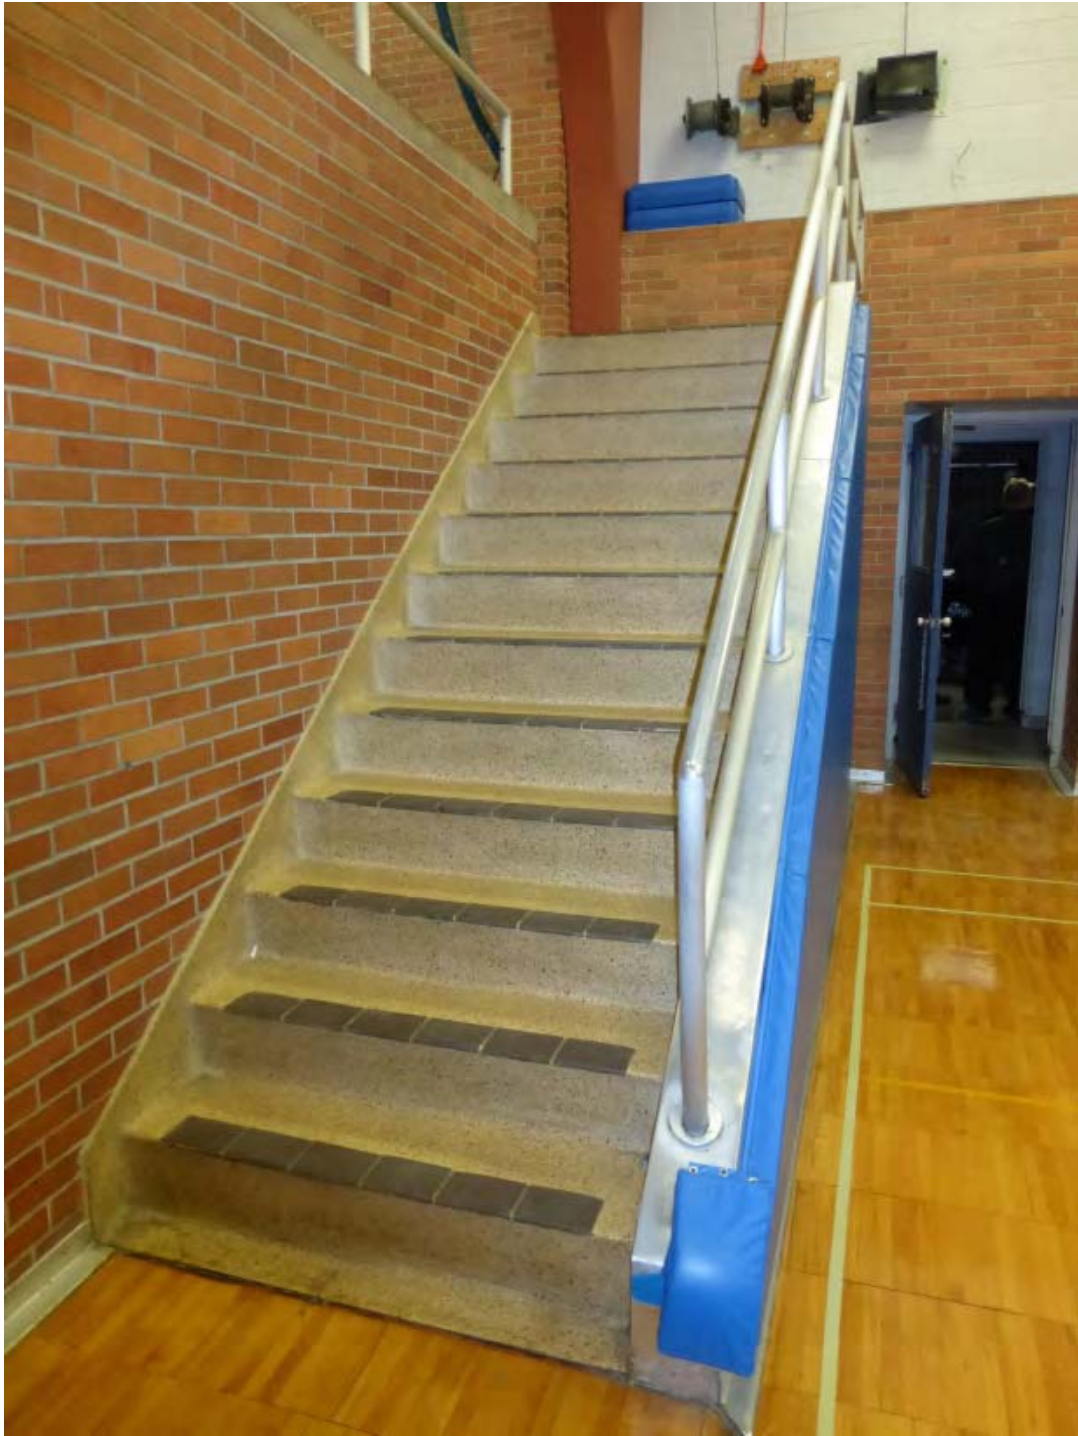
AB-12	Stair Handrail	Stairs to Gymnasium Balcony Boy's Locker Room	AB-12A AB-12B	1	4	2	7		Handrail missing from one side of stair (required on both sides).	Add handrail at wall.	26	LF	\$ 50.00	\$ 1,300					\$ 1,960
AB-13	Boy's and Girl's Toilet Rooms	Various Locations	AB-13	1	4	2	7		Toilet rooms do not meet current accessibility requirements.	Provide new plumbing fixtures, lighting, floor/wall/ceiling finishes, stalls and automatic door operators.	1,800	SF	\$ 55.00	\$ 99,000			\$ 3,300.00	\$ 5,940,000	\$ 9,106,812
AB-14	Boy's and Girl's Toilet Rooms	Locker Rooms	AB-14	1	4	2	7		Toilet rooms do not meet current accessibility requirements.	Provide new plumbing fixtures, lighting, floor/wall/ceiling finishes and stalls.	225	SF	\$ 55.00	\$ 12,375			\$ 3,300.00	\$ 742,500	\$ 1,138,352
AB-15	Bleacher Guardrails	Gymnasium	--	1	3	2	6		Open ends of wood bleachers do not have guardrails.	Add removable guardrails to open ends of retractable bleachers.	136	LF	\$ 80.00	\$ 10,880					\$ 16,407

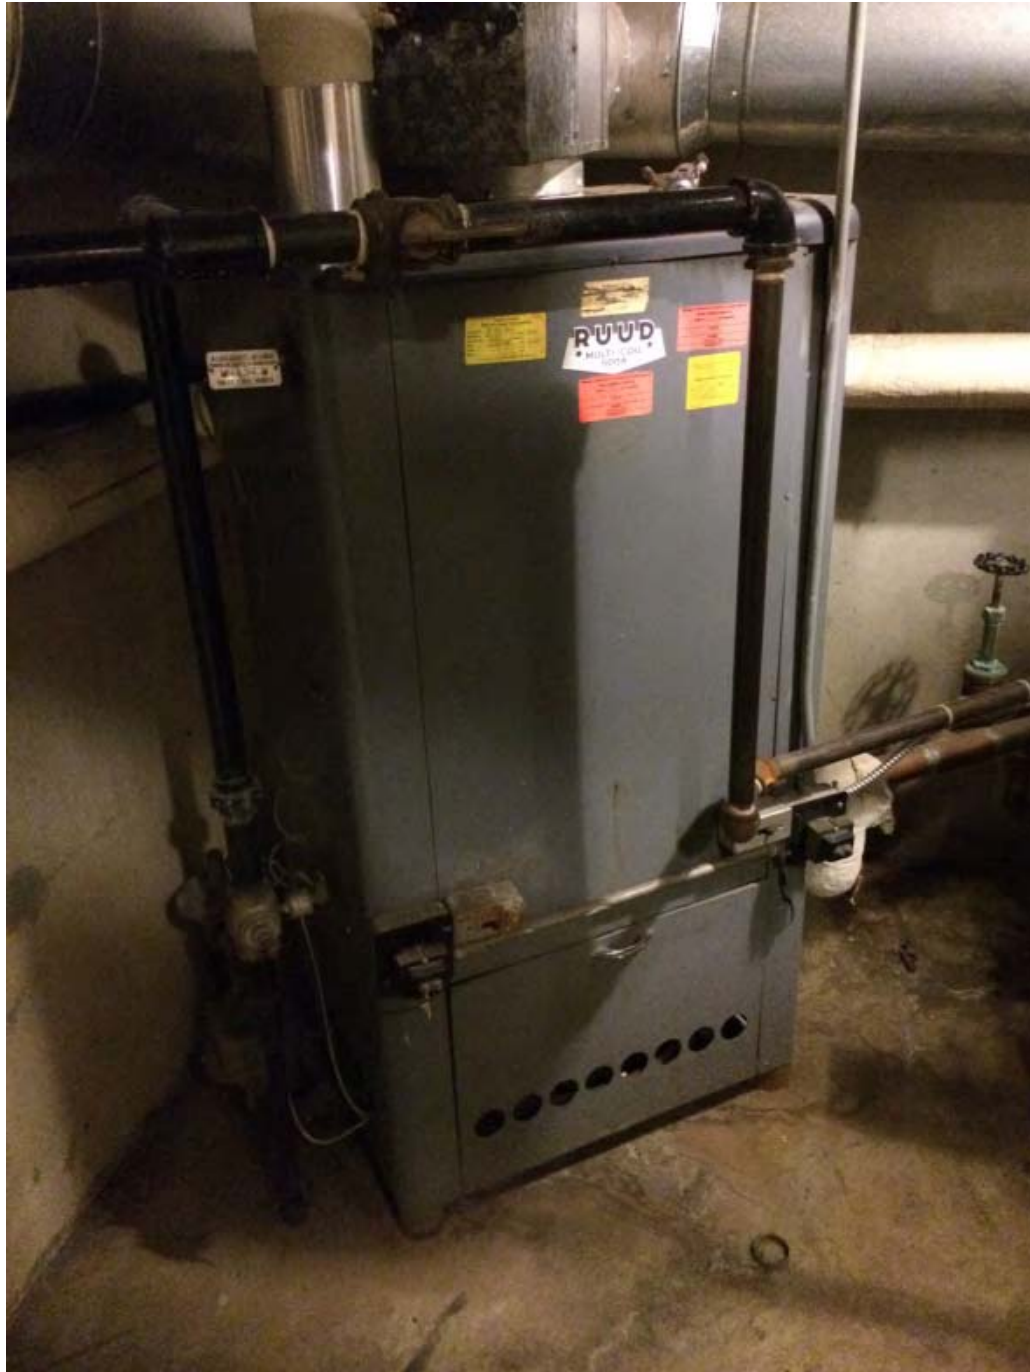
MS-1	Building Controls	Entire Building	MS-1	2	2	1	5	X	Existing controls are outdated.	Provide new DDC controls throughout.	90,000	SF			\$ 3.32	\$ 298,800			\$ 450,590
MS-2	Domestic Water Heater HTR-1	Boiler Room	MS-2	2	2	1	5	X	Existing Ruud water heater is beyond its useful life.	Replace with 199 MBH, 80 gallon standalone unit and stack.	1	LS			\$ 5,000.00	\$ 5,000			\$ 7,540
MS-3	Domestic Water Heater HTR-2	Boiler Room	MS-3	3	3	1	7	X	Existing Lochinvar water heater is beyond its useful life.	Replace with like and kind; 399 MBH unit and new stack.	1	LS			\$ 7,300.00	\$ 7,300			\$ 11,008
MS-4	Condensate Return System	Boiler Room	MS-4	4	3	1	8	X	Receiver tank and pumps are in poor condition.	Replace with packaged receiver system.	1	LS			\$ 9,800.00	\$ 9,800	\$ 1,350.00	\$ 1,350	\$ 16,814
MS-5	Sump Pump	Boiler Room	MS-5	3	3	1	7		Existing duplex sump system is in disrepair.	Rebuild entire duplex sump system.	1	LS			\$ 5,000.00	\$ 5,000	\$ 1,350.00	\$ 1,350	\$ 9,576

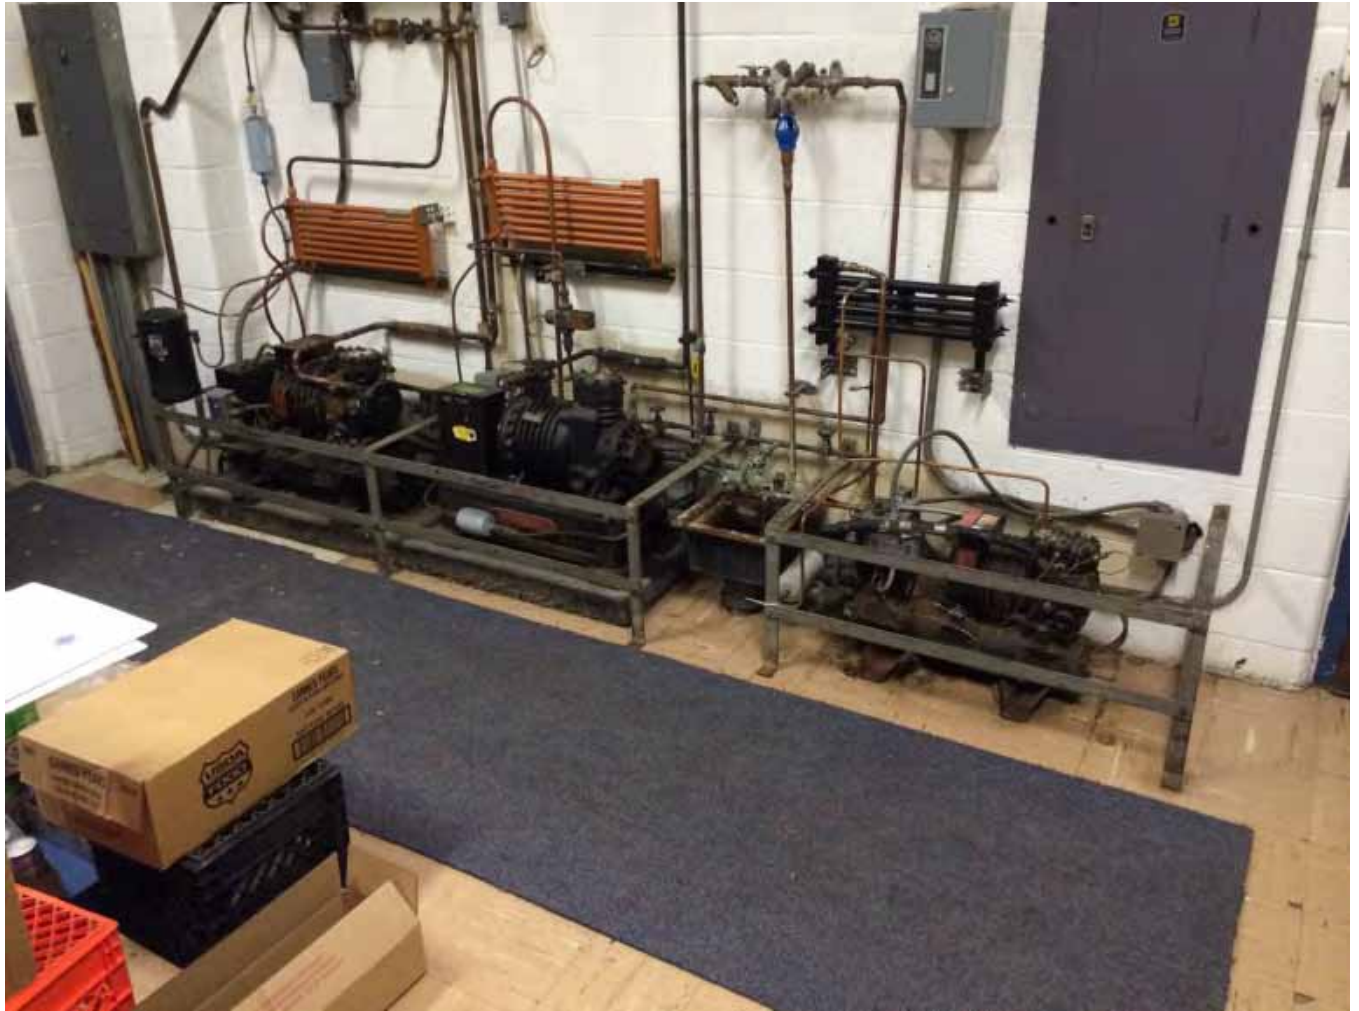
MS-9	Kitchen Hood	Kitchen	MS-9	4	4	1	9		Main kitchen hood is beyond its useful life.	Replace with new stainless steel hood and chemical fire suppression system.	1	LS			\$ 14,500.00	\$ 14,500	\$ 400.00	\$ 400	\$ 22,469
MS-10	Refrigeration Compressors	Kitchen	MS-10	2	2	1	5	X	Existing compressors use domestic water and are not code compliant.	Replace with new air-cooled units.	3	EA			\$ 6,500.00	\$ 19,500	\$ 350.00	\$ 1,050	\$ 30,989
MS-11	Locker Rooms Heating and Ventilating Units	Boy's and Girl's Locker Rooms	MS-11	4	4	4	12		Existing ceiling hung units are in fair condition.	Replace with like and kind; new distribution ductwork.	2	EA			\$ 9,500.00	\$ 19,000	\$ 185.00	\$ 370	\$ 29,210
MS-12	Rooftop Unit RTU-1	Roof	MS-12	4	4	1	9	X	Existing unit is beyond its useful life.	Replace with like and kind; 7,000 CFM HVAC unit.	1	EA			\$ 28,800.00	\$ 28,800	\$ 6,212.00	\$ 6,212	\$ 52,798
MS-13	Rooftop Units RTU-2 and RTU-3	Roof	MS-13	4	4	2	10	X	Existing unit is beyond its useful life.	Replace with like and kind; average size of 1,800 and 3,000 CFM.	1	EA			\$ 13,000.00	\$ 13,000	\$ 3,230.00	\$ 3,230	\$ 24,475
