# ANDERSON MIDDLE SCHOOL

**BERKLEY SCHOOLS**  
**Comprehensive Academic Spaces, Facilities and Technologies Needs Assessment**

**Anderson Middle School**

| Address: 3205 Catalpa, Berkley, Michigan<br>Bldg. Area: 95,908 GSF<br>No. of Floors: 2<br>Year Built: 1956<br>Evaluation Date: January 2014 | <b>Item No. Codes</b><br>AB: Accessibility Improvement/Building Code<br>AD: Academic/Space Deficiencies<br>BE: Building Exterior<br>BI: Building Interior<br>BS: Building System<br>ES: Electrical System<br>MS: Mechanical System<br>PS: Plumbing System<br>SC: Site Circulation<br>SE: Specialty Equipment/Other<br>IT: Technology | | <b>Building Deficiencies Priorities by Category</b><br><div style="display: flex; justify-content: space-around;"> <div style="background-color: yellow; padding: 5px;"> <b>Consequences of the Problem</b><br/> 1. Hazards<br/> 2. Interruption<br/> 3. Deterioration<br/> 4. Utility<br/> 5. Energy </div> <div style="background-color: lightgreen; padding: 5px;"> <b>Need</b><br/> 1. Critical<br/> 2. Urgent<br/> 3. Necessary<br/> 4. ADA<br/> 5. Desirable </div> <div style="background-color: orange; padding: 5px;"> <b>Frequency of Use</b><br/> 1. Constant<br/> 2. Frequent<

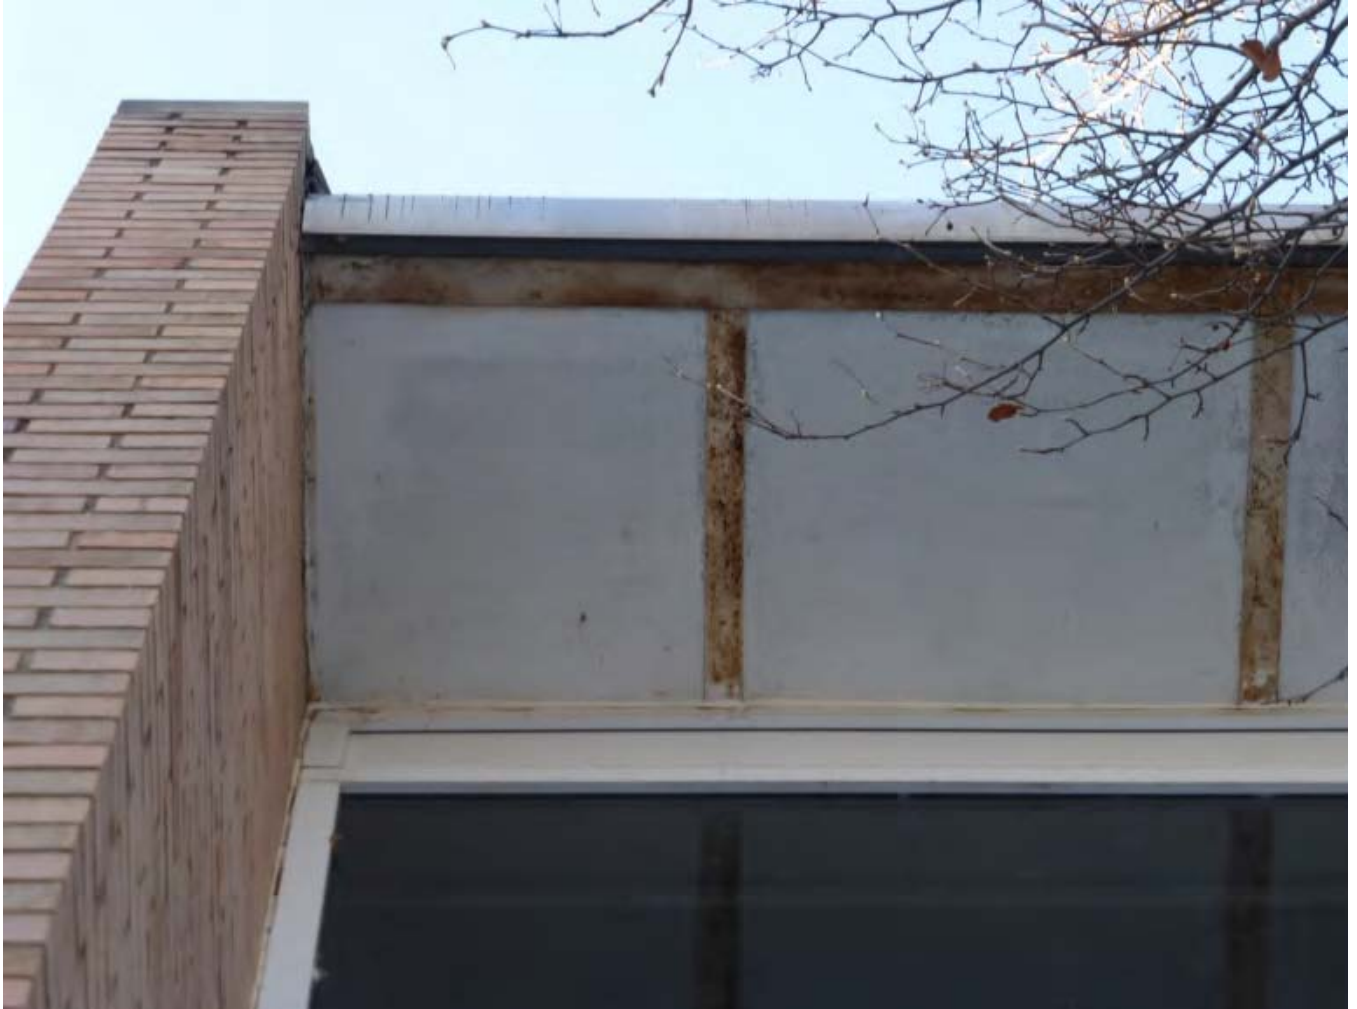
| No. | Item/Description | Location | Photo No. | Cons. | Need | Freq. | Score | Energy | Notes | Action | Qty. | Unit | Architectural | | Mechanical | | Electrical | | 2014 Project Cost |
|---|--|--|---|---|---|---|---|---|---|---|---|---|---|---|---|---|---|---|---|
| BE-1 | Overhangs/Soffits | Entire Building | BE-1 | 3 | 3 | 2 | 8 | | Paint is peeling and steel is rusted. | Provide aluminum soffit panels. | 1,700 | SF | \$ 6.00 | \$ 10,200 | | | | | \$ 15,382 |

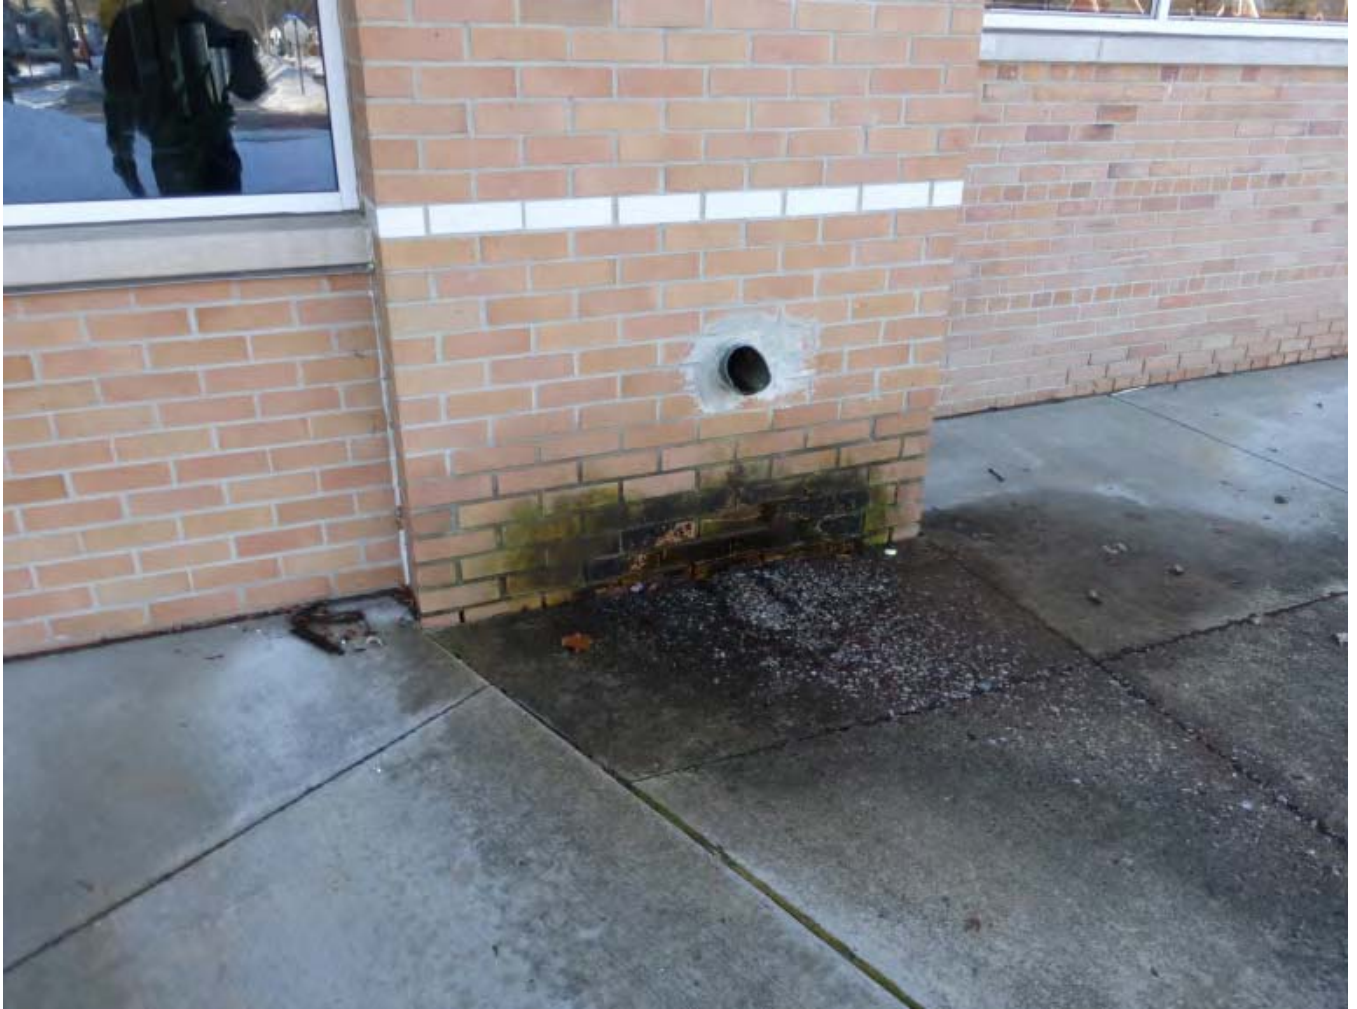
| No. | Item/Description | Location | Photo No. | Cons. | Need | Freq. | Score | Energy | Notes | Action | Qty. | Unit | Architectural | | Mechanical | | Electrical | | 2014 Project Cost |
|---|--|--|---|---|---|---|---|---|---|---|---|---|---|---|---|---|---|---|---|
| BE-2 | Brick Veneer at Base of Walls | Where roofs drains to pavement adjacent to walls and at main entrances | BE-2 | 3 | 3 | 2 | 8 | | Brick and mortar joints deteriorated from roof water drainage. | Control roof drainage where possible and clean/tuck point brick. | 600 | SF | \$ 10.50 | \$ 6,300 | | | | | \$ 9,500 |

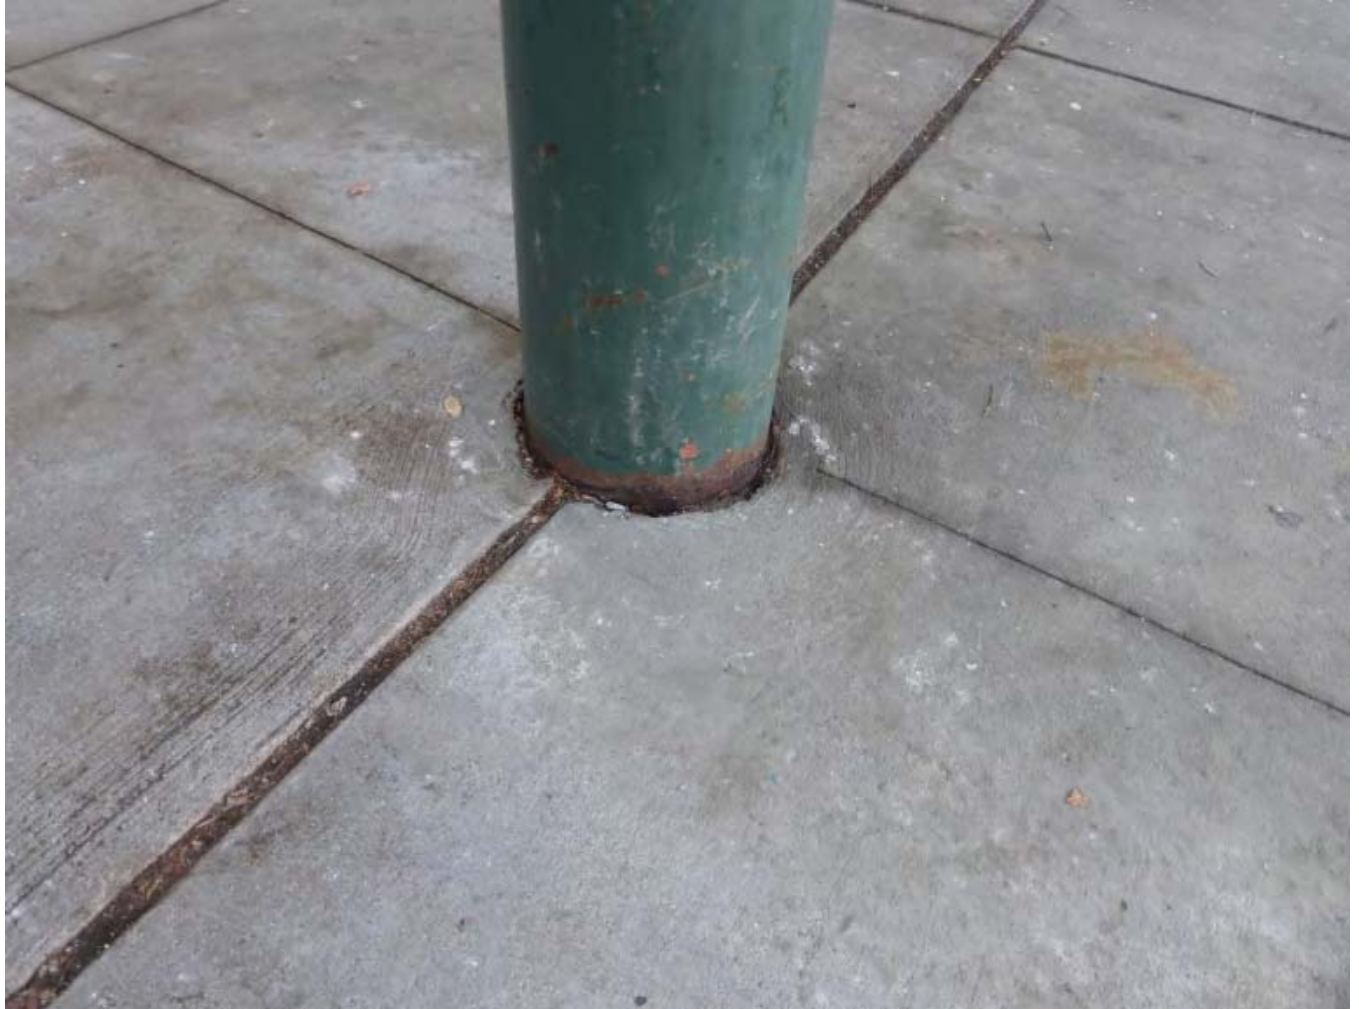
| No. | Item/Description | Location | Photo No. | Cons. | Need | Freq. | Score | Energy | Notes | Action | Qty. | Unit | Architectural | | Mechanical | | Electrical | | 2014 Project Cost |
|---|--|--|---|---|---|---|---|---|---|---|---|---|---|---|---|---|---|---|---|
| BE-4 | Entrance Canopy Columns | Main Entrance | BE-4 | 3 | 3 | 2 | 8 | | Steel is rusted. | Paint columns. | 4 | EA | \$ 125.00 | \$ 500 | | | | | \$ 754 |

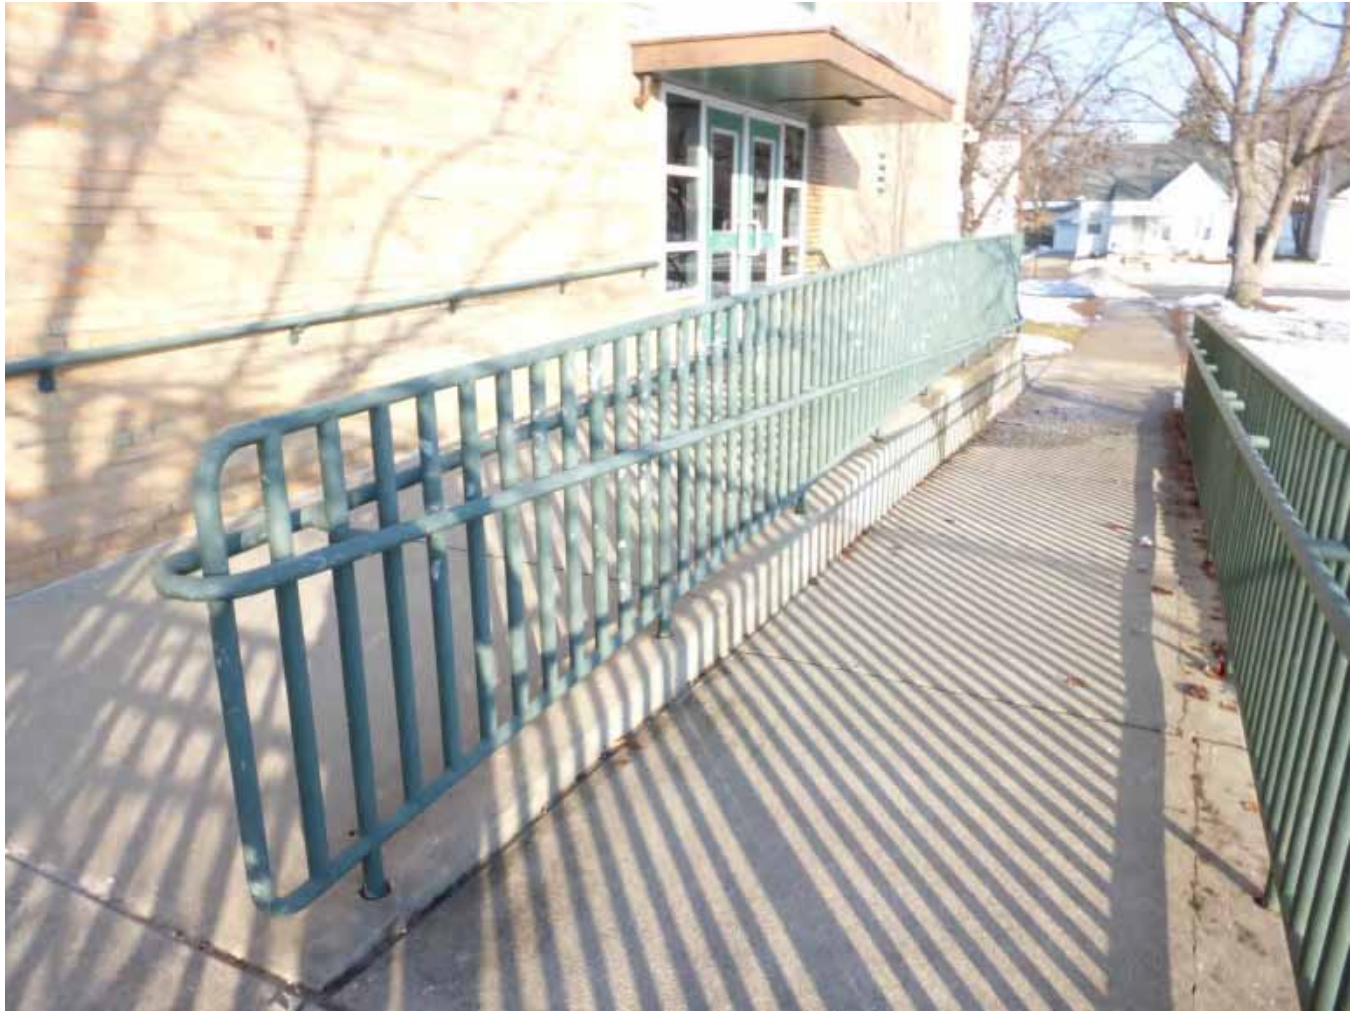
| No. | Item/Description | Location | Photo No. | Cons. | Need | Freq. | Score | Energy | Notes | Action | Qty. | Unit | Architectural | | Mechanical | | Electrical | | 2014 Project Cost |
|---|--|--|---|---|---|---|---|---|---|---|---|---|---|---|---|---|---|---|---|
| BE-5 | Steel Stair/Ramp Railings | Building Entrances | BE-5 | 3 | 3 | 2 | 8 | | Paint is peeling and steel is rusted. | Paint railings. | 150 | LF | \$ 5.00 | \$ 750 | | | | | \$ 1,131 |

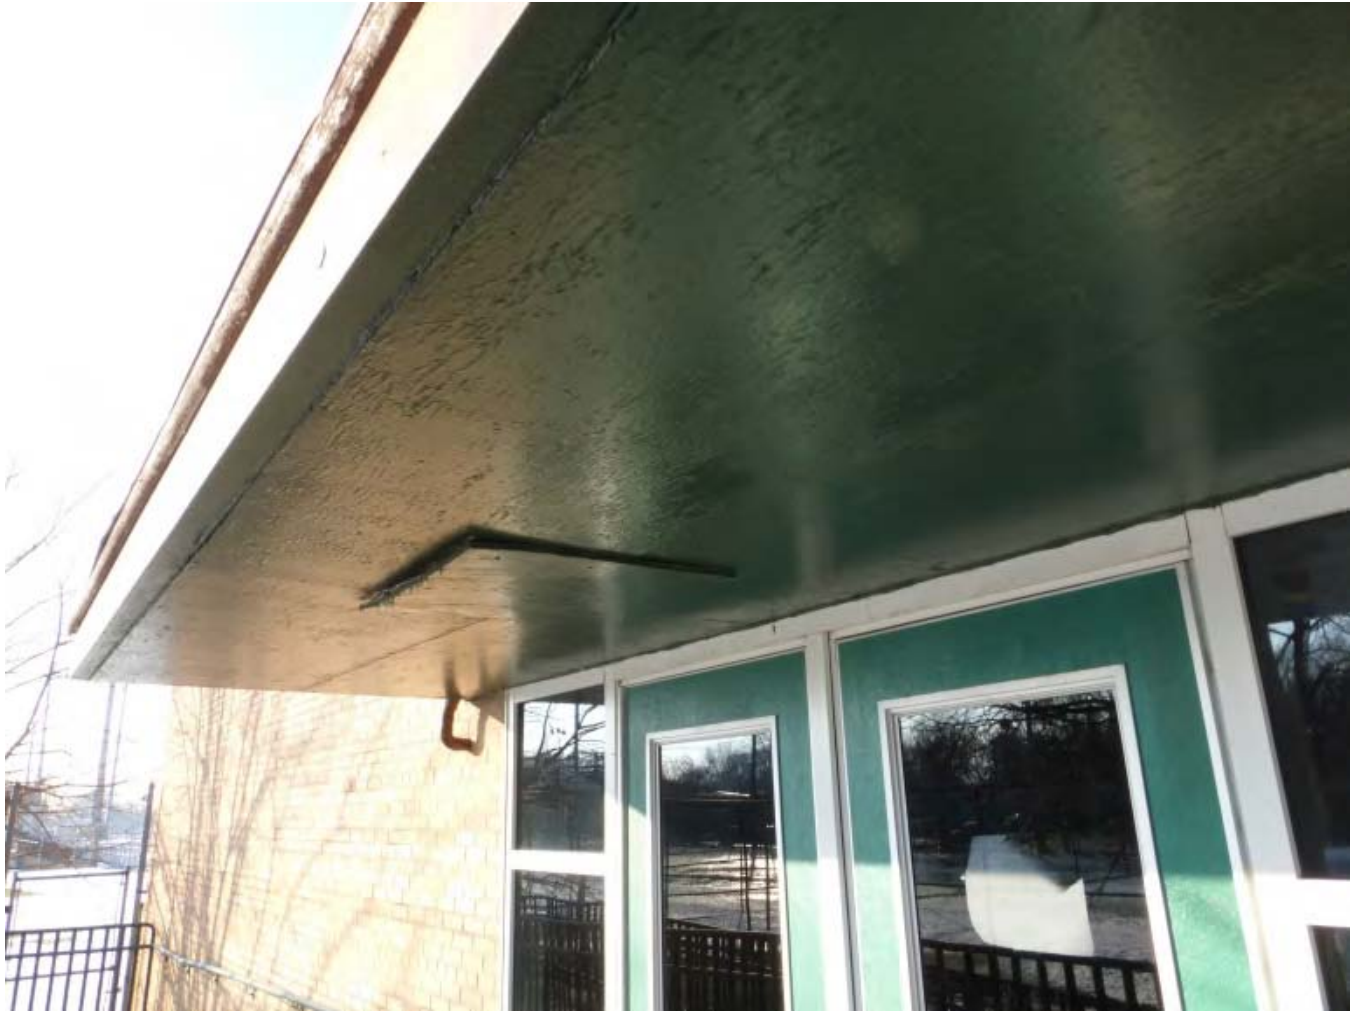
| No. | Item/Description | Location | Photo No. | Cons. | Need | Freq. | Score | Energy | Notes | Action | Qty. | Unit | Architectural | | Mechanical | | Electrical | | 2014 Project Cost |
|---|--|--|---|---|---|---|---|---|---|---|---|---|---|---|---|---|---|---|---|
| BE-7 | Entrance Canopy Soffits | East Entrance | BE-7 | 3 | 3 | 2 | 8 | | Wood is deteriorated and paint is peeling. | Provide aluminum soffit panels. | 130 | SF | \$ 7.50 | \$ 975 | | | | | \$ 1,470 |

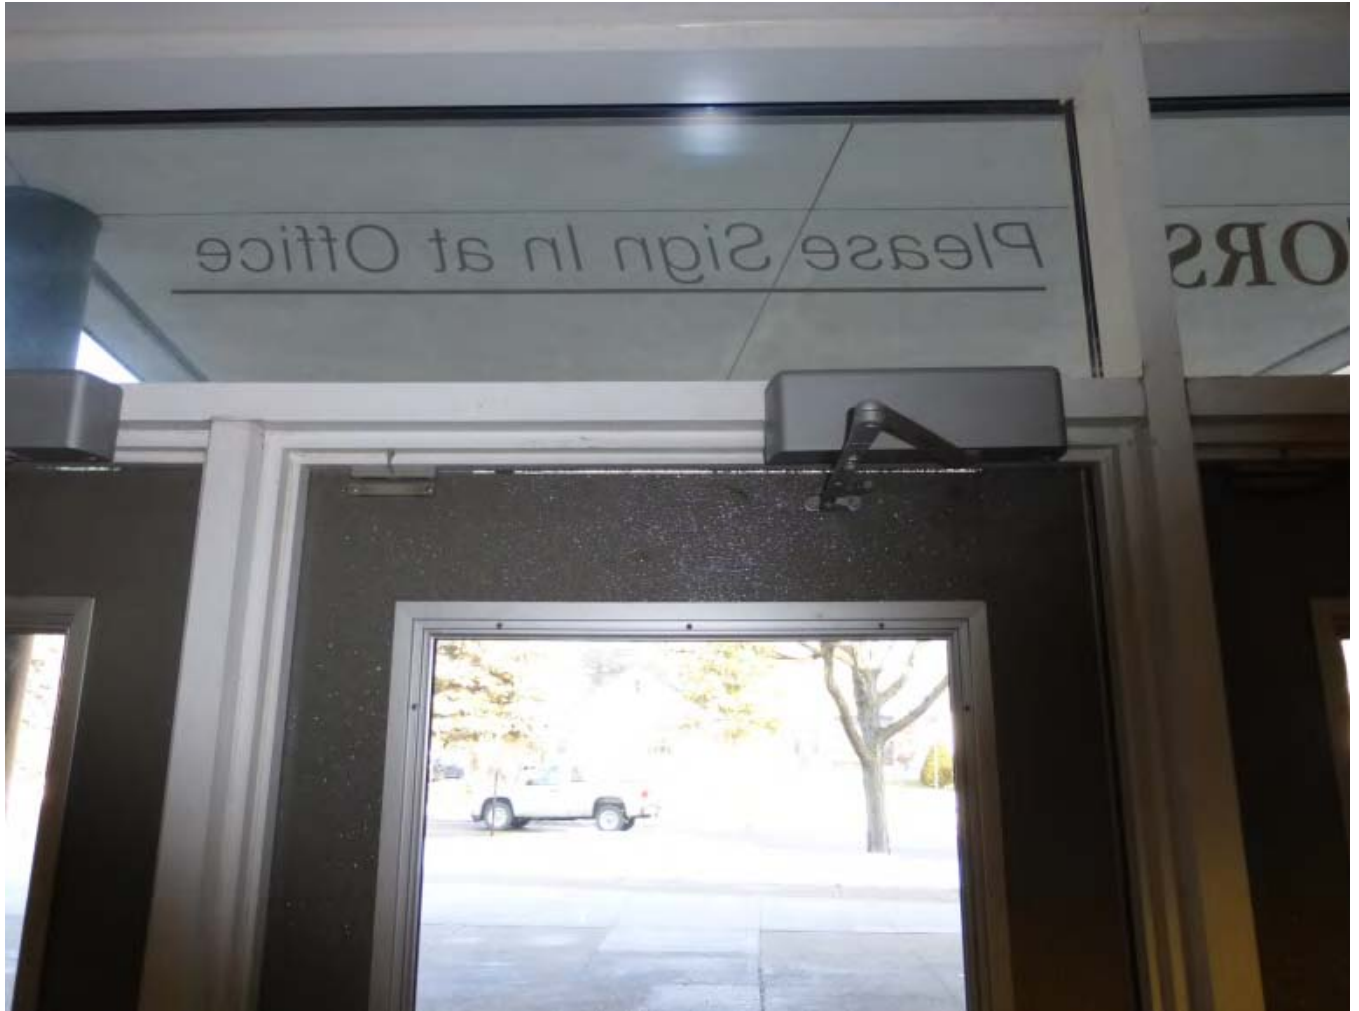
| No. | Item/Description | Location | Photo No. | Cons. | Need | Freq. | Score | Energy | Notes | Action | Qty. | Unit | Architectural | | Mechanical | | Electrical | | 2014 Project Cost |
|---|--|--|---|---|---|---|---|---|---|---|---|---|---|---|---|---|---|---|---|
| BE-9 | Fiberglass Reinforced Panel Door Seals | Main Entrances | BE-9 | 4 | 3 | 2 | 9 | | Doors not sealed at perimeter. | Add/replace door seals. | 4 | EA | \$ 100.00 | \$ 400 | | | | | \$ 603 |

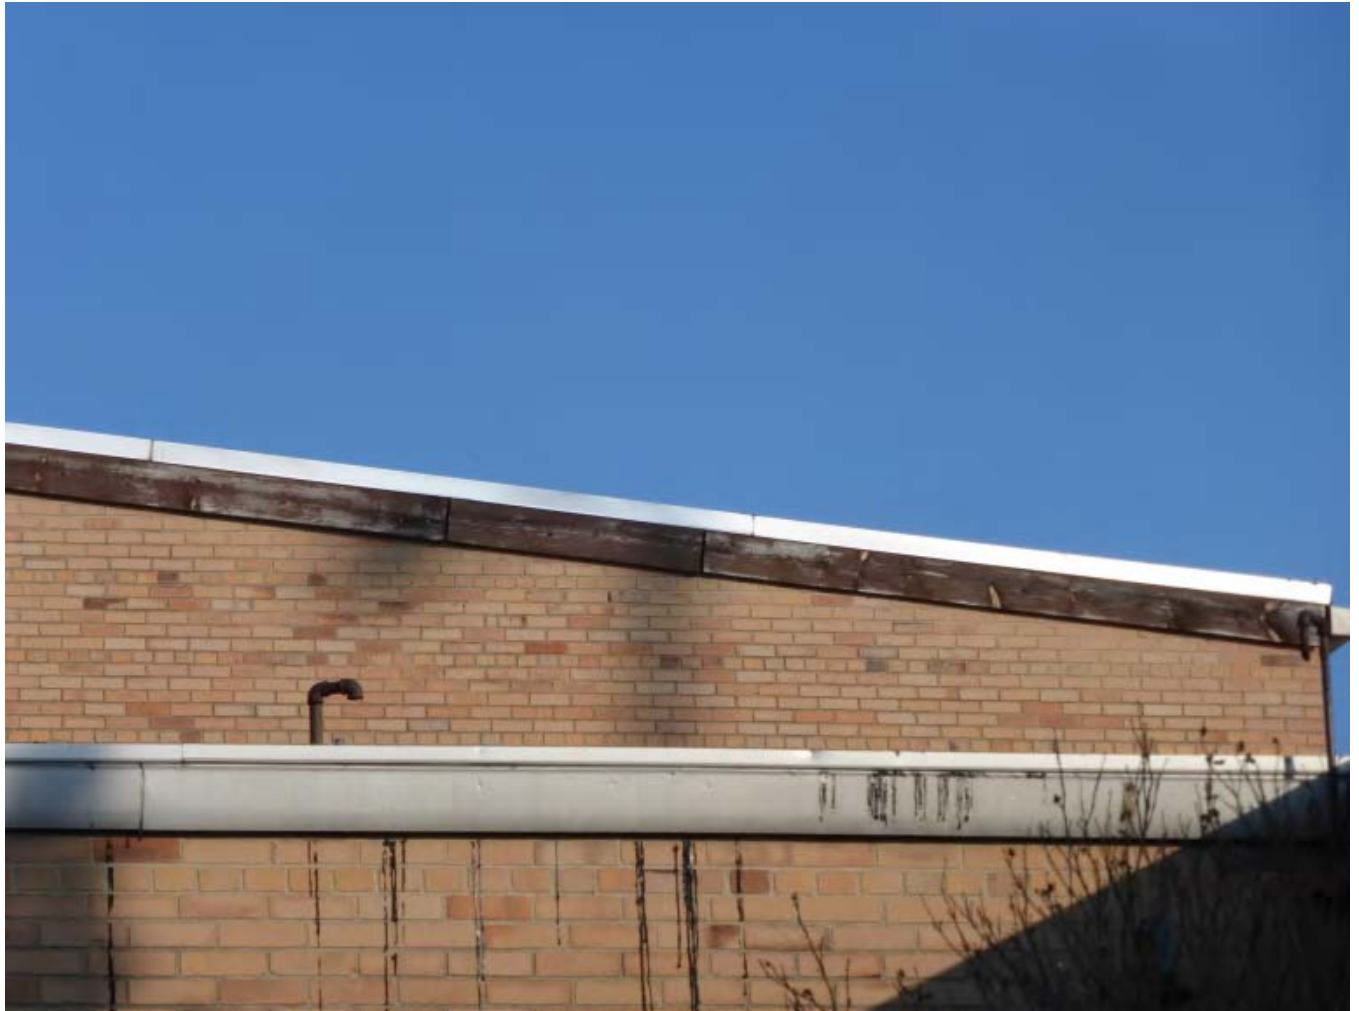
| No. | Item/Description | Location | Photo No. | Cons. | Need | Freq. | Score | Energy | Notes | Action | Qty. | Unit | Architectural | | Mechanical | | Electrical | | 2014 Project Cost |
|---|--|--|---|---|---|---|---|---|---|---|---|---|---|---|---|---|---|---|---|
| BE-10 | Wood Fascia | Gymnasium Roof | BE-10 | 3 | 3 | 2 | 8 | | Deteriorated, peeling paint. | Replace with aluminum fascia. | 220 | LF | \$ 12.00 | \$ 2,640 | | | | | \$ 3,981 |

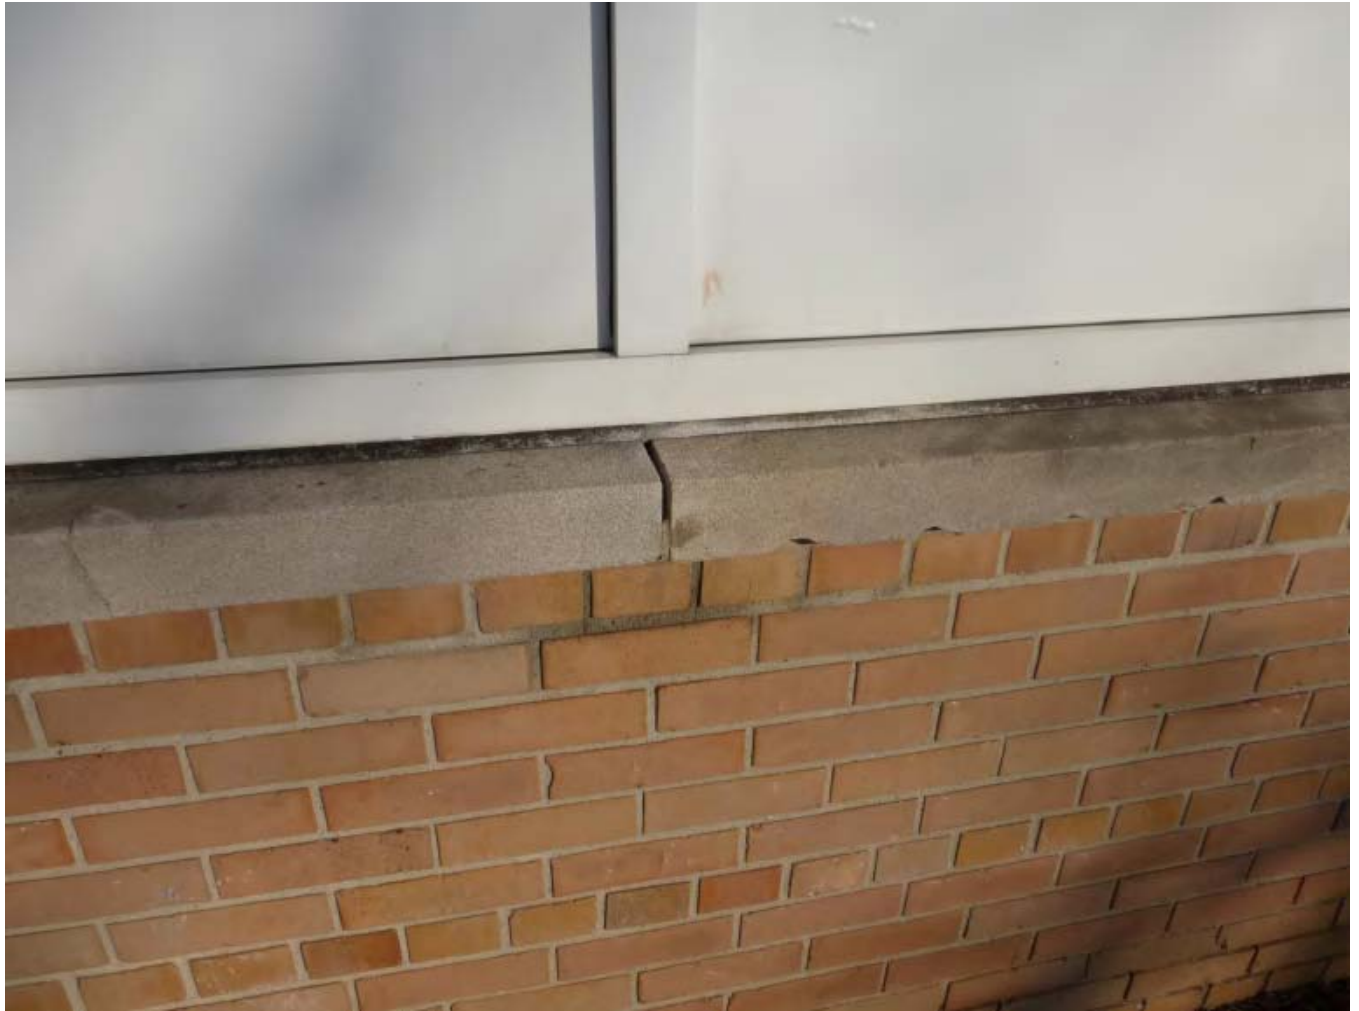
| No. | Item/Description | Location | Photo No. | Cons. | Need | Freq. | Score | Energy | Notes | Action | Qty. | Unit | Architectural | | Mechanical | | Electrical | | 2014 Project Cost |
|---|--|--|---|---|---|---|---|---|---|---|---|---|---|---|---|---|---|---|---|
| BE-11 | Stone Window Sills | Entire Building | BE-11 | 4 | 3 | 2 | 9 | | Sealant missing at joints. | Provide sealant. | 750 | LF | \$ 4.75 | \$ 3,563 | | | | | \$ 5,372 |

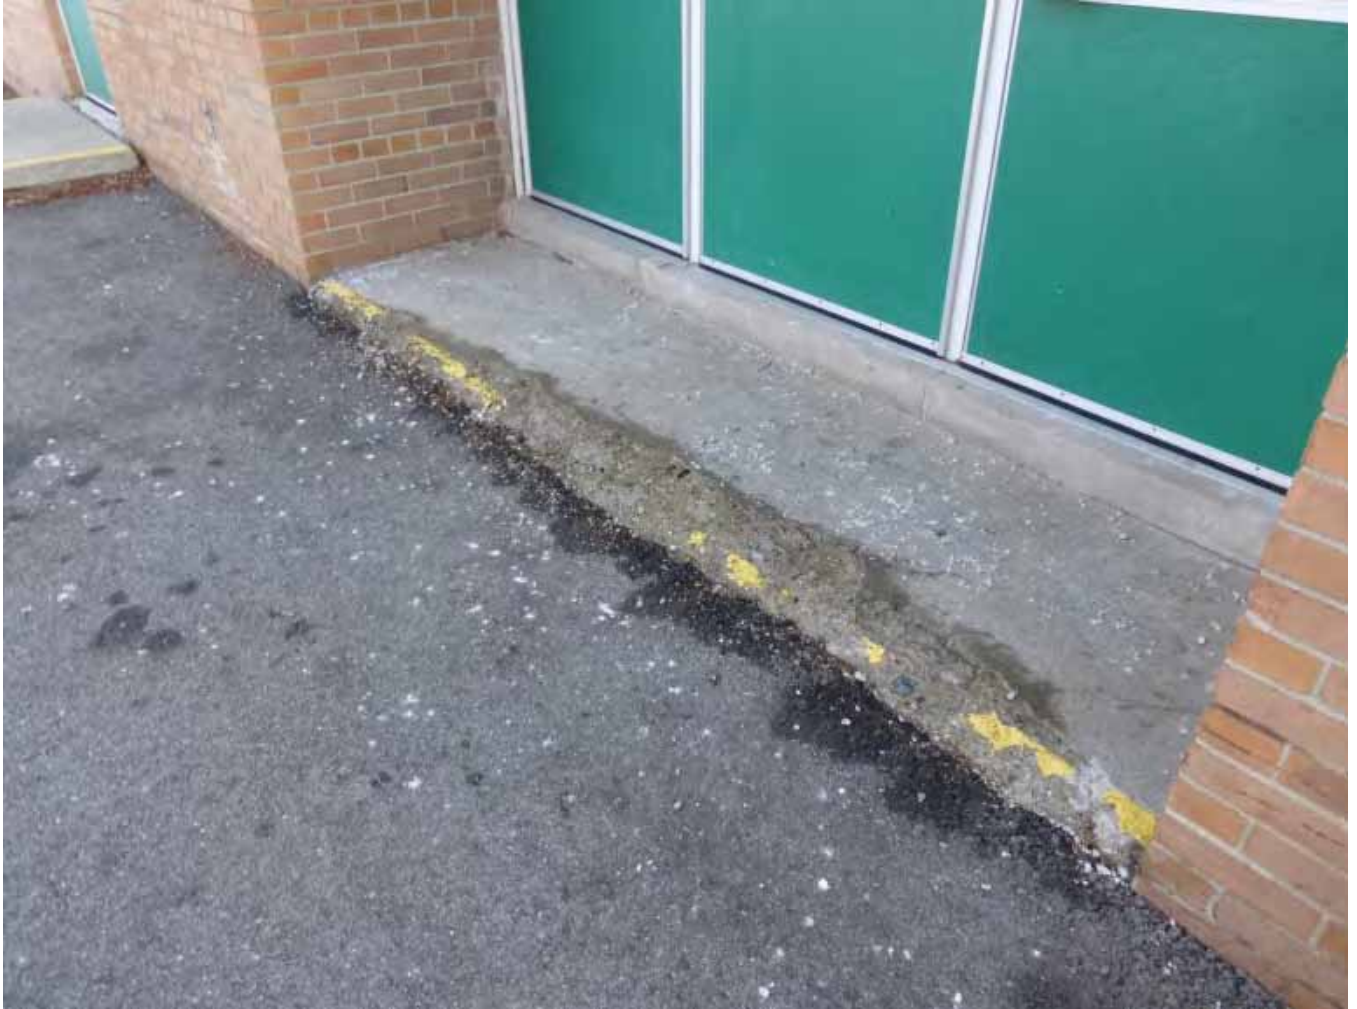
| No. | Item/Description | Location | Photo No. | Cons. | Need | Freq. | Score | Energy | Notes | Action | Qty. | Unit | Architectural | | Mechanical | | Electrical | | 2014 Project Cost |
|---|--|--|---|---|---|---|---|---|---|---|---|---|---|---|---|---|---|---|---|
| BE-12 | Concrete Slab | West Entrance | BE-12 | 1 | 2 | 2 | 5 | | Irregular and rough, possible tripping hazard. | Repair/replace concrete. | 20 | SF | \$ 115.00 | \$ 2,300 | | | | | \$ 3,468 |

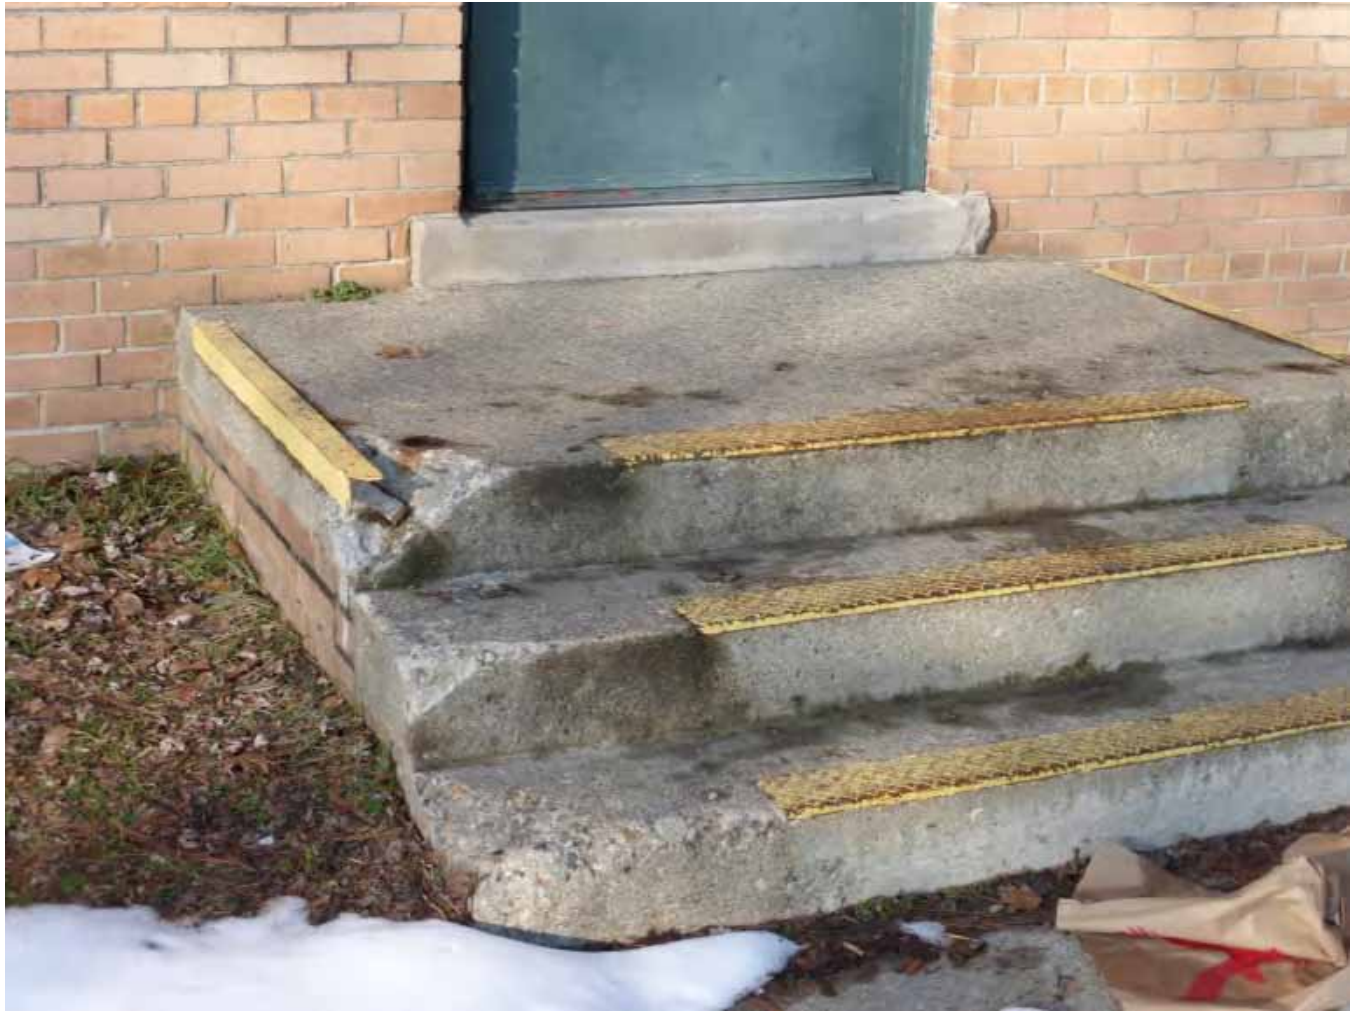
| No. | Item/Description | Location | Photo No. | Cons. | Need | Freq. | Score | Energy | Notes | Action | Qty. | Unit | Architectural | | Mechanical | | Electrical | | 2014 Project Cost |
|---|--|--|---|---|---|---|---|---|---|---|---|---|---|---|---|---|---|---|---|
| BE-13 | Concrete Stairs | Locker Room Entrances | BE-13 | 3 | 3 | 2 | 8 | | Concrete is deteriorated. | Repair concrete. | 1 | LS | \$ 500.00 | \$ 500 | | | | | \$ 754 |

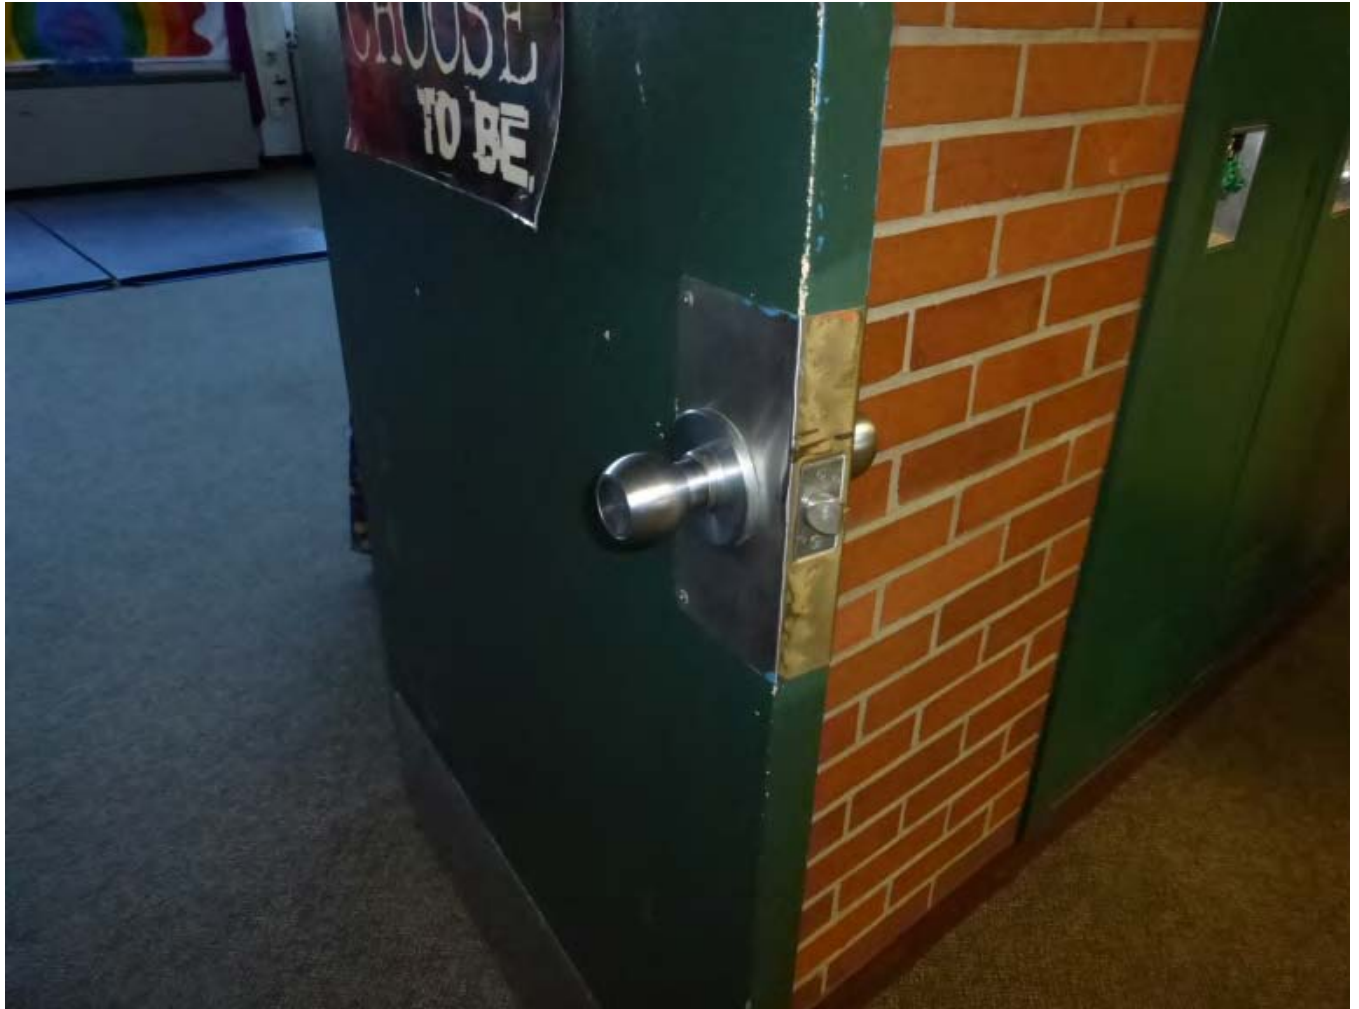
| No. | Item/Description | Location | Photo No. | Cons. | Need | Freq. | Score | Energy | Notes | Action | Qty. | Unit | Architectural | | Mechanical | | Electrical | | 2014 Project Cost |
|---|--|--|---|---|---|---|---|---|---|---|---|---|---|---|---|---|---|---|---|
| BI-1 | Original Hollow Metal, Wood Doors and Frames | Entire Building | BI-1 | 4 | 3 | 1 | 8 | | Deteriorated, nonfunctional and do not meet current code requirements. | Replace with wood doors and hollow metal frames. | 132 | EA | \$ 2,350.00 | \$ 310,200 | | | | | \$ 467,782 |

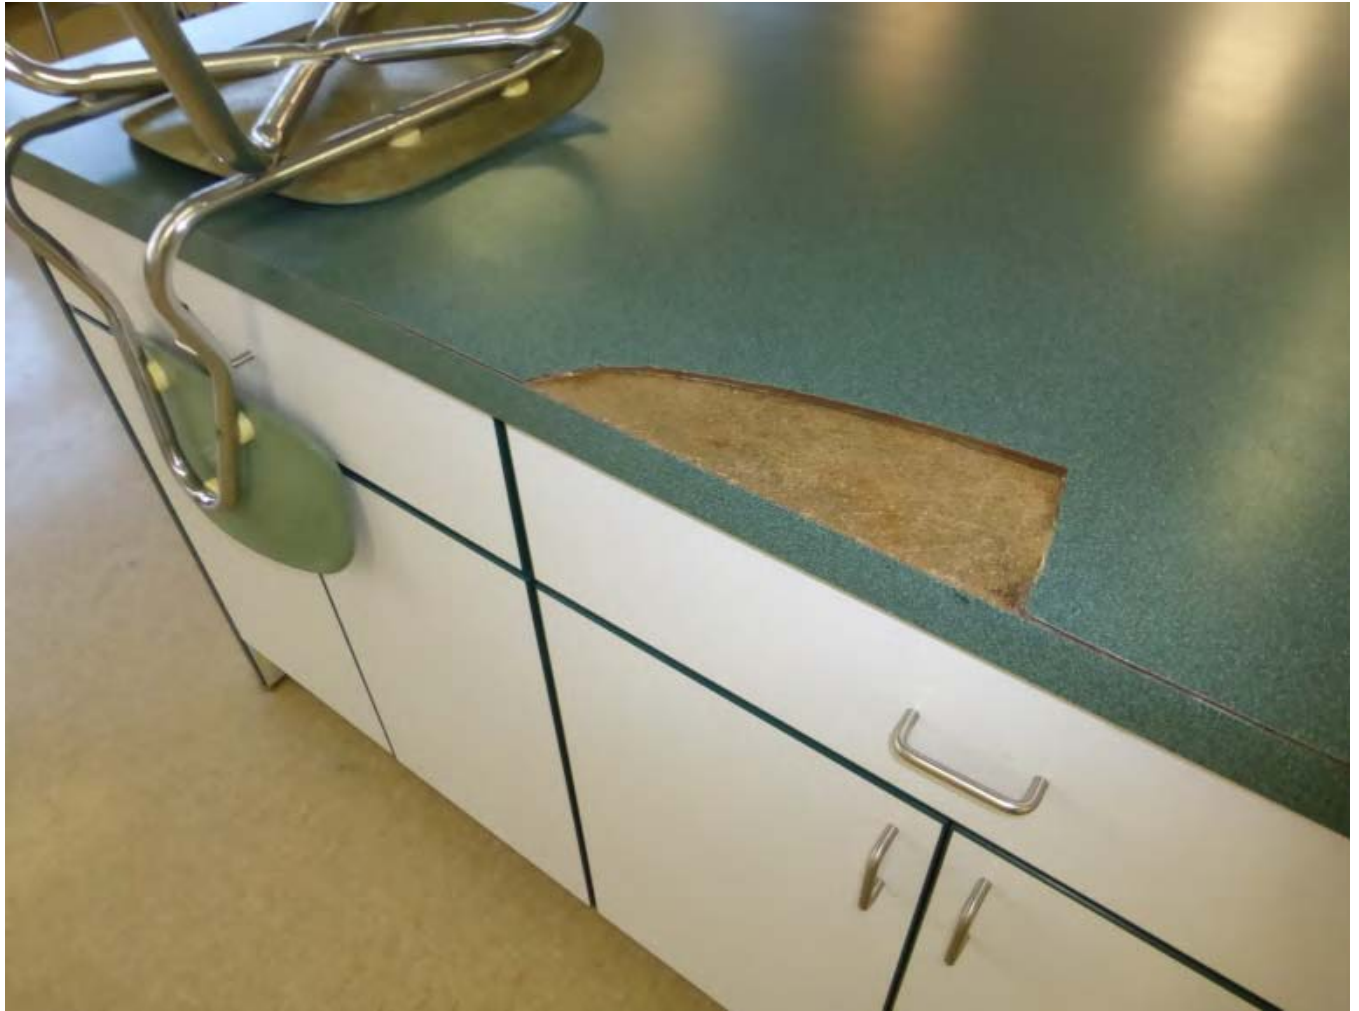
| No. | Item/Description | Location | Photo No. | Cons. | Need | Freq. | Score | Energy | Notes | Action | Qty. | Unit | Architectural | | Mechanical | | Electrical | | 2014 Project Cost |
|---|--|--|---|---|---|---|---|---|---|---|---|---|---|---|---|---|---|---|---|
| BI-2 | Plastic Laminate Counter Tops | Home Economics | BI-2 | 4 | 3 | 2 | 9 | | Delaminating. | Replace with solid surface material and new sinks with point of use TMV. | 100 | LF | \$ 150.00 | \$ 15,000 | \$ 90.00 | \$ 9,000 | | | \$ 36,192 |

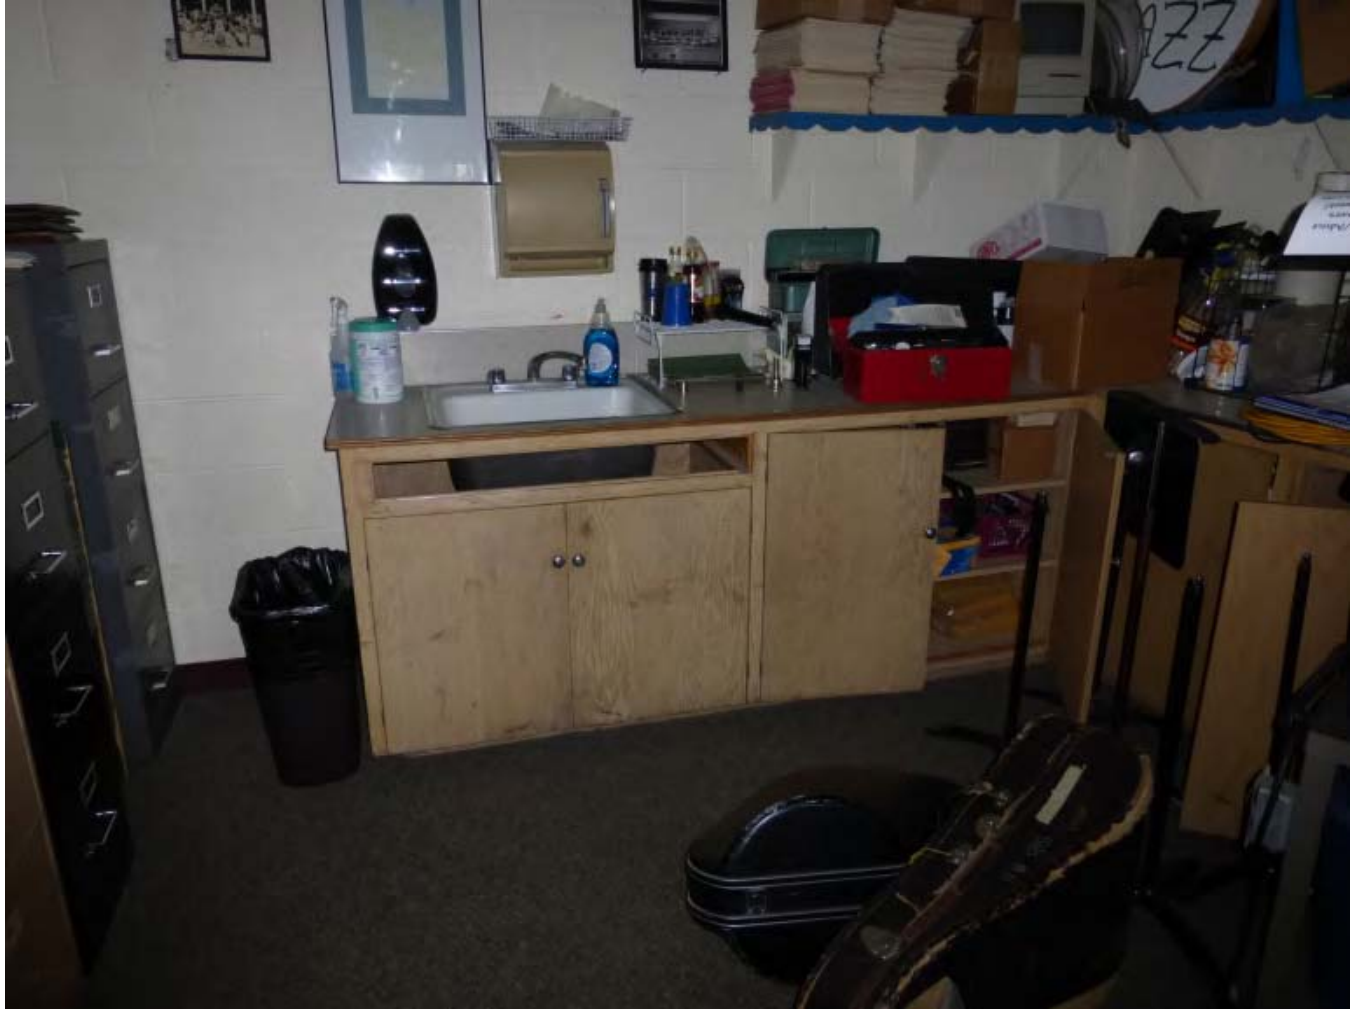
| No. | Item/Description | Location | Photo No. | Cons. | Need | Freq. | Score | Energy | Notes | Action | Qty. | Unit | Architectural | | Mechanical | | Electrical | | 2014 Project Cost |
|---|--|--|---|---|---|---|---|---|---|---|---|---|---|---|---|---|---|---|---|
| BI-4 | Casework Cabinets | Band Classroom | BI-4 | 3 | 3 | 2 | 8 | | Poor condition. | Replace cabinets. | 15 | LF | \$ 300.00 | \$ 4,500 | | | | | \$ 6,786 |

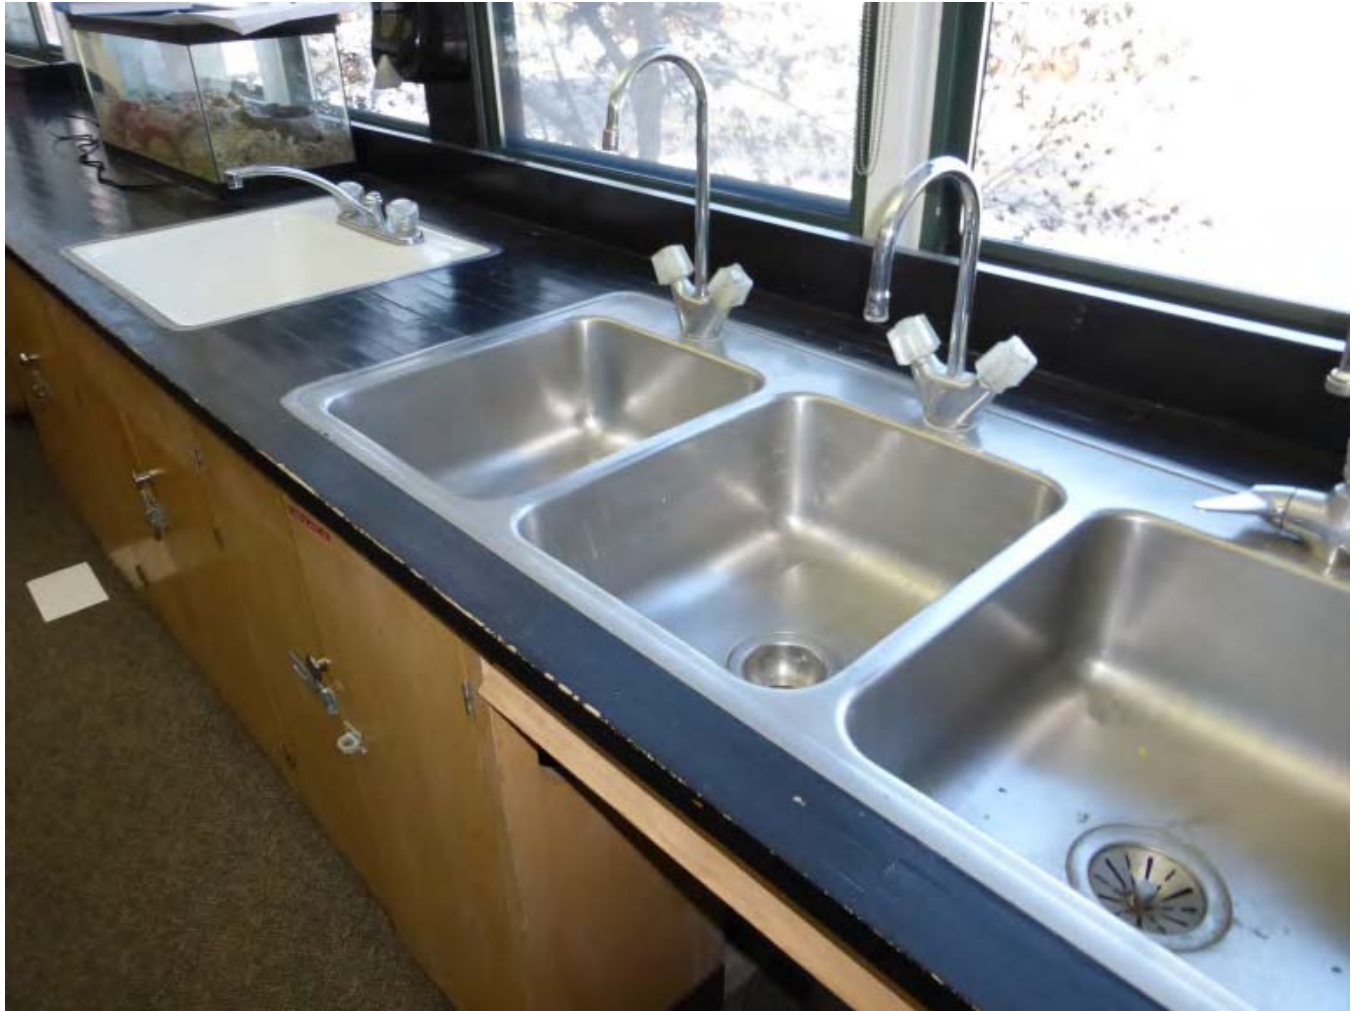
| No. | Item/Description | Location | Photo No. | Cons. | Need | Freq. | Score | Energy | Notes | Action | Qty. | Unit | Architectural | | Mechanical | | Electrical | | 2014 Project Cost |
|---|--|--|---|---|---|---|---|---|---|---|---|---|---|---|---|---|---|---|---|
| BI-5 | Wood Cabinets and Counter Tops | Science Classrooms | BI-5 | 4 | 5 | 2 | 11 | | Poor condition. | Replace cabinets and provide epoxy counter tops. | 96 | LF | \$ 350.00 | \$ 33,600 | | | | | \$ 50,669 |

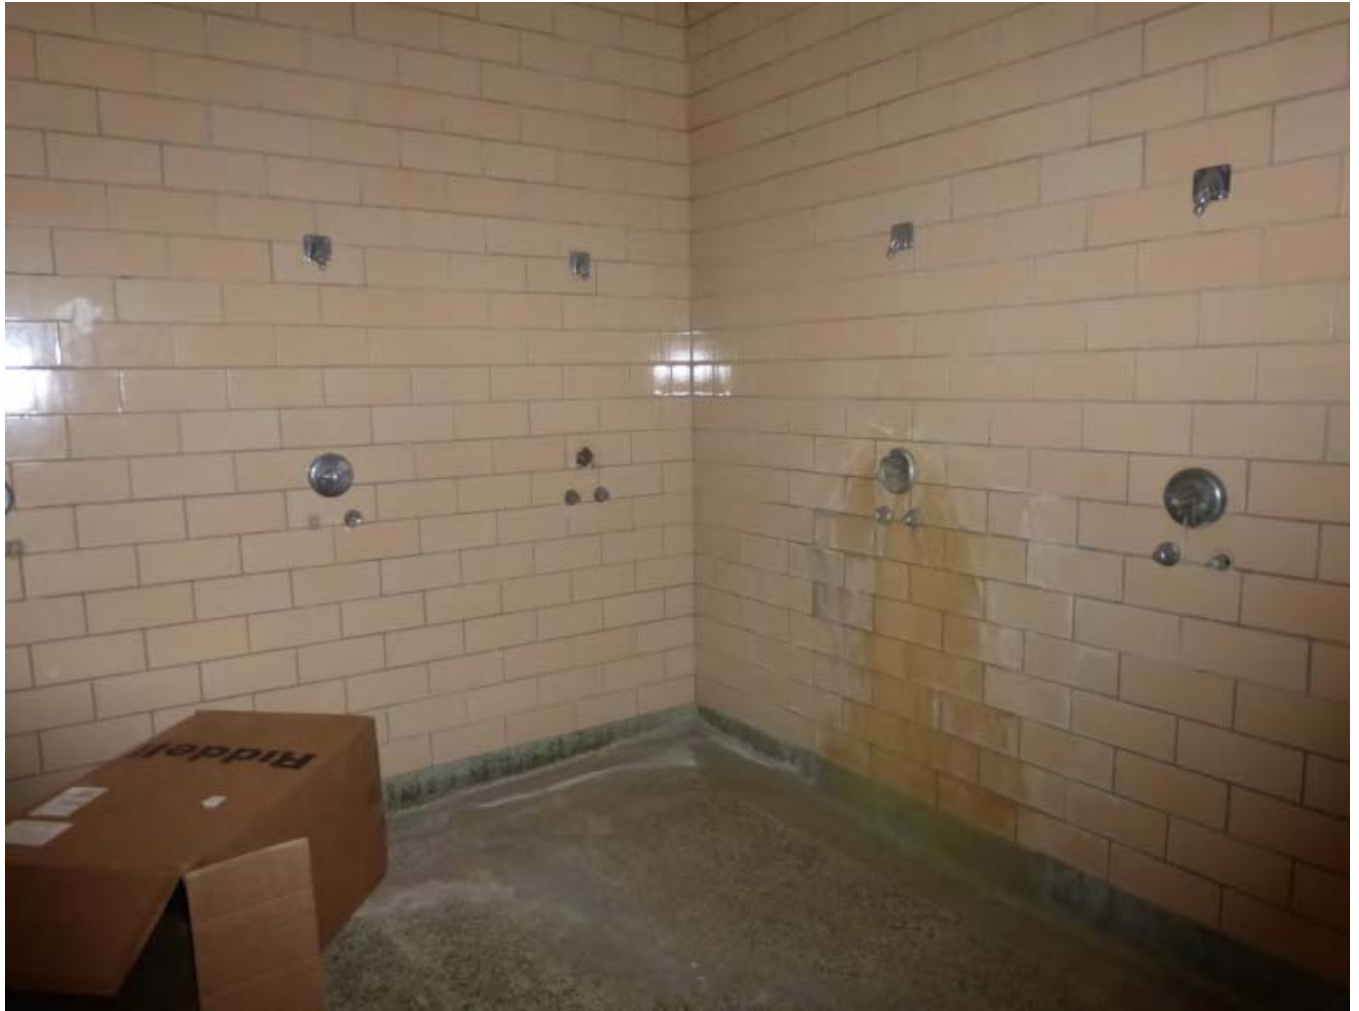
| No. | Item/Description | Location | Photo No. | Cons. | Need | Freq. | Score | Energy | Notes | Action | Qty. | Unit | Architectural | | Mechanical | | Electrical | | 2014 Project Cost |
|---|--|--|---|---|---|---|---|---|---|---|---|---|---|---|---|---|---|---|---|
| BI-6 | Shower Rooms | Boy's and Girl's Locker Rooms | BI-6 | 4 | 5 | 2 | 11 | | Rooms are abandoned and in need of updating and repair. | Reduce/replace number of shower heads, add barrier free shower stall and repair floor, wall and ceiling finishes. | 380 | SF | \$ 40.00 | \$ 15,200 | \$ 34.00 | \$ 12,920 | \$ 5.00 | \$ 1,900 | \$ 45,270 |
