# ANDERSON MIDDLE SCHOOL

**BERKLEY SCHOOLS**  
**Comprehensive Academic Spaces, Facilities and Technologies Needs Assessment**

**Anderson Middle School**

| Address: 3205 Catalpa, Berkley, Michigan<br>Bldg. Area: 95,908 GSF<br>No. of Floors: 2<br>Year Built: 1956<br>Evaluation Date: January 2014 | <b>Item No. Codes</b><br>AB: Accessibility Improvement/Building Code<br>AD: Academic/Space Deficiencies<br>BE: Building Exterior<br>BI: Building Interior<br>BS: Building System<br>ES: Electrical System<br>MS: Mechanical System<br>PS: Plumbing System<br>SC: Site Circulation<br>SE: Specialty Equipment/Other<br>IT: Technology | | <b>Building Deficiencies Priorities by Category</b><br><div style="display: flex; justify-content: space-around;"> <div style="background-color: yellow; padding: 5px;"> <b>Consequences of the Problem</b><br/> 1. Hazards<br/> 2. Interruption<br/> 3. Deterioration<br/> 4. Utility<br/> 5. Energy </div> <div style="background-color: lightgreen; padding: 5px;"> <b>Need</b><br/> 1. Critical<br/> 2. Urgent<br/> 3. Necessary<br/> 4. ADA<br/> 5. Desirable </div> <div style="background-color: orange; padding: 5px;"> <b>Frequency of Use</b><br/> 1. Constant<br/> 2. Frequent<

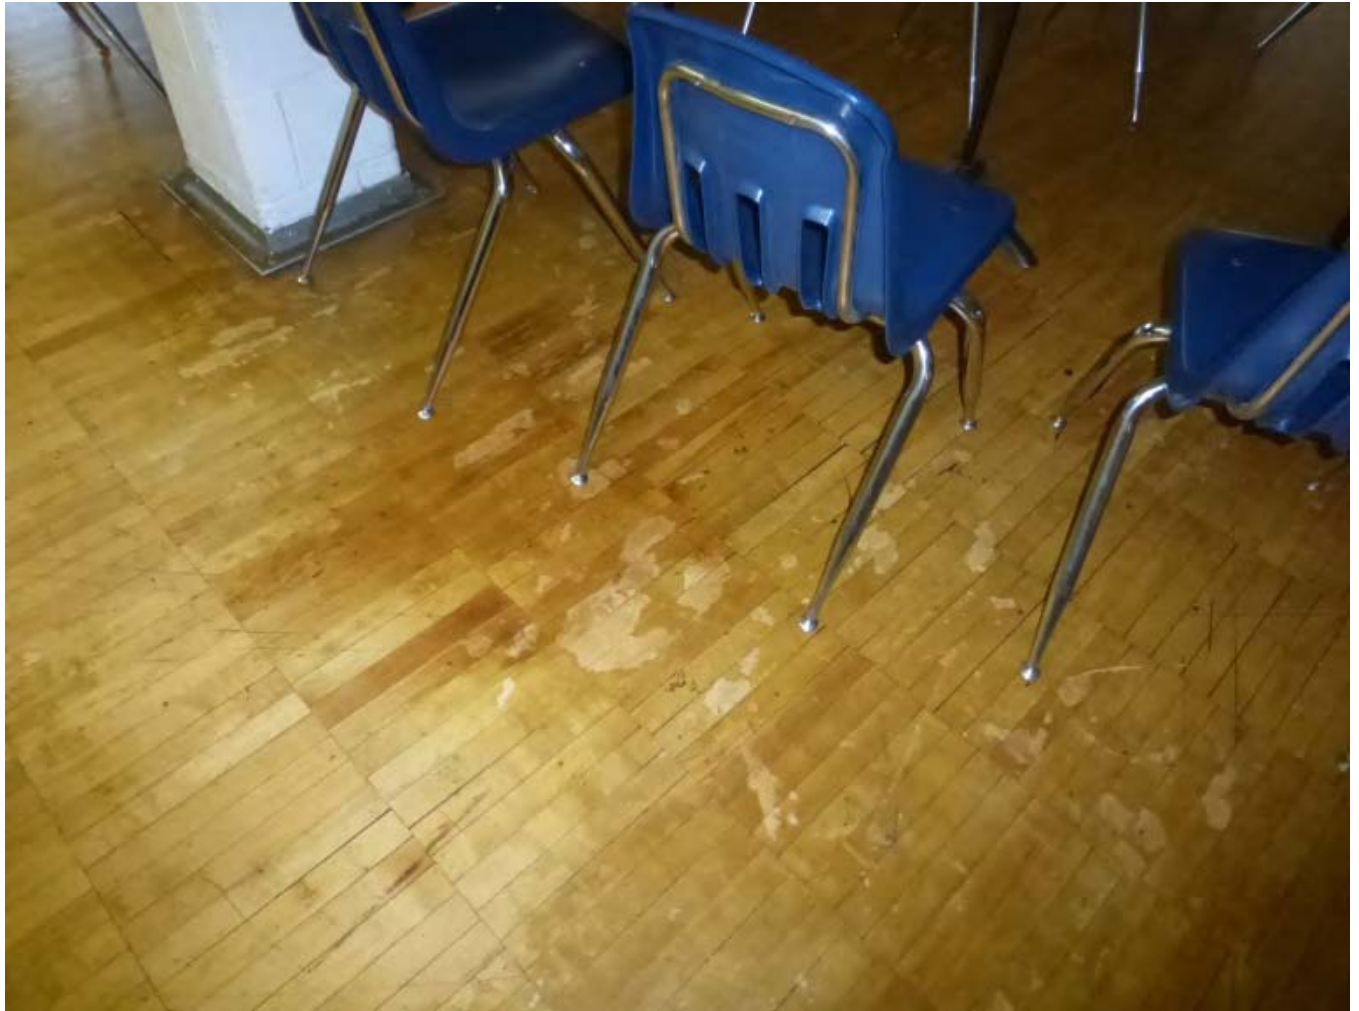
BI-7A

| No. | Item/Description | Location | Photo No. | Cons. | Need | Freq. | Score | Energy | Notes | Action | Qty. | Unit | Architectural | | Mechanical | | Electrical | | 2014 Project Cost |
|---|--|--|---|---|---|---|---|---|---|---|---|---|---|---|---|---|---|---|---|
| BI-7 | Wood Floor | Music and Gym Stage | BI-7A<br>BI-7B | 4 | 5 | 3 | 12 | | Poor condition. | Refinish wood floors. | 1,875 | SF | \$ 3.50 | \$ 6,563 | | | | | \$ 9,896 |

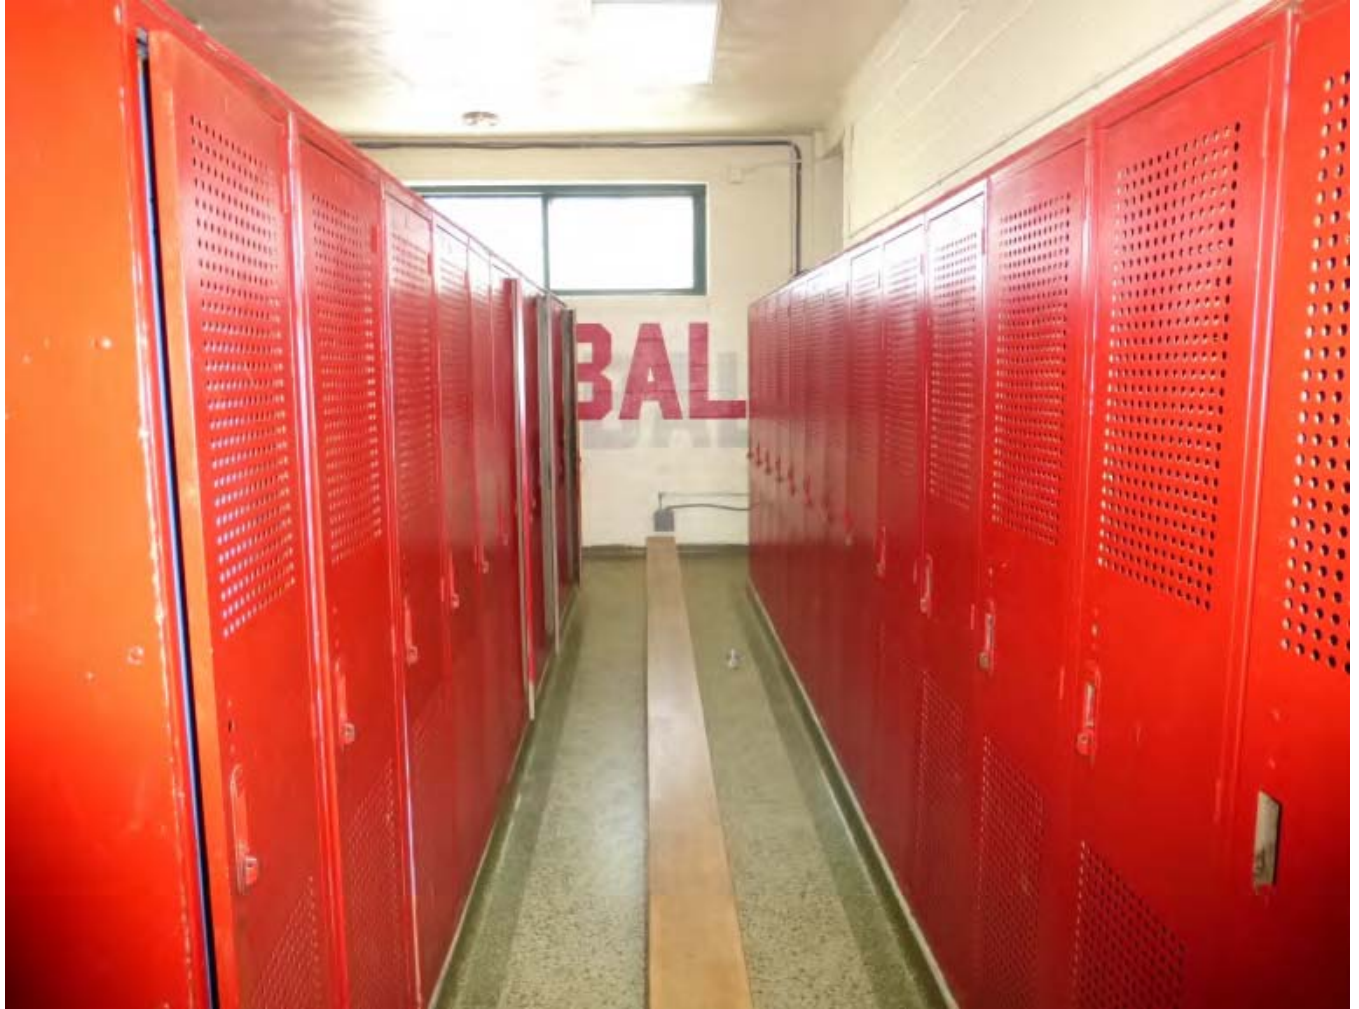
| No. | Item/Description | Location | Photo No. | Cons. | Need | Freq. | Score | Energy | Notes | Action | Qty. | Unit | Architectural | | Mechanical | | Electrical | | 2014 Project Cost |
|---|--|--|---|---|---|---|---|---|---|---|---|---|---|---|---|---|---|---|---|
| BI-8 | Lockers | Boy's, Girl's and Team Locker Rooms | BI-8 | 4 | 5 | 2 | 11 | | Poor condition. | Replace lockers and benches. | 400 | LF | \$ 550.00 | \$ 220,000 | | | | | \$ 331,760 |

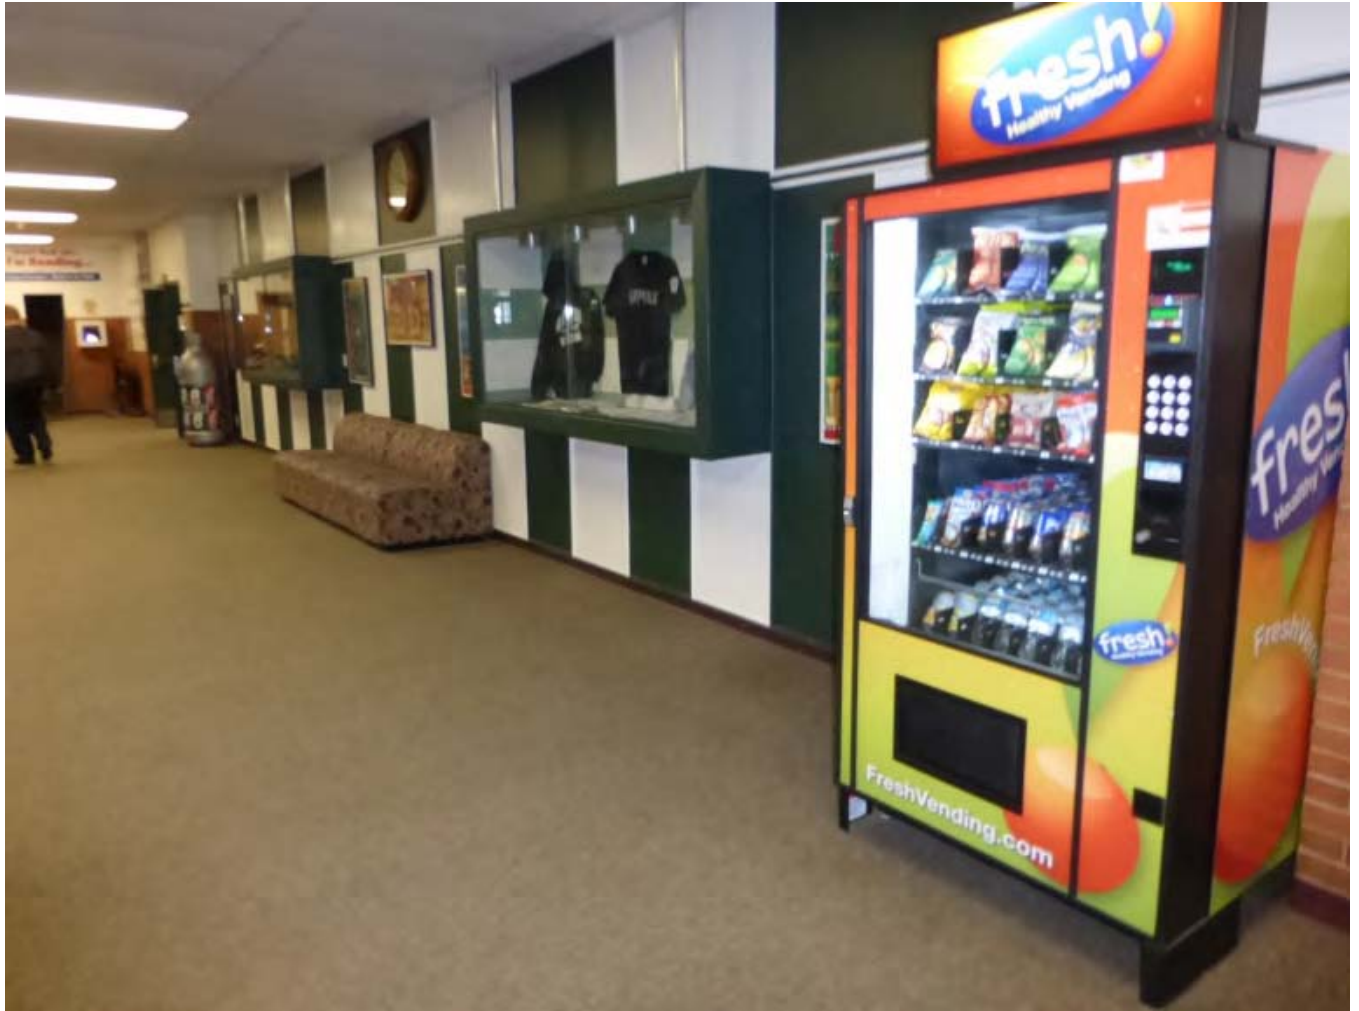
| No. | Item/Description | Location | Photo No. | Cons. | Need | Freq. | Score | Energy | Notes | Action | Qty. | Unit | Architectural | | Mechanical | | Electrical | | 2014 Project Cost |
|--|---|--|---|---|---|---|---|---|---|--|---|---|---|---|---|---|---|---|---|
| AB-1 | Furniture and Equipment | Corridors | AB-1 | 1 | 4 | 1 | 6 | | Loose furniture and equipment not permitted in corridors. | Remove furniture and equipment. | -- | -- | | | | | | | |

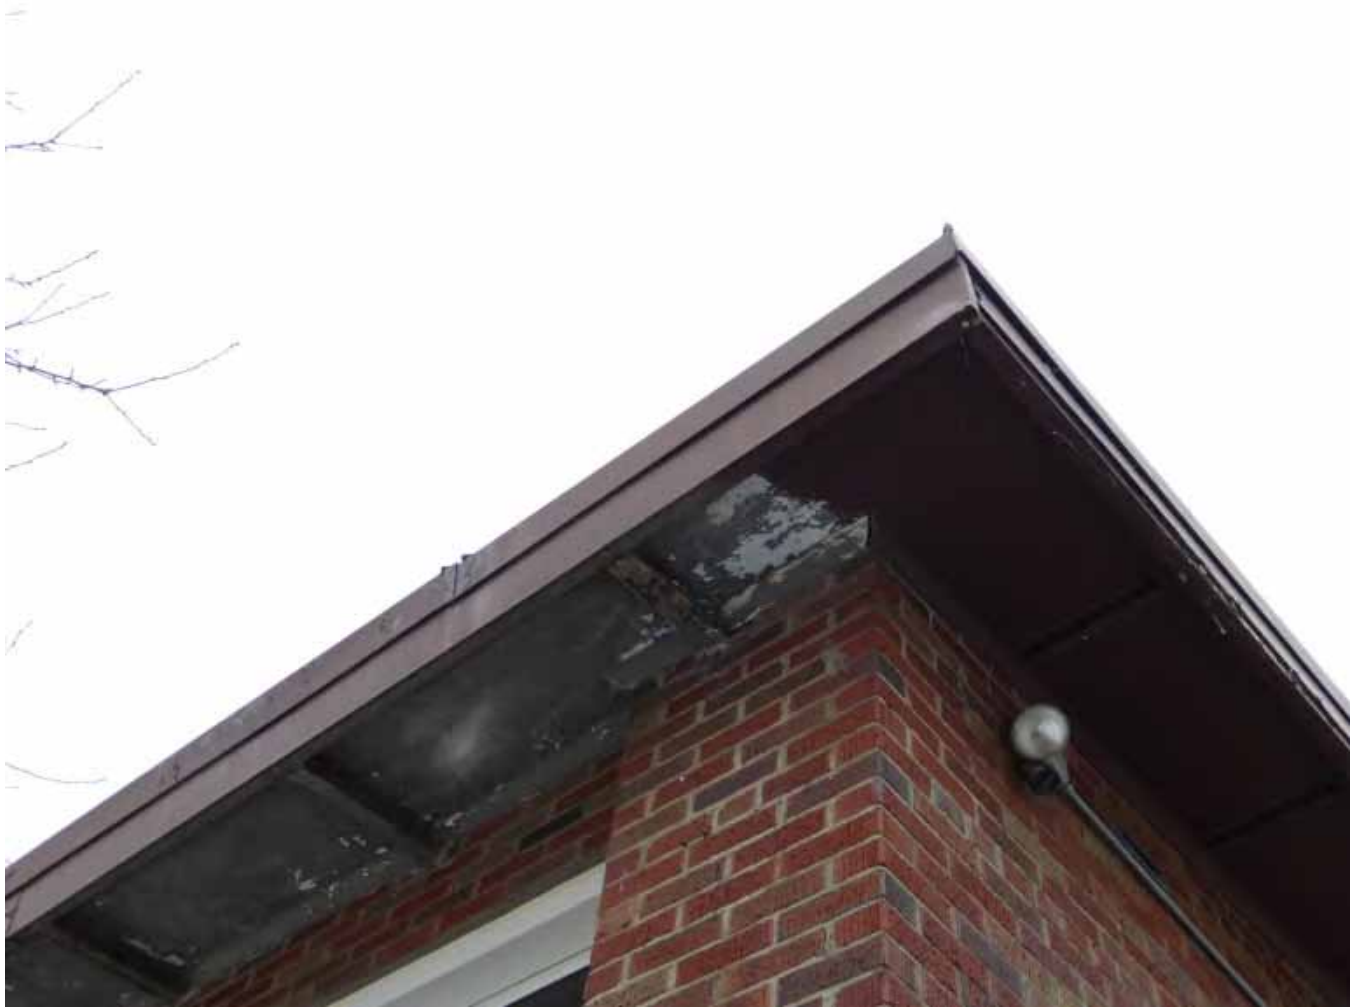
| No. | Item/Description | Location | Photo No. | Cons. | Need | Freq. | Score | Energy | Notes | Action | Qty. | Unit | Architectural | | Mechanical | | Electrical | | 2014 Project Cost |
|---|---|---|---|---|---|---|---|---|--|--|---|---|---|---|---|---|---|---|---|
| BE-1 | Overhangs/Soffits | Entire Building | BE-1 | 3 | 3 | 2 | 8 | | Paint is peeling and steel is rusted. | Provide aluminum soffit panels. | 1,320 | LF | \$ 6.00 | \$ 7,920 | | | | | \$ 11,943 |

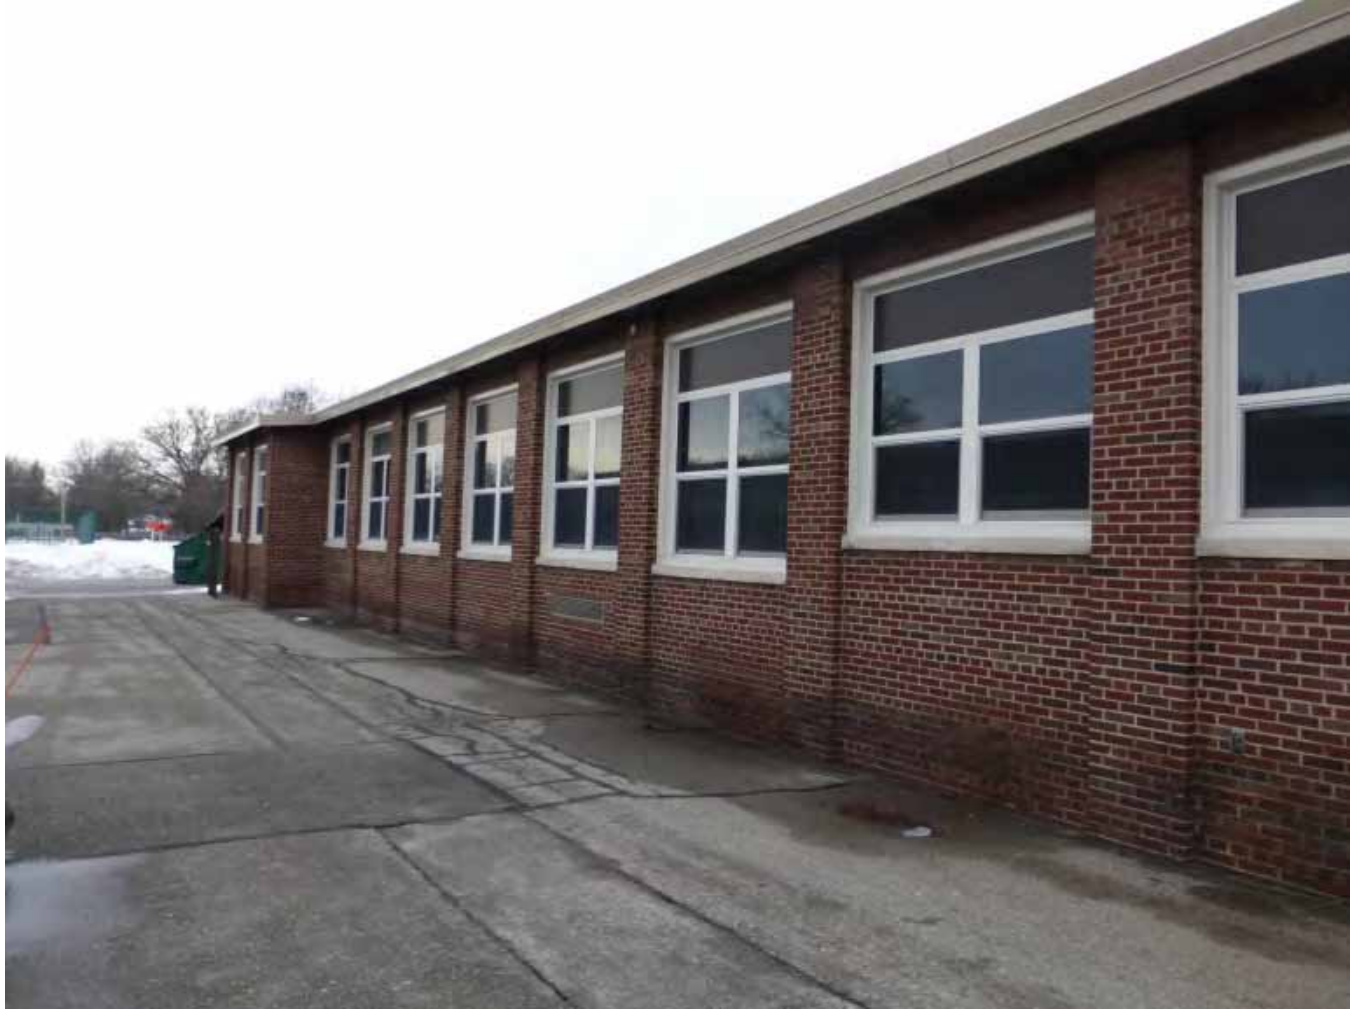
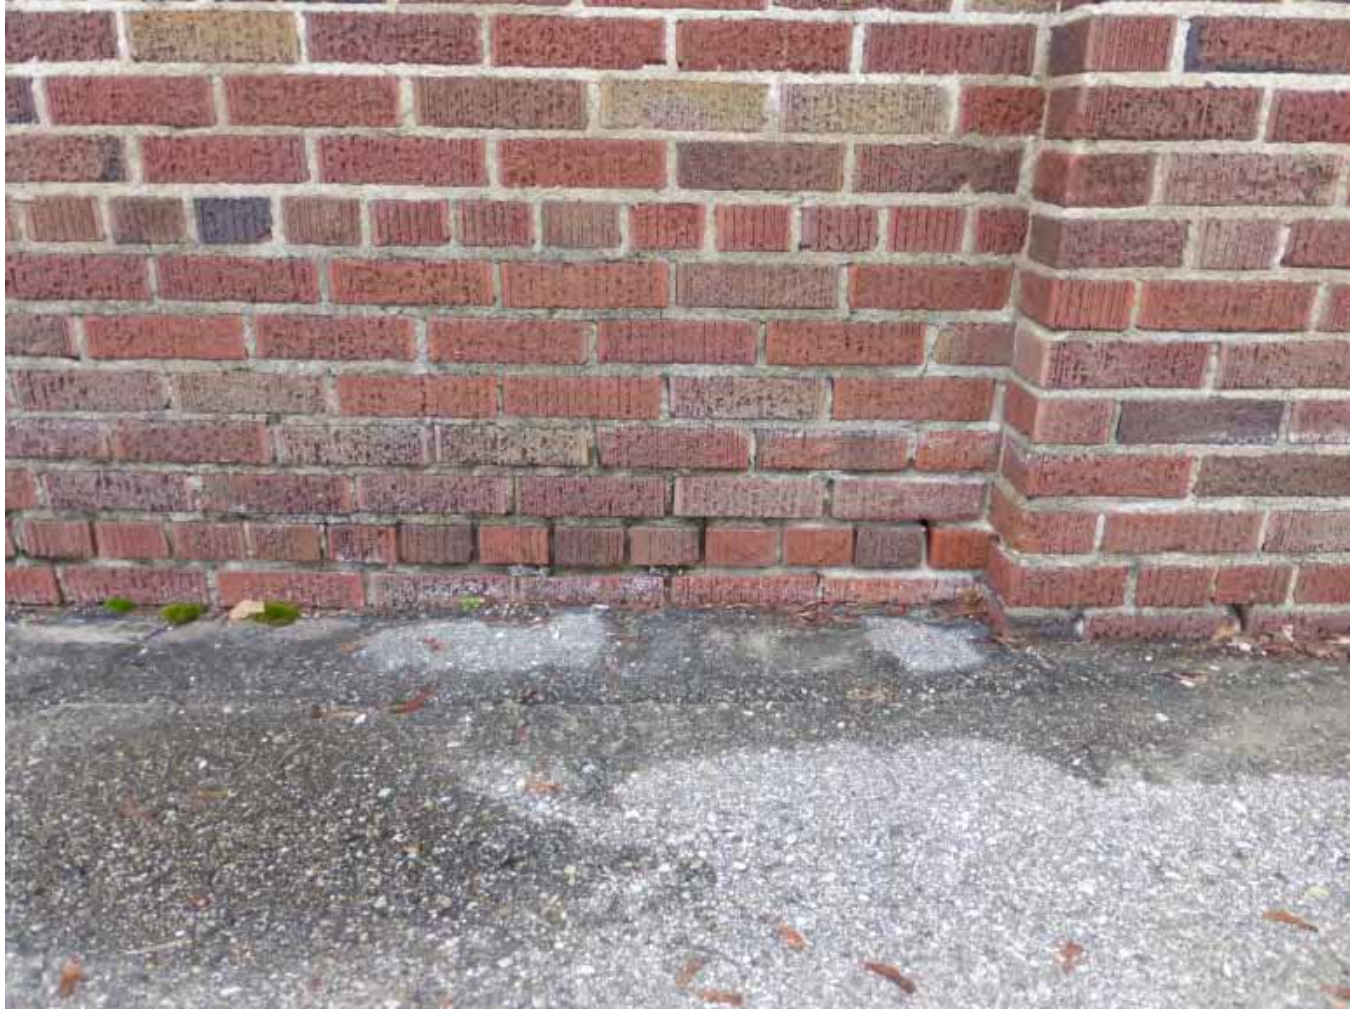
| No. | Item/Description | Location | Photo No. | Cons. | Need | Freq. | Score | Energy | Notes | Action | Qty. | Unit | Architectural | | Mechanical | | Electrical | | 2014 Project Cost |
|---|---|---|---|---|---|---|---|---|--|--|---|---|---|---|---|---|---|---|---|
| BE-2 | Brick Veneer at Base of Walls | Where Roofs Drain to Pavement Adjacent to Walls | BE-2 | 3 | 3 | 2 | 8 | | Brick and mortar joints deteriorated from roof water drainage. | Control roof drainage where possible and clean/tuck point brick. | 1,300 | SF | \$ 10.50 | \$ 13,650 | | | | | \$ 20,584 |

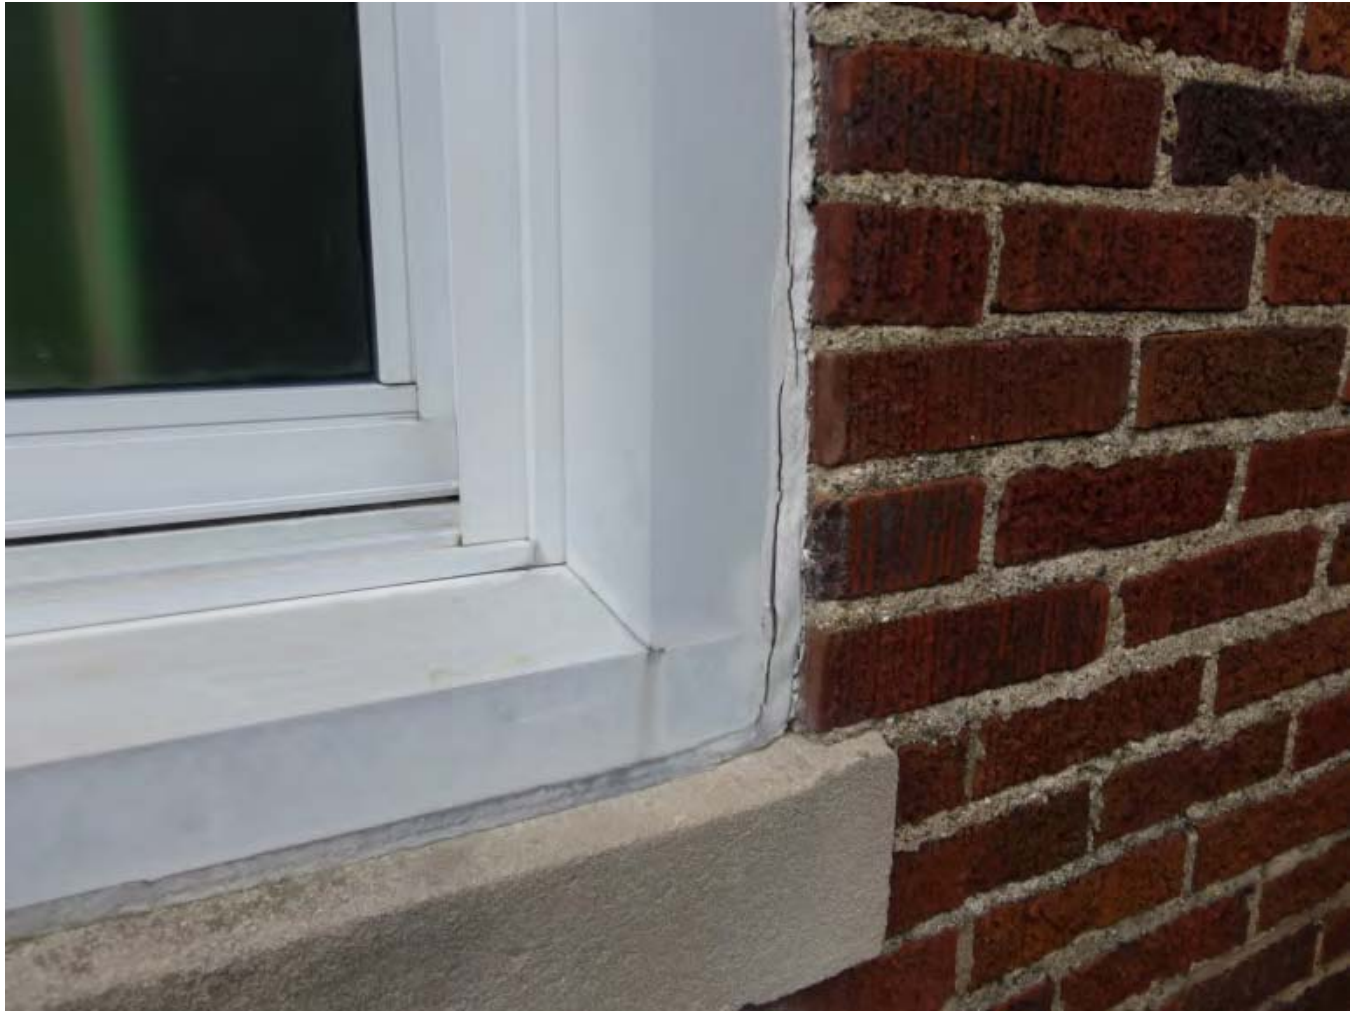
| No. | Item/Description | Location | Photo No. | Cons. | Need | Freq. | Score | Energy | Notes | Action | Qty. | Unit | Architectural | | Mechanical | | Electrical | | 2014 Project Cost |
|---|---|---|---|---|---|---|---|---|--|--|---|---|---|---|---|---|---|---|---|
| BE-3 | Sealant at Door and Window Openings | Entire Building | BE-3 | 3 | 3 | 2 | 8 | | Sealant deteriorated and cracked. | Replace sealant. | 2,500 | LF | \$ 4.75 | \$ 11,875 | | | | | \$ 17,908 |

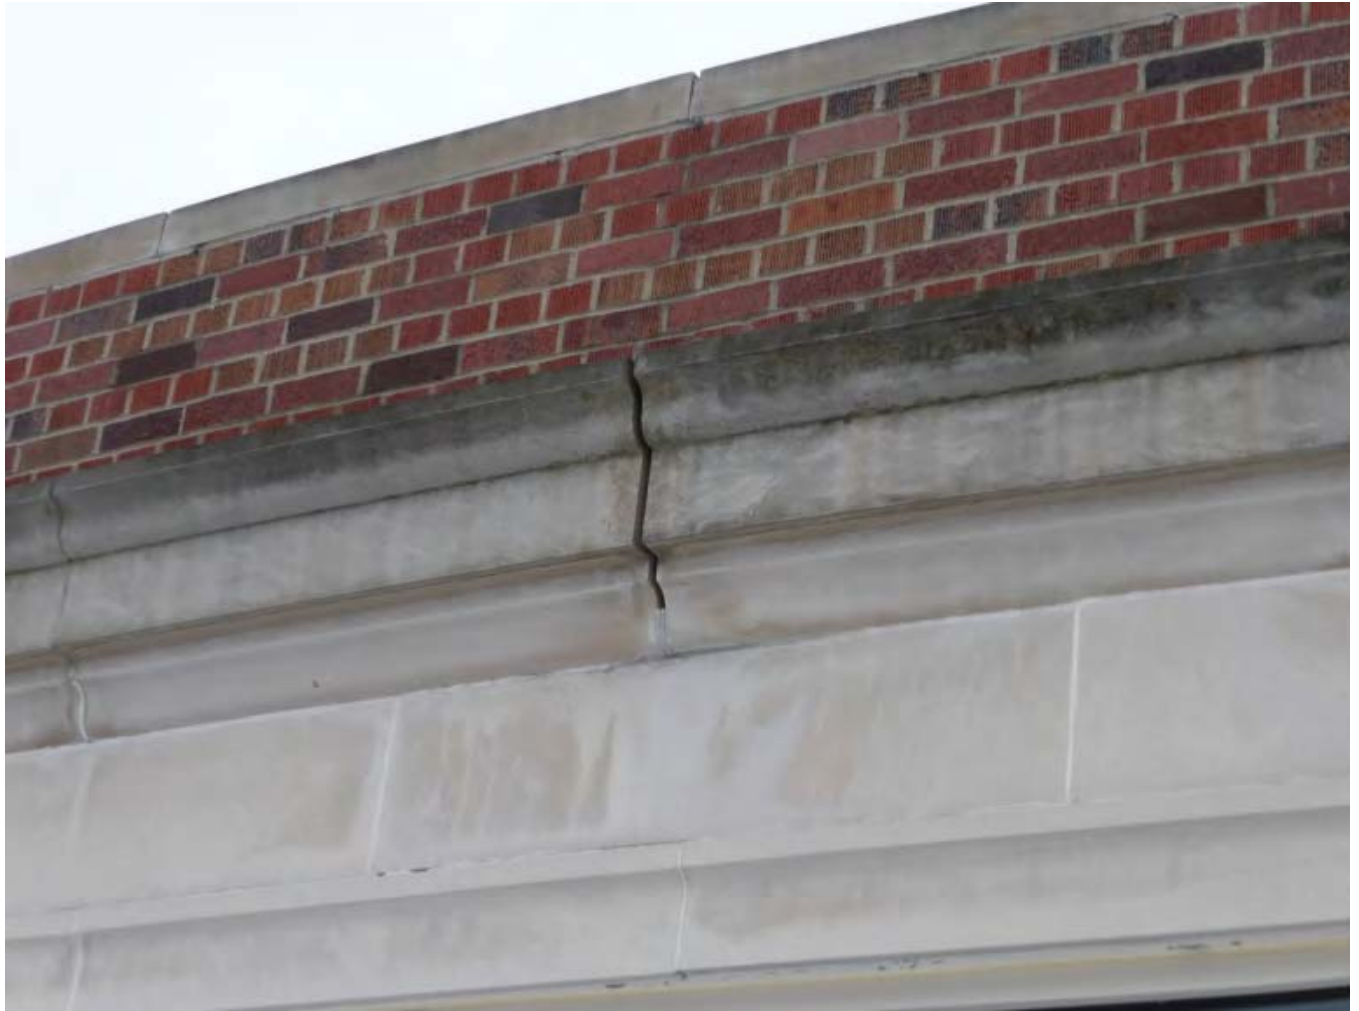
| No. | Item/Description | Location | Photo No. | Cons. | Need | Freq. | Score | Energy | Notes | Action | Qty. | Unit | Architectural | | Mechanical | | Electrical | | 2014 Project Cost |
|---|---|---|---|---|---|---|---|---|--|--|---|---|---|---|---|---|---|---|---|
| BE-4 | Sealant at Stone | Media Center | BE-4 | 3 | 3 | 2 | 8 | | Sealant at joints is missing. | Replace sealant. | 600 | LF | \$ 4.75 | \$ 2,850 | | | | | \$ 4,298 |

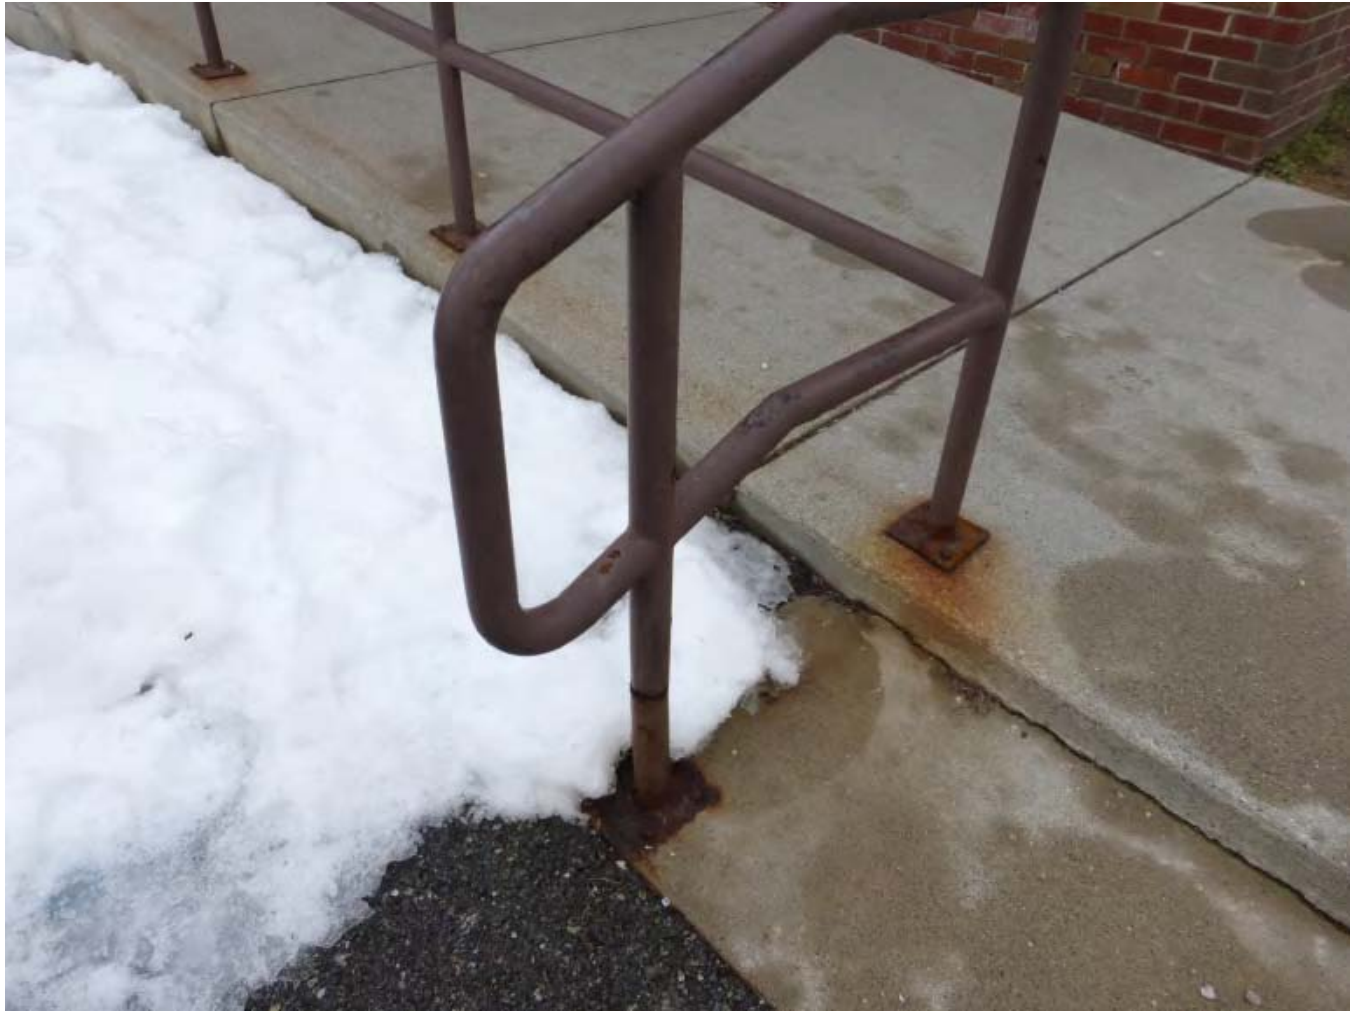
| No. | Item/Description | Location | Photo No. | Cons. | Need | Freq. | Score | Energy | Notes | Action | Qty. | Unit | Architectural | | Mechanical | | Electrical | | 2014 Project Cost |
|---|---|---|---|---|---|---|---|---|--|--|---|---|---|---|---|---|---|---|---|
| BE-5 | Steel Stair/Ramp Railings | Building Entrances | BE-5 | 3 | 3 | 2 | 8 | | Paint is peeling and steel is rusted. | Paint railings. | 115 | LF | \$ 5.00 | \$ 575 | | | | | \$ 867 |

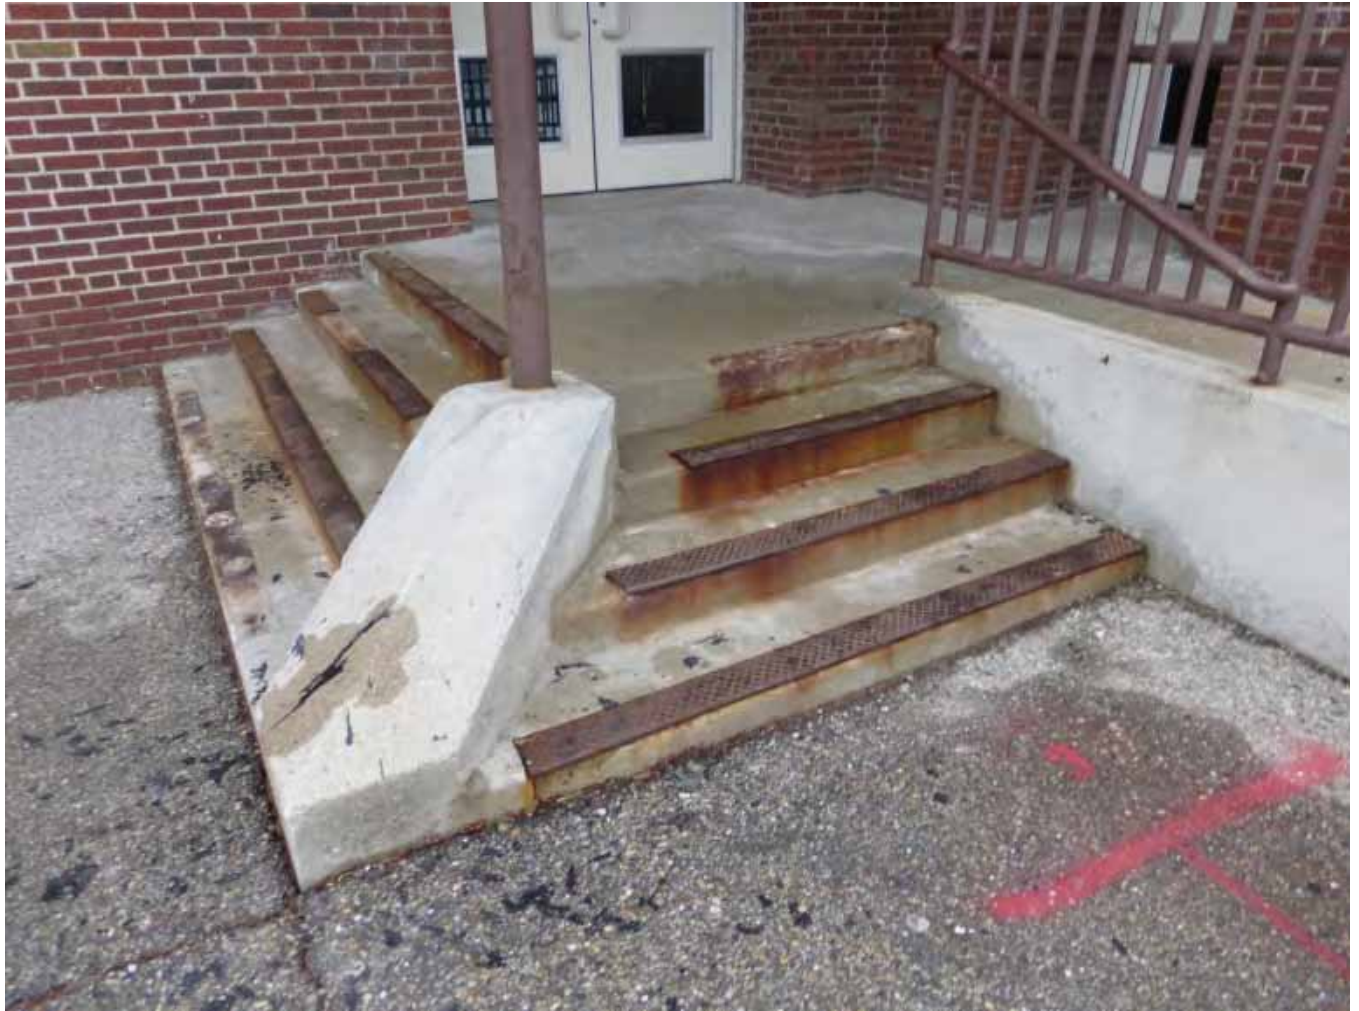
| No. | Item/Description | Location | Photo No. | Cons. | Need | Freq. | Score | Energy | Notes | Action | Qty. | Unit | Architectural | | Mechanical | | Electrical | | 2014 Project Cost |
|---|---|---|---|---|---|---|---|---|--|--|---|---|---|---|---|---|---|---|---|
| BE-6 | Metal Stair Treads | Southwest Building Entrance | BE-6 | 1 | 2 | 2 | 5 | | Treads are missing and rusted. | Replace with aluminum treads. | 50 | LF | \$ 60.00 | \$ 3,000 | | | | | \$ 4,524 |

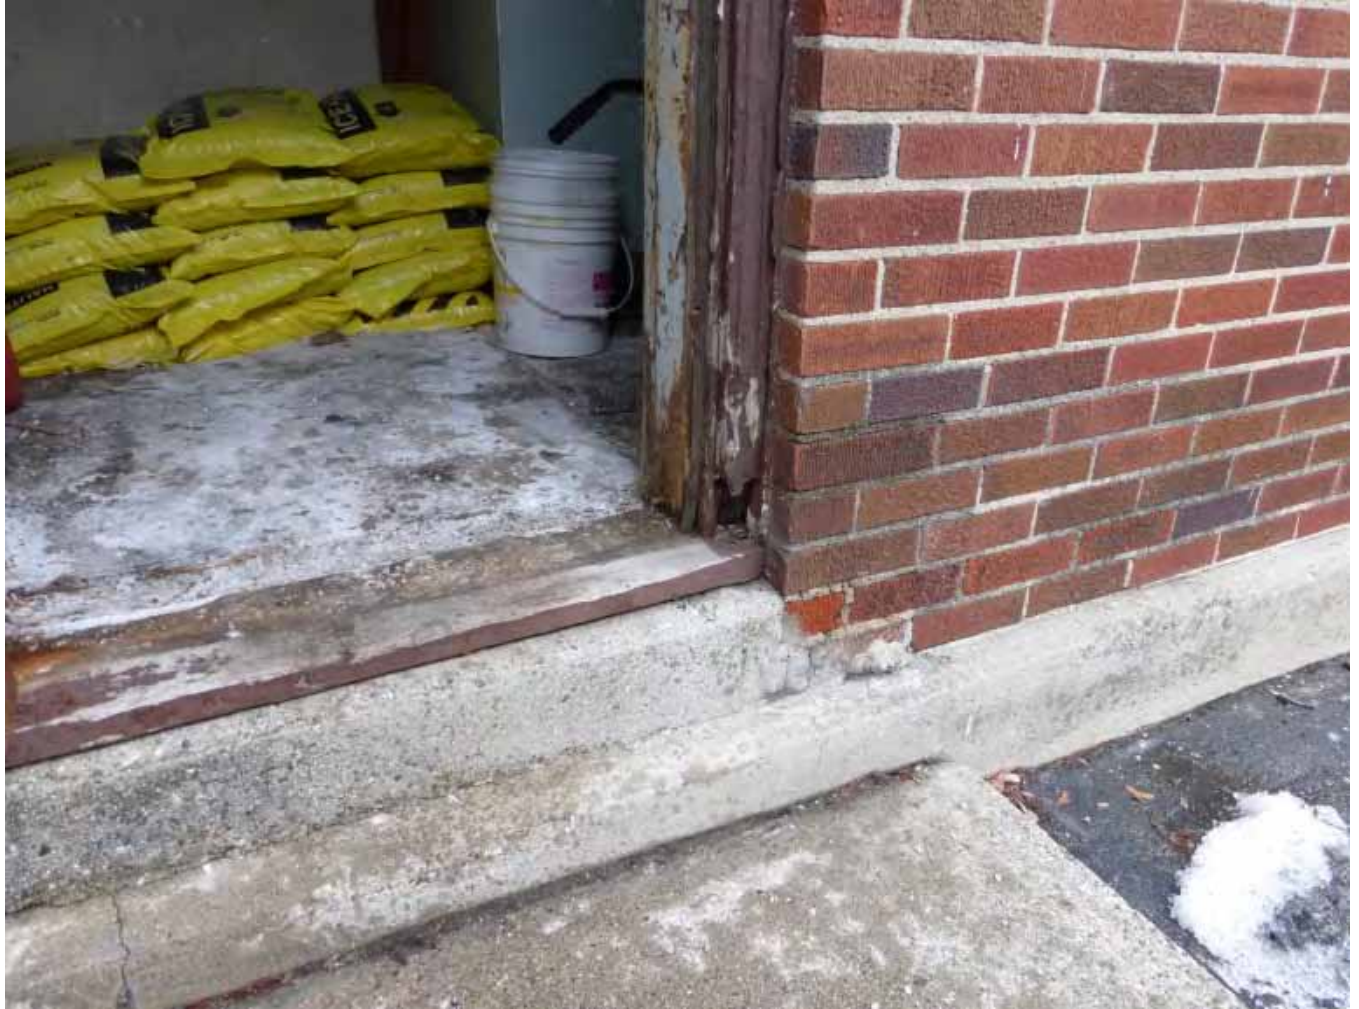
| No. | Item/Description | Location | Photo No. | Cons. | Need | Freq. | Score | Energy | Notes | Action | Qty. | Unit | Architectural | | Mechanical | | Electrical | | 2014 Project Cost |
|---|---|---|---|---|---|---|---|---|--|--|---|---|---|---|---|---|---|---|---|
| BE-7 | Steel Doors and Frames | Entire Building | BE-7 | 3 | 3 | 1 | 7 | | Deteriorated and rusted. | Replace with aluminum frames and fiberglass reinforced panel doors. | 3 | EA | \$ 2,800.00 | \$ 8,400 | | | | | \$ 12,667 |

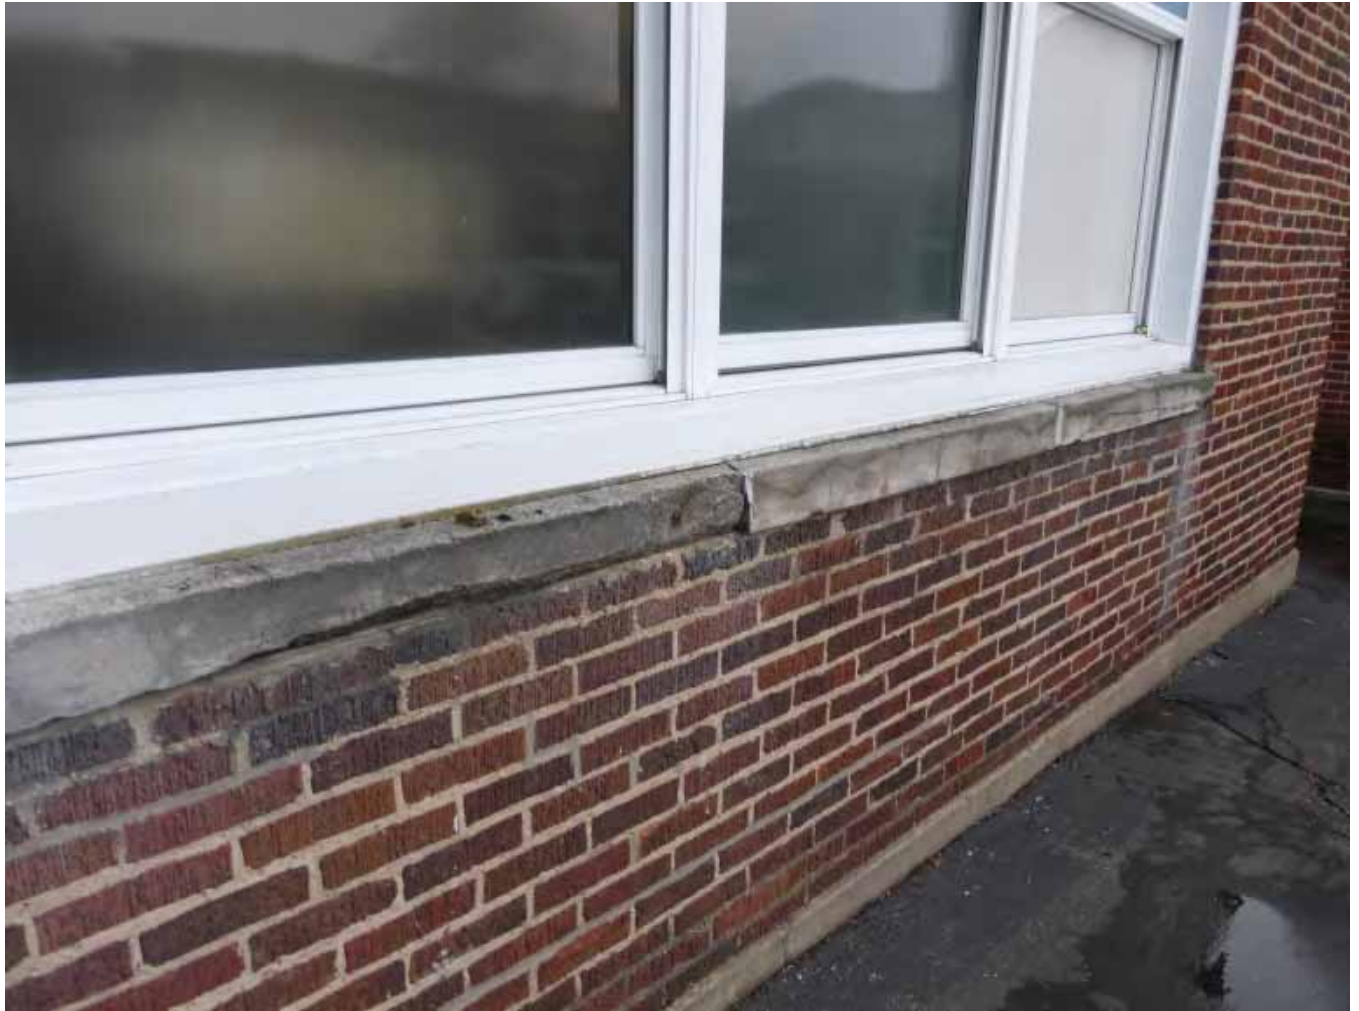
| No. | Item/Description | Location | Photo No. | Cons. | Need | Freq. | Score | Energy | Notes | Action | Qty. | Unit | Architectural | | Mechanical | | Electrical | | 2014 Project Cost |
|---|---|---|---|---|---|---|---|---|--|--|---|---|---|---|---|---|---|---|---|
| BE-8 | Stone Window Sills | Various Locations | BE-8 | 4 | 3 | 2 | 9 | | Deteriorated, sealant missing. | Replace sills and sealant. | 75 | | \$ 30.00 | \$ 2,250 | | | | | \$ 3,393 |

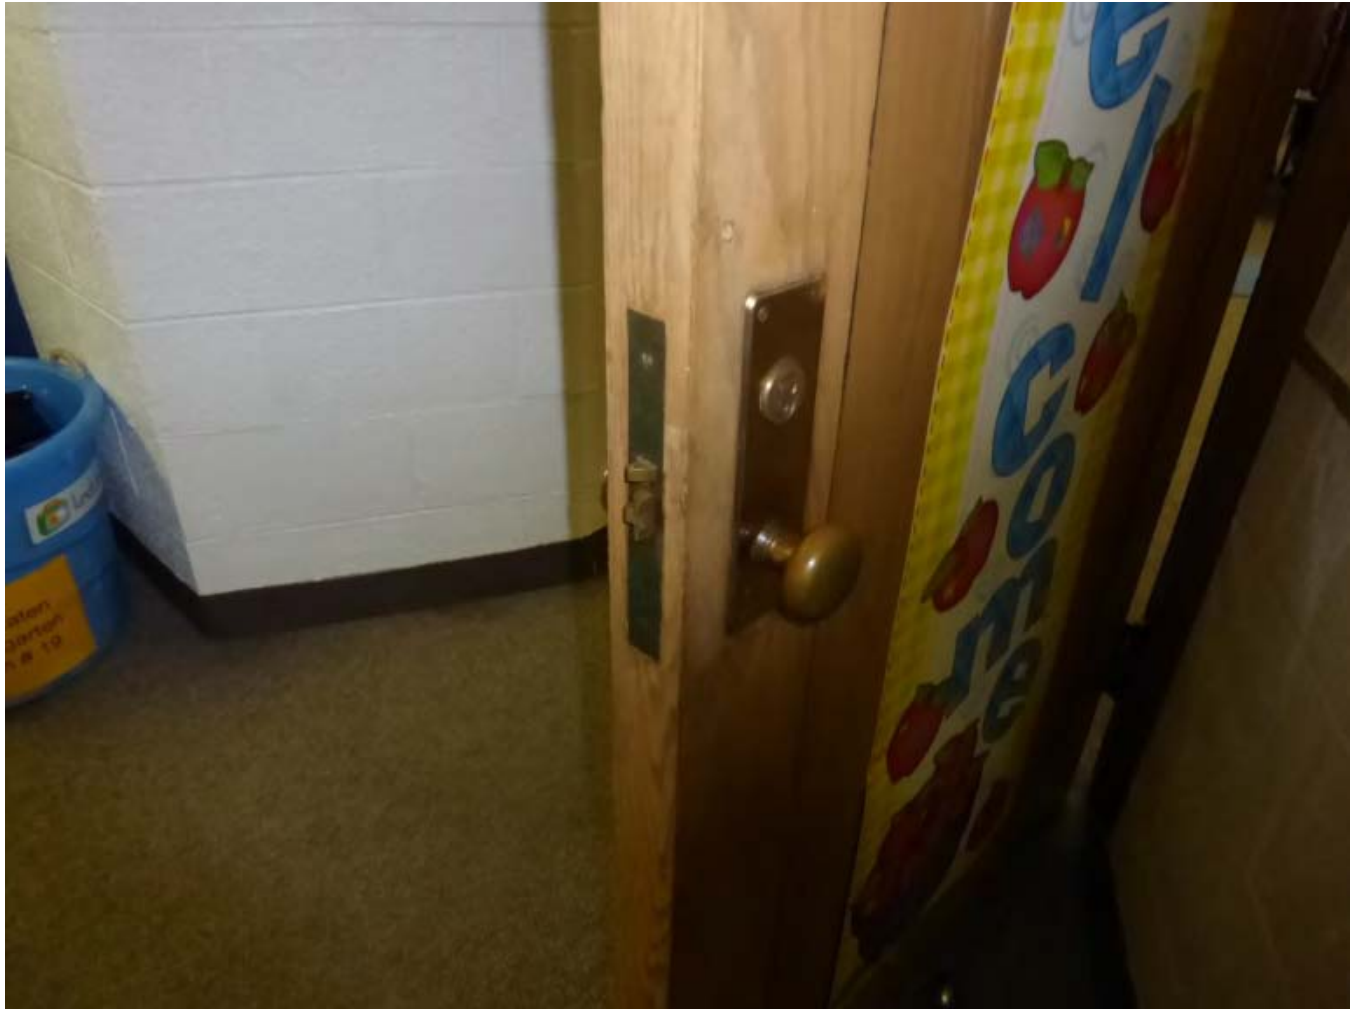
| No. | Item/Description | Location | Photo No. | Cons. | Need | Freq. | Score | Energy | Notes | Action | Qty. | Unit | Architectural | | Mechanical | | Electrical | | 2014 Project Cost |
|---|---|---|---|---|---|---|---|---|--|--|---|---|---|---|---|---|---|---|---|
| BI-1 | Original Wood Doors and Frames | Entire Building | BI-1 | 4 | 3 | 1 | 8 | | Deteriorated, nonfunctional and do not meet current code requirements. | Replace with wood doors and hollow metal frames. | 53 | EA | \$ 2,350.00 | \$ 124,550 | | | | | \$ 187,821 |

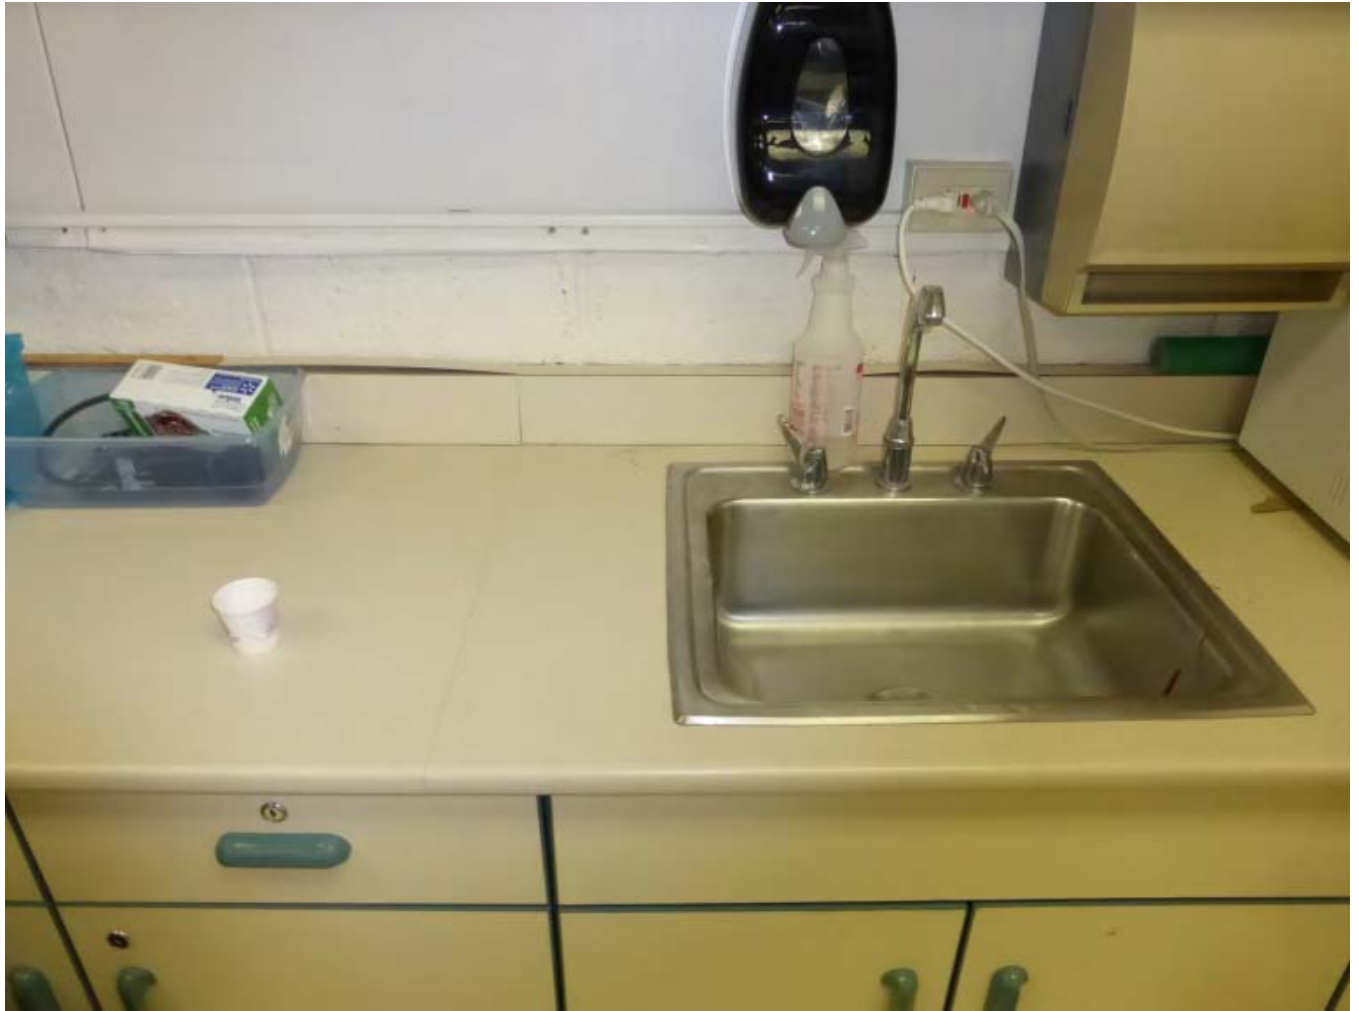
| No. | Item/Description | Location | Photo No. | Cons. | Need | Freq. | Score | Energy | Notes | Action | Qty. | Unit | Architectural | | Mechanical | | Electrical | | 2014 Project Cost |
|---|---|---|---|---|---|---|---|---|--|--|---|---|---|---|---|---|---|---|---|
| BI-2 | Plastic Laminate Counter Tops | Classrooms | BI-2 | 4 | 3 | 2 | 9 | | Delaminating. | Replace with solid surface material. And install new sink with point of use TMV. | 318 | LF | \$ 150.00 | \$ 47,700 | \$ 65.00 | \$ 20,670 | | | \$ 103,102 |

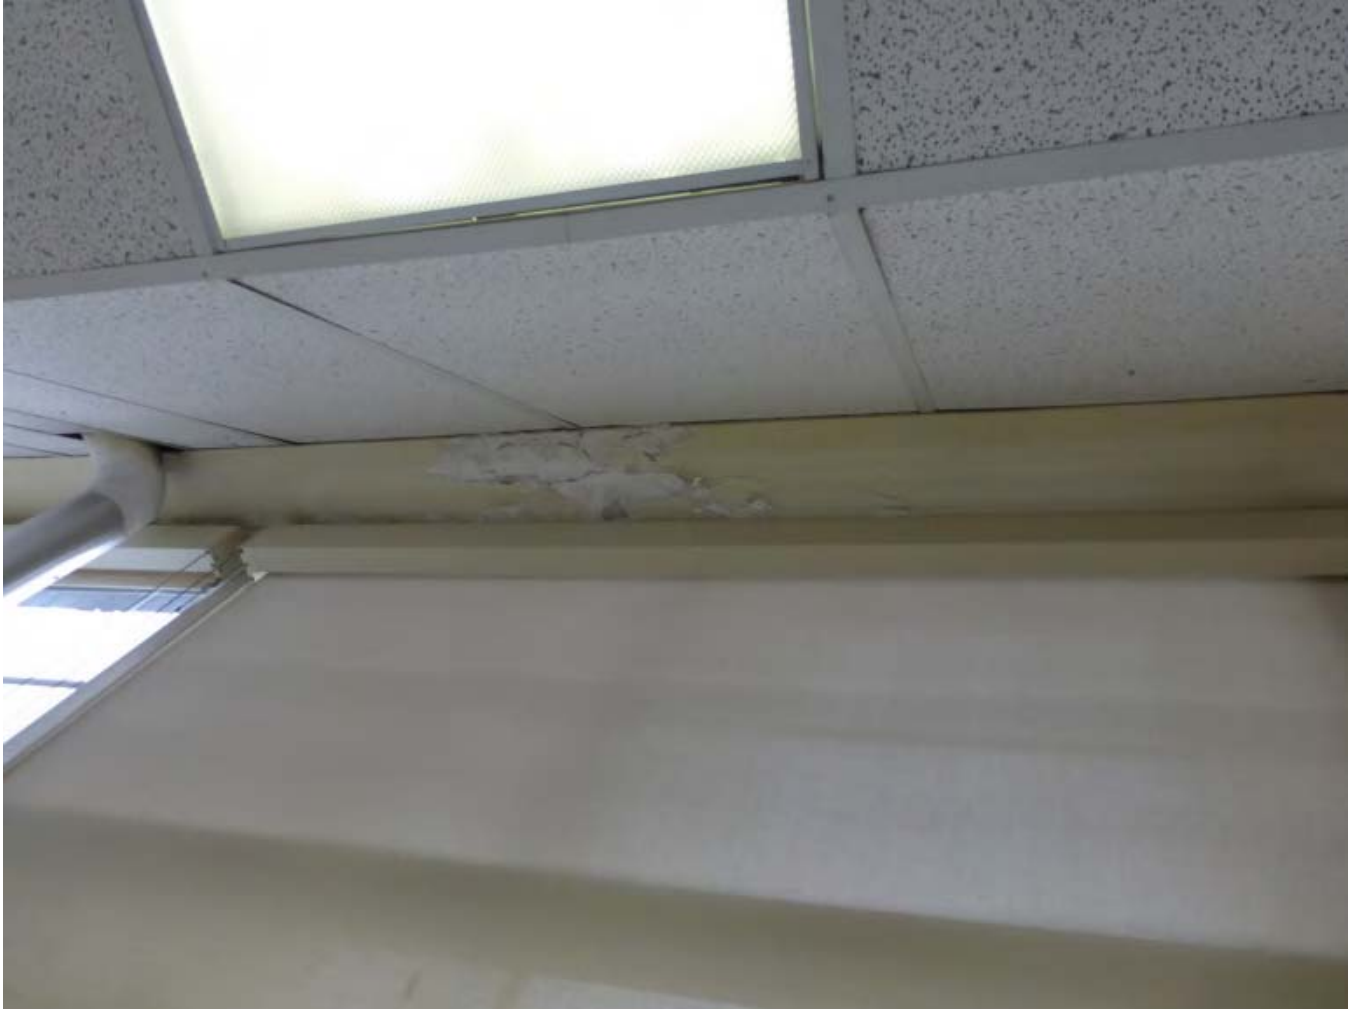
| No. | Item/Description | Location | Photo No. | Cons. | Need | Freq. | Score | Energy | Notes | Action | Qty. | Unit | Architectural | | Mechanical | | Electrical | | 2014 Project Cost |
|---|---|---|---|---|---|---|---|---|--|--|---|---|---|---|---|---|---|---|---|
| BI-4 | Gypsum Board Soffits | 2nd Floor Classrooms | BI-4 | 4 | 5 | 1 | 10 | | Deteriorated and paint is peeling. | Repair and repaint. | 100 | SF | \$ 5.00 | \$ 500 | | | | | \$ 754 |
