# ANDERSON MIDDLE SCHOOL

**BERKLEY SCHOOLS**  
**Comprehensive Academic Spaces, Facilities and Technologies Needs Assessment**

**Anderson Middle School**

| Address: 3205 Catalpa, Berkley, Michigan<br>Bldg. Area: 95,908 GSF<br>No. of Floors: 2<br>Year Built: 1956<br>Evaluation Date: January 2014 | <b>Item No. Codes</b><br>AB: Accessibility Improvement/Building Code<br>AD: Academic/Space Deficiencies<br>BE: Building Exterior<br>BI: Building Interior<br>BS: Building System<br>ES: Electrical System<br>MS: Mechanical System<br>PS: Plumbing System<br>SC: Site Circulation<br>SE: Specialty Equipment/Other<br>IT: Technology | | <b>Building Deficiencies Priorities by Category</b><br><div style="display: flex; justify-content: space-around;"> <div style="background-color: yellow; padding: 5px;"> <b>Consequences of the Problem</b><br/> 1. Hazards<br/> 2. Interruption<br/> 3. Deterioration<br/> 4. Utility<br/> 5. Energy </div> <div style="background-color: lightgreen; padding: 5px;"> <b>Need</b><br/> 1. Critical<br/> 2. Urgent<br/> 3. Necessary<br/> 4. ADA<br/> 5. Desirable </div> <div style="background-color: orange; padding: 5px;"> <b>Frequency of Use</b><br/> 1. Constant<br/> 2. Frequent<

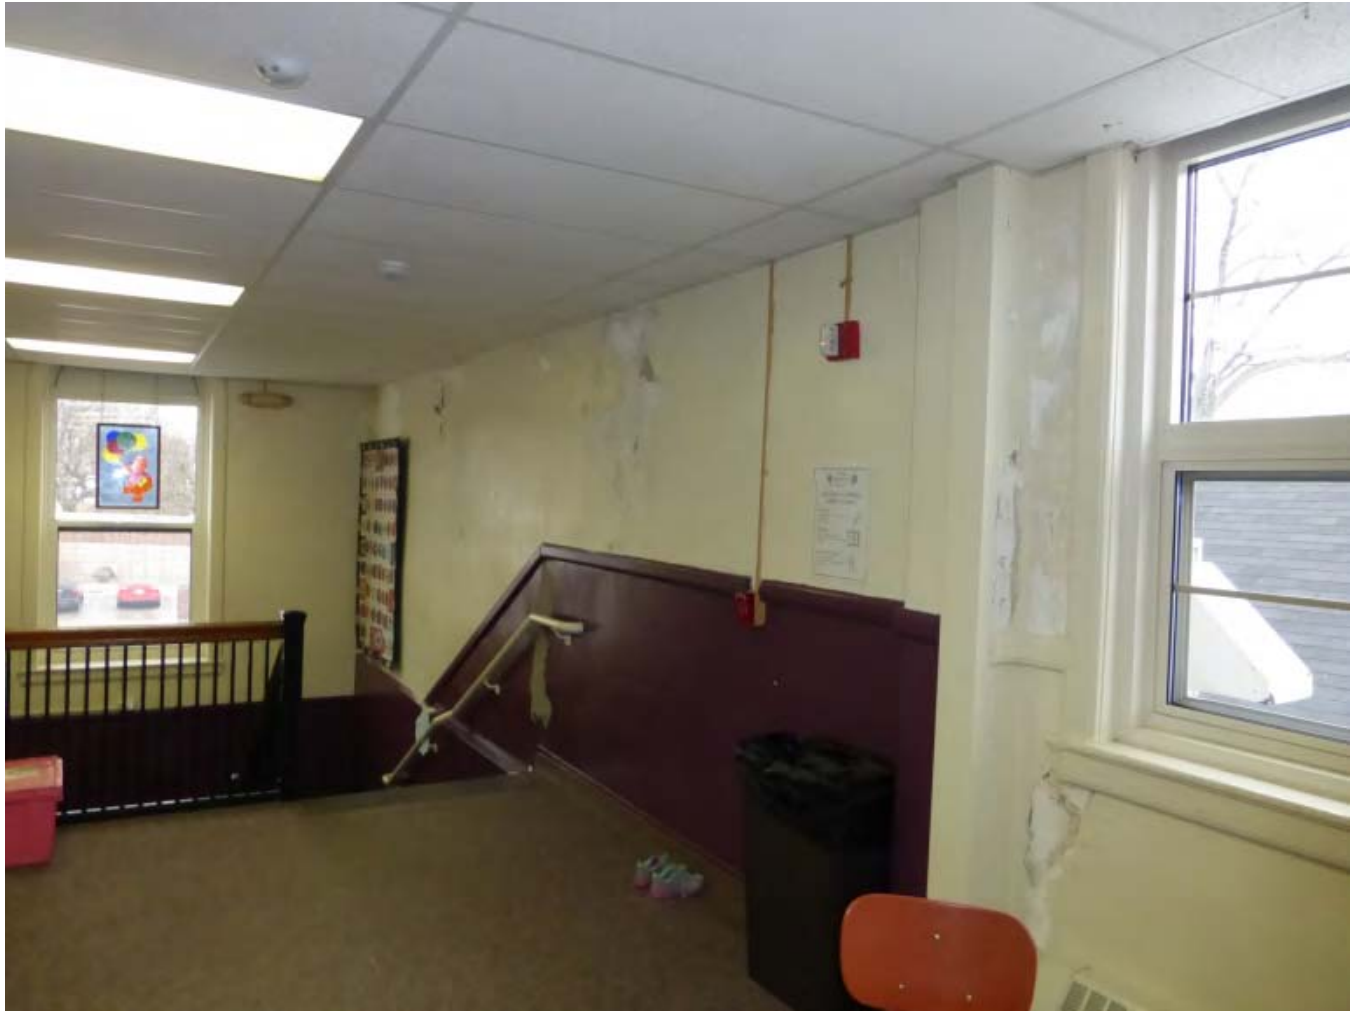
| No. | Item/Description | Location | Photo No. | Cons. | Need | Freq. | Score | Energy | Notes | Action | Qty. | Unit | Architectural | | Mechanical | | Electrical | | 2014 Project Cost |
|---|---|---|---|---|---|---|---|---|--|--|---|---|---|---|---|---|---|---|---|
| BI-5 | Stair Wall | 2nd Floor East Stair | BI-5 | 3 | 3 | 1 | 7 | | Plaster is deteriorated and paint is peeling. | Repair wall and paint. | 250 | SF | \$ 5.00 | \$ 1,250 | | | | | \$ 1,885 |

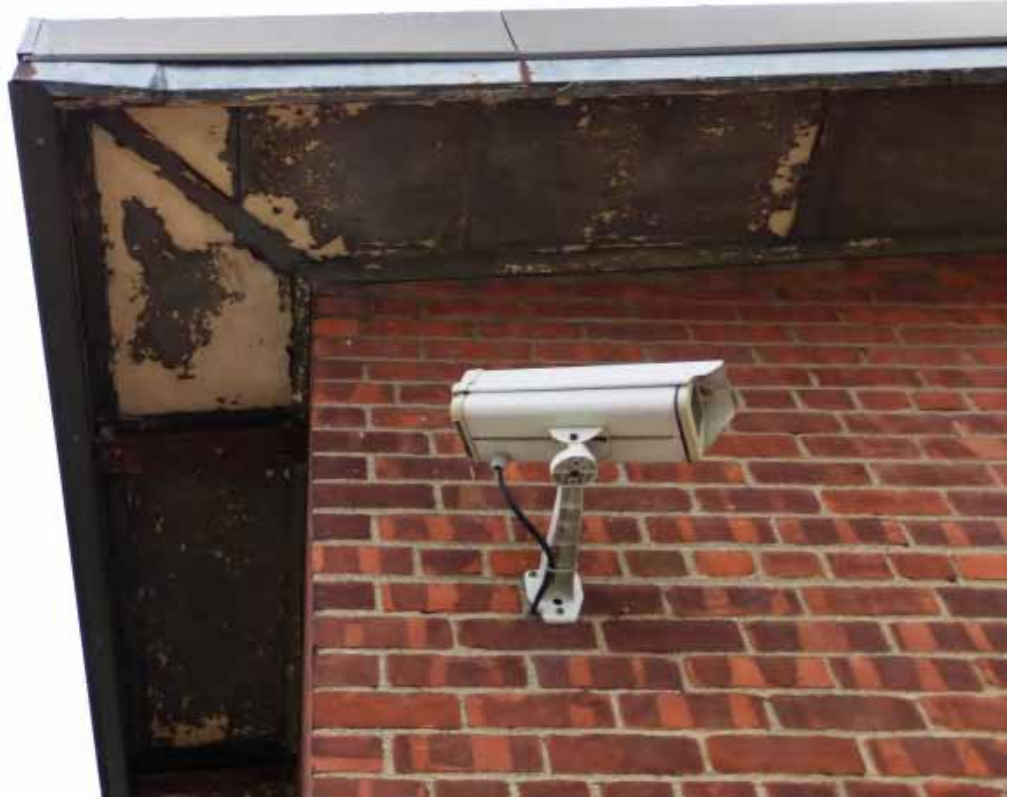
| No. | Item/Description | Location | Photo No. | Cons. | Need | Freq. | Score | Energy | Notes | Action | Qty. | Unit | Architectural | | Mechanical | | Electrical | | 2014 Project Cost |
|---|---|--|---|---|---|---|---|---|---|---|---|---|---|---|---|---|---|---|---|
| BE-1 | Overhangs/Soffits | Entire Building | BE-1 | 3 | 3 | 2 | 8 | | Paint is peeling and steel is rusted. | Provide aluminum soffit panels. | 2,200 | SF | \$ 6.00 | \$ 13,200 | | | | | \$ 19,906 |

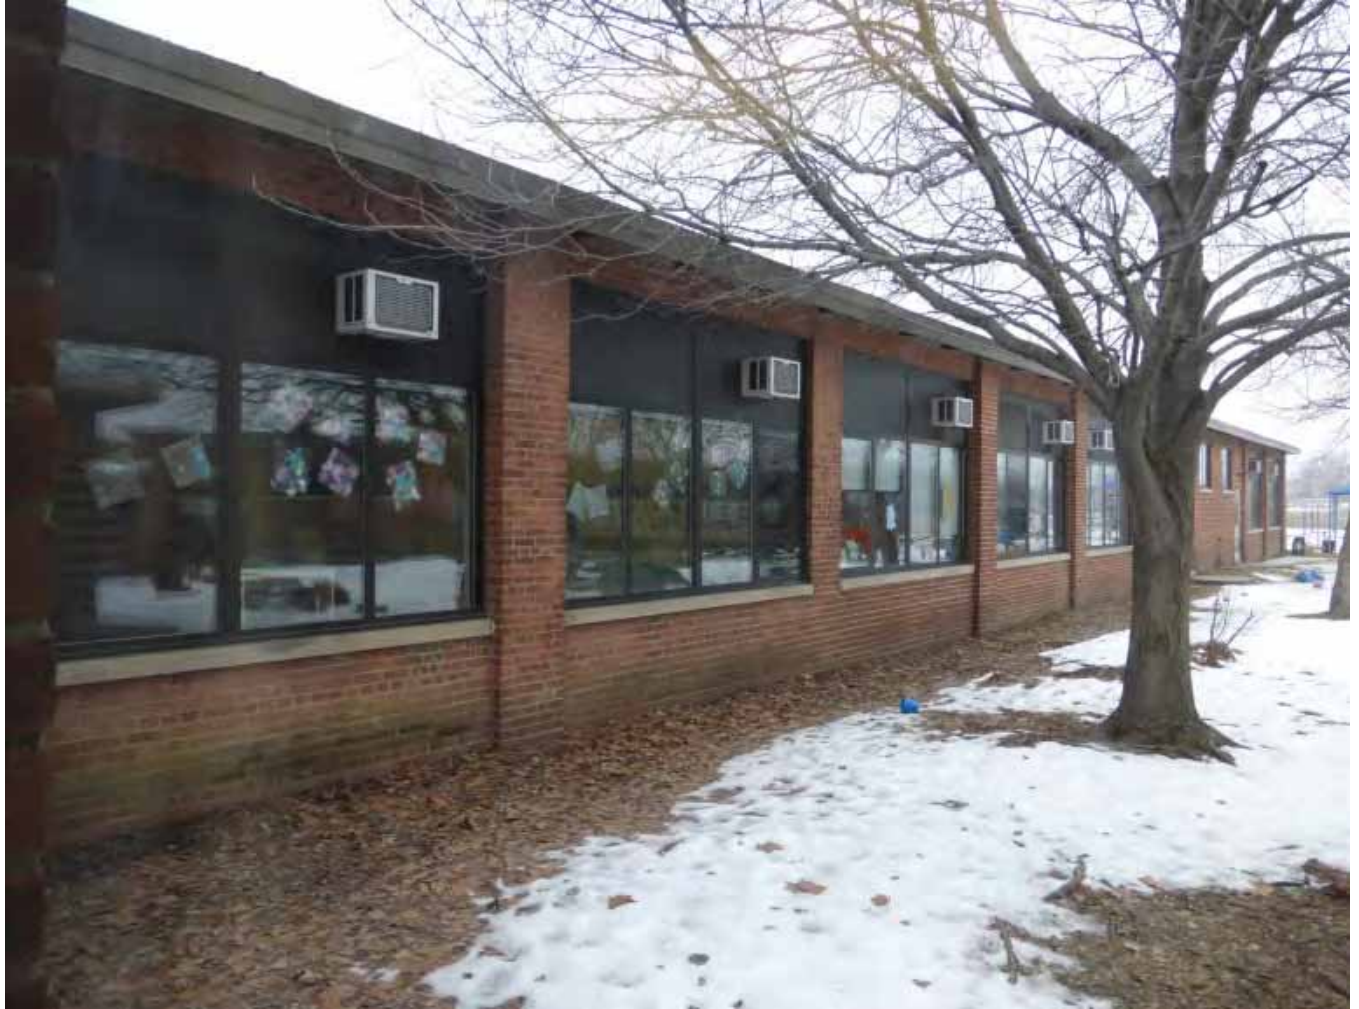
| No. | Item/Description | Location | Photo No. | Cons. | Need | Freq. | Score | Energy | Notes | Action | Qty. | Unit | Architectural | | Mechanical | | Electrical | | 2014 Project Cost |
|---|---|--|---|---|---|---|---|---|---|---|---|---|---|---|---|---|---|---|---|
| BE-2 | Brick Veneer at Base of Walls | Where roofs drain to grade adjacent to walls | BE-2 | 3 | 3 | 2 | 8 | | Brick and mortar joints deteriorated from roof water drainage. | Control roof drainage where possible and clean/tuck point brick. | 2,750 | SF | \$ 10.50 | \$ 28,875 | | | | | \$ 43,544 |

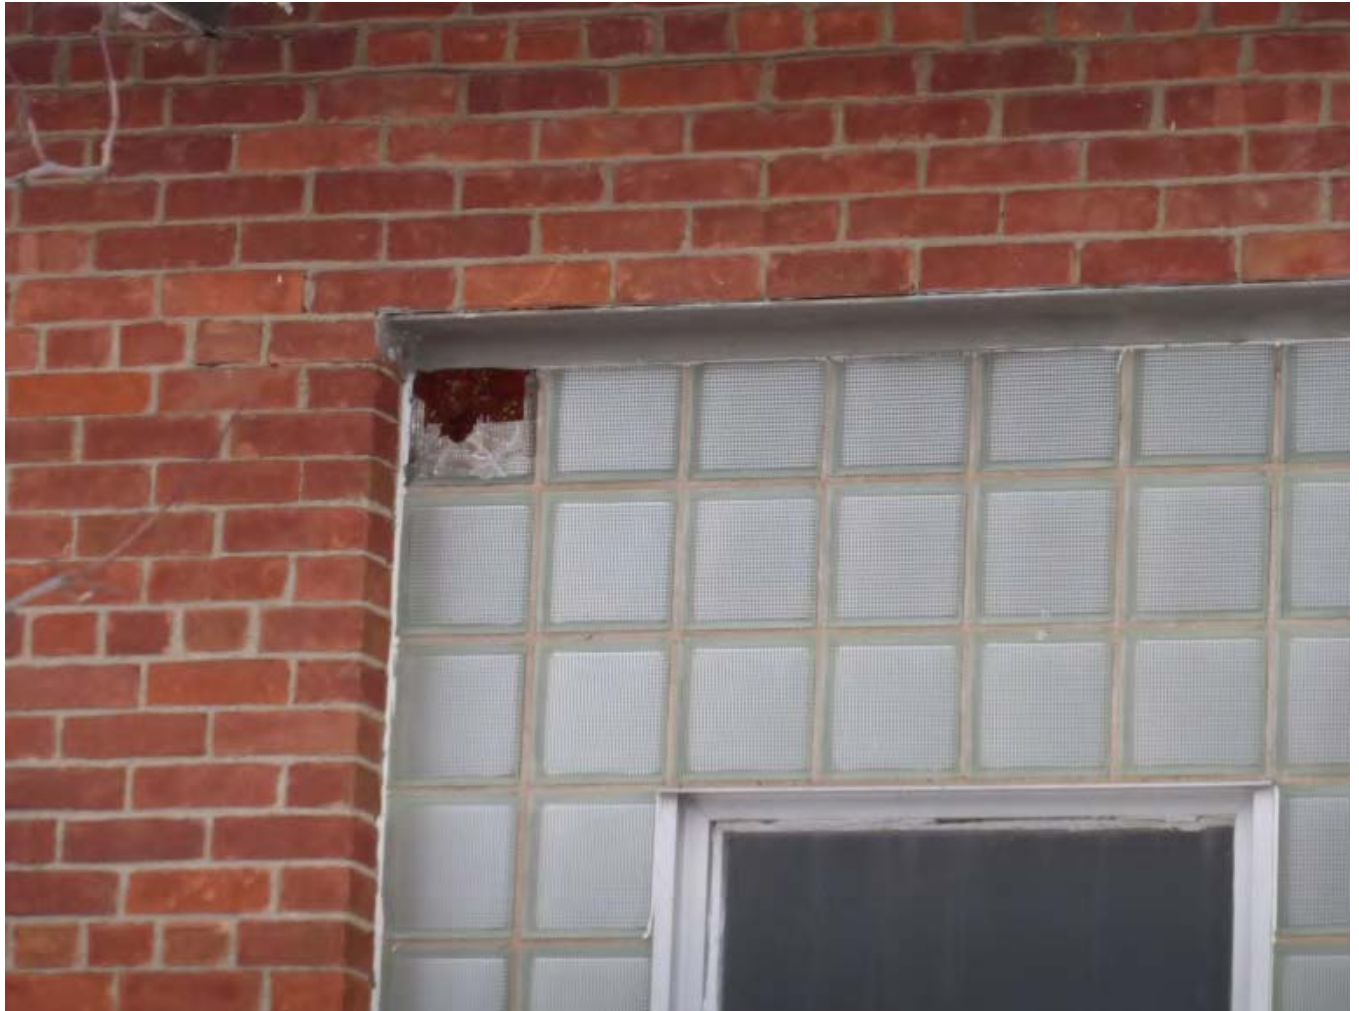
| No. | Item/Description | Location | Photo No. | Cons. | Need | Freq. | Score | Energy | Notes | Action | Qty. | Unit | Architectural | | Mechanical | | Electrical | | 2014 Project Cost |
|---|---|--|---|---|---|---|---|---|---|---|---|---|---|---|---|---|---|---|---|
| BE-5 | Glass Block Windows | North Elevation | BE-5 | 4 | 3 | 2 | 9 | | Broken glass block. | Replace glass block. | 20 | SF | \$ 50.00 | \$ 1,000 | | | | | \$ 1,508 |

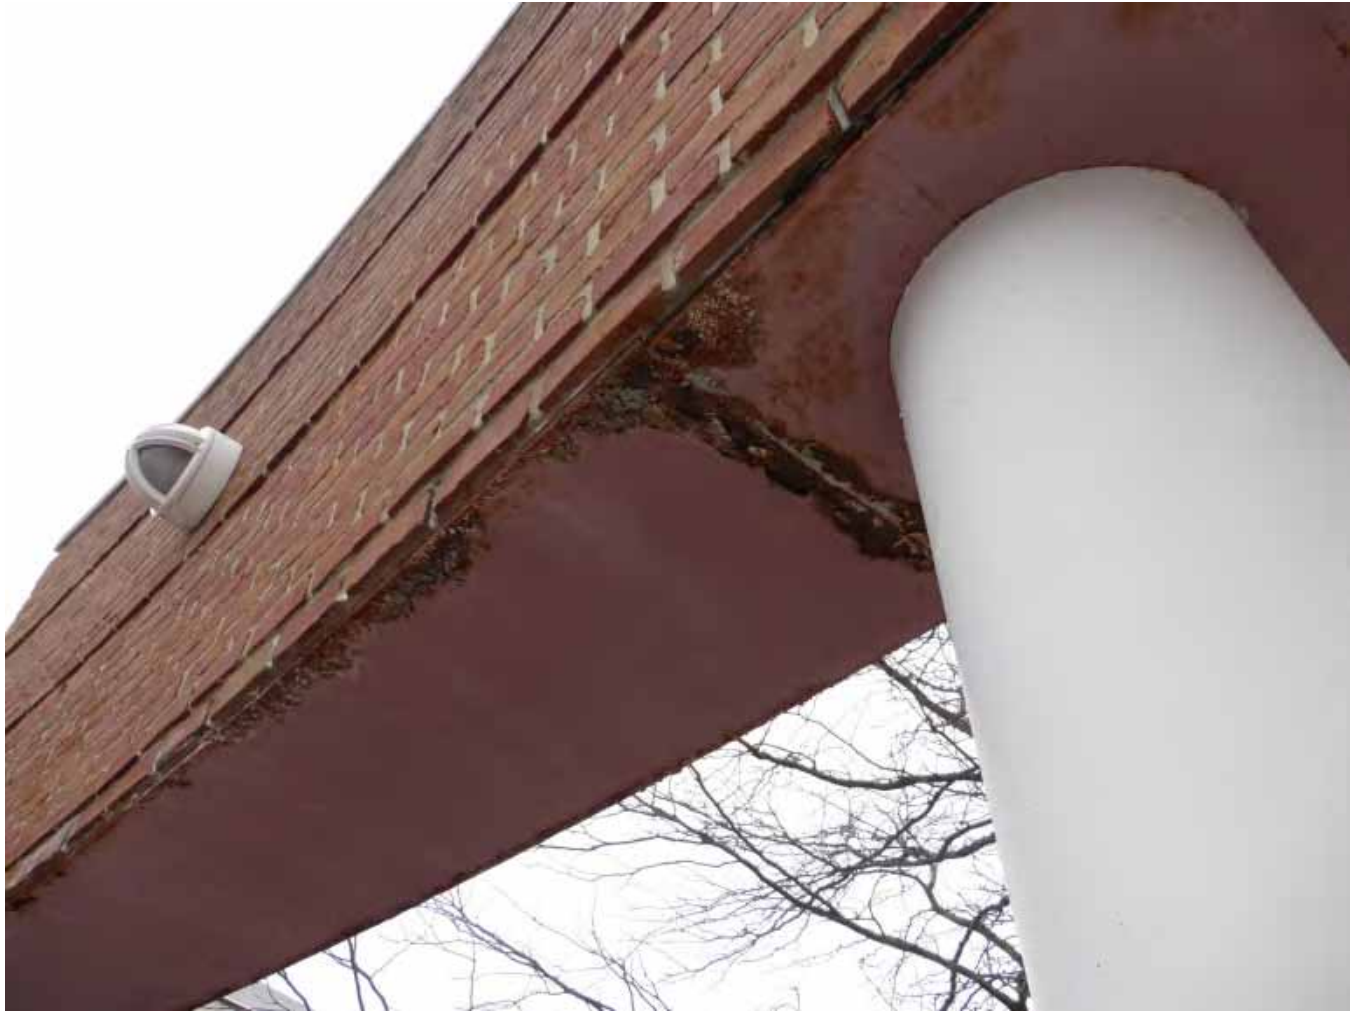
| No. | Item/Description | Location | Photo No. | Cons. | Need | Freq. | Score | Energy | Notes | Action | Qty. | Unit | Architectural | | Mechanical | | Electrical | | 2014 Project Cost |
|---|---|--|---|---|---|---|---|---|---|---|---|---|---|---|---|---|---|---|---|
| BE-6 | Steel Lintels at Wall Openings | Media Center | BE-6 | 2 | 2 | 2 | 6 | | Steel is rusted. | Paint lintels. | 60 | SF | \$ 18.00 | \$ 1,080 | | | | | \$ 1,629 |

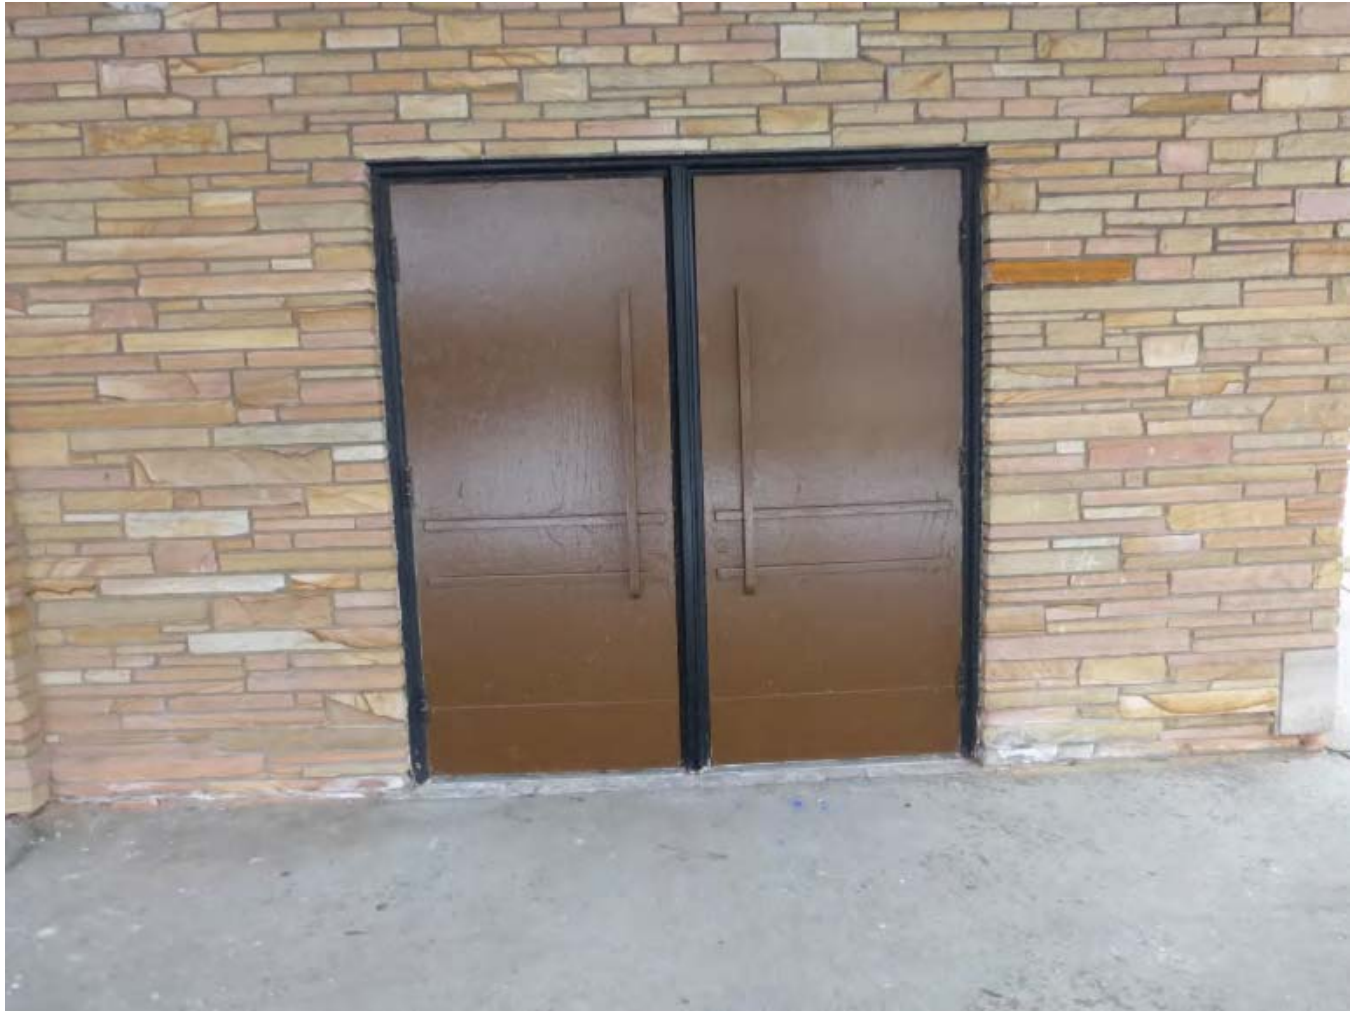
| No. | Item/Description | Location | Photo No. | Cons. | Need | Freq. | Score | Energy | Notes | Action | Qty. | Unit | Architectural | | Mechanical | | Electrical | | 2014 Project Cost |
|---|---|--|---|---|---|---|---|---|---|---|---|---|---|---|---|---|---|---|---|
| BE-7 | Steel Doors and Frames | Entire Building | BE-7 | 3 | 3 | 1 | 7 | | Deteriorated and rusted. | Replace with aluminum frames and fiberglass reinforced panel doors. | 5 | EA | \$ 2,800.00 | \$ 14,000 | | | | | \$ 21,112 |

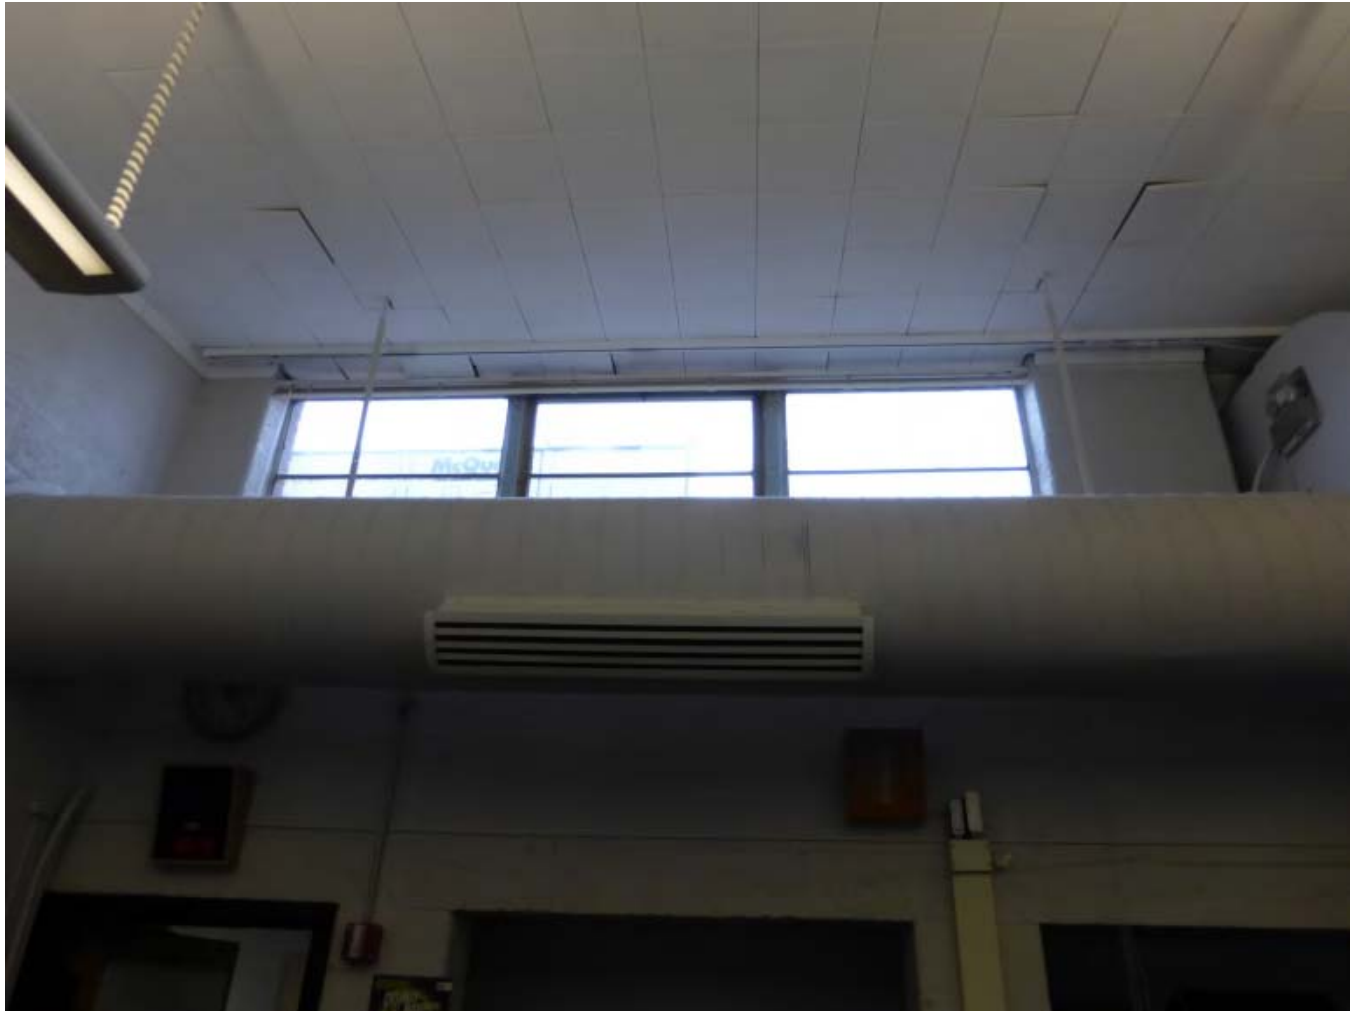
| No. | Item/Description | Location | Photo No. | Cons. | Need | Freq. | Score | Energy | Notes | Action | Qty. | Unit | Architectural | | Mechanical | | Electrical | | 2014 Project Cost |
|---|---|--|---|---|---|---|---|---|---|---|---|---|---|---|---|---|---|---|---|
| BE-8 | Clerestory Windows | Classrooms | BE-8 | 4 | 5 | 2 | 11 | X | Single glazed glass. | Replace with aluminum frames and insulating glass. | 400 | SF | \$ 80.00 | \$ 32,000 | | | | | \$ 48,256 |

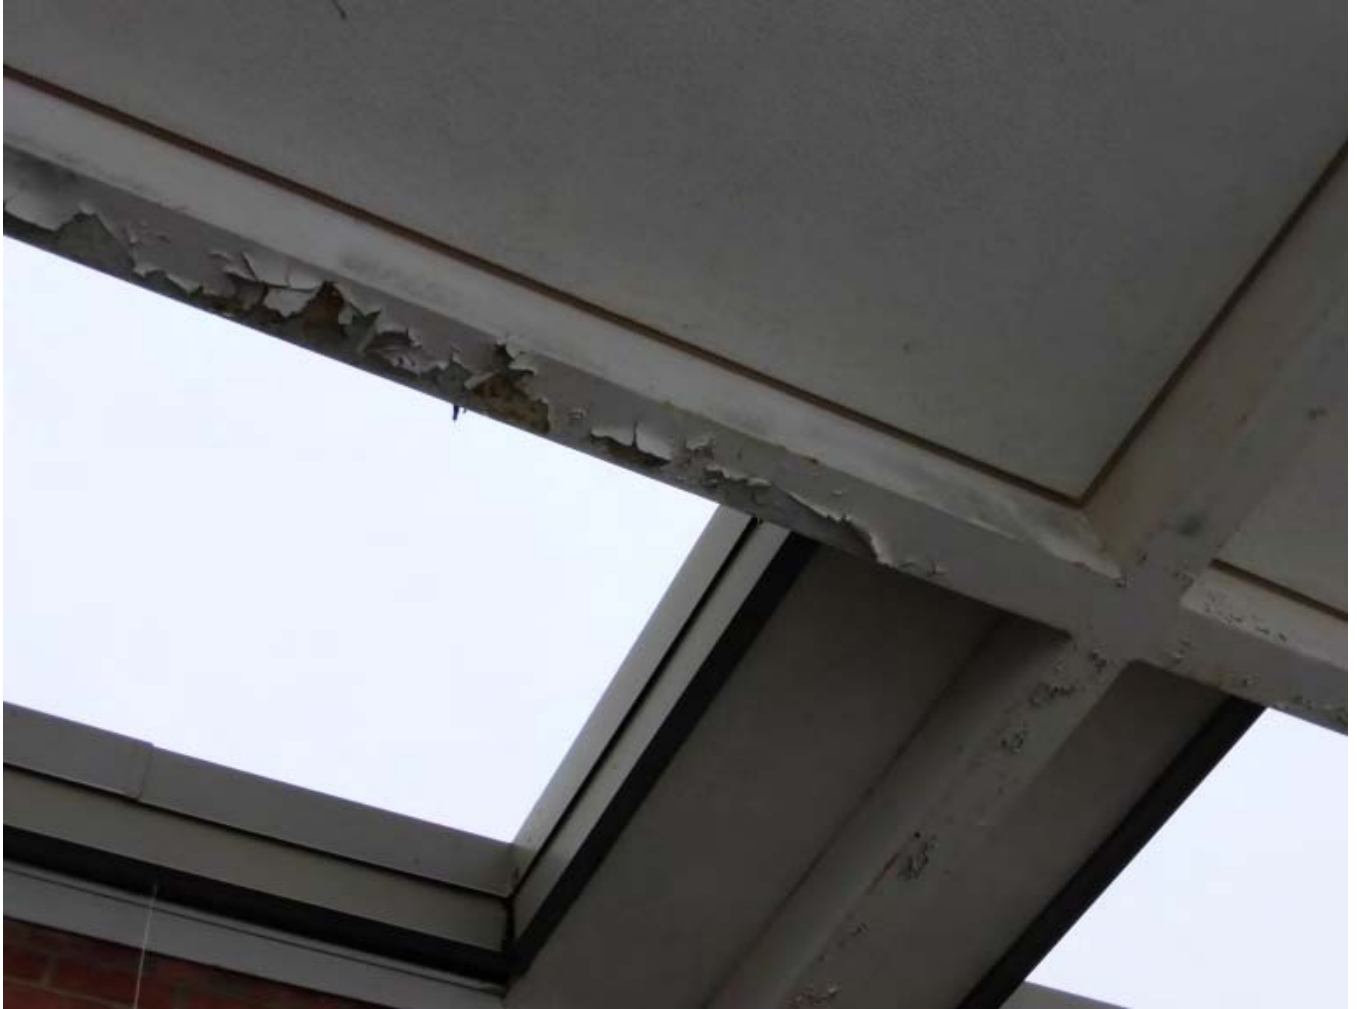
BE-9A

| No. | Item/Description | Location | Photo No. | Cons. | Need | Freq. | Score | Energy | Notes | Action | Qty. | Unit | Architectural | | Mechanical | | Electrical | | 2014 Project Cost |
|---|---|--|---|---|---|---|---|---|---|---|---|---|---|---|---|---|---|---|---|
| BE-9 | Entrance Canopy Soffits | Building Entrances | BE-9A<br>BE-9B | 3 | 3 | 2 | 8 | | Deteriorated and paint is peeling. | Provide aluminum soffit panels. | 1,600 | SF | \$ 7.50 | \$ 12,000 | | | | | \$ 18,096 |

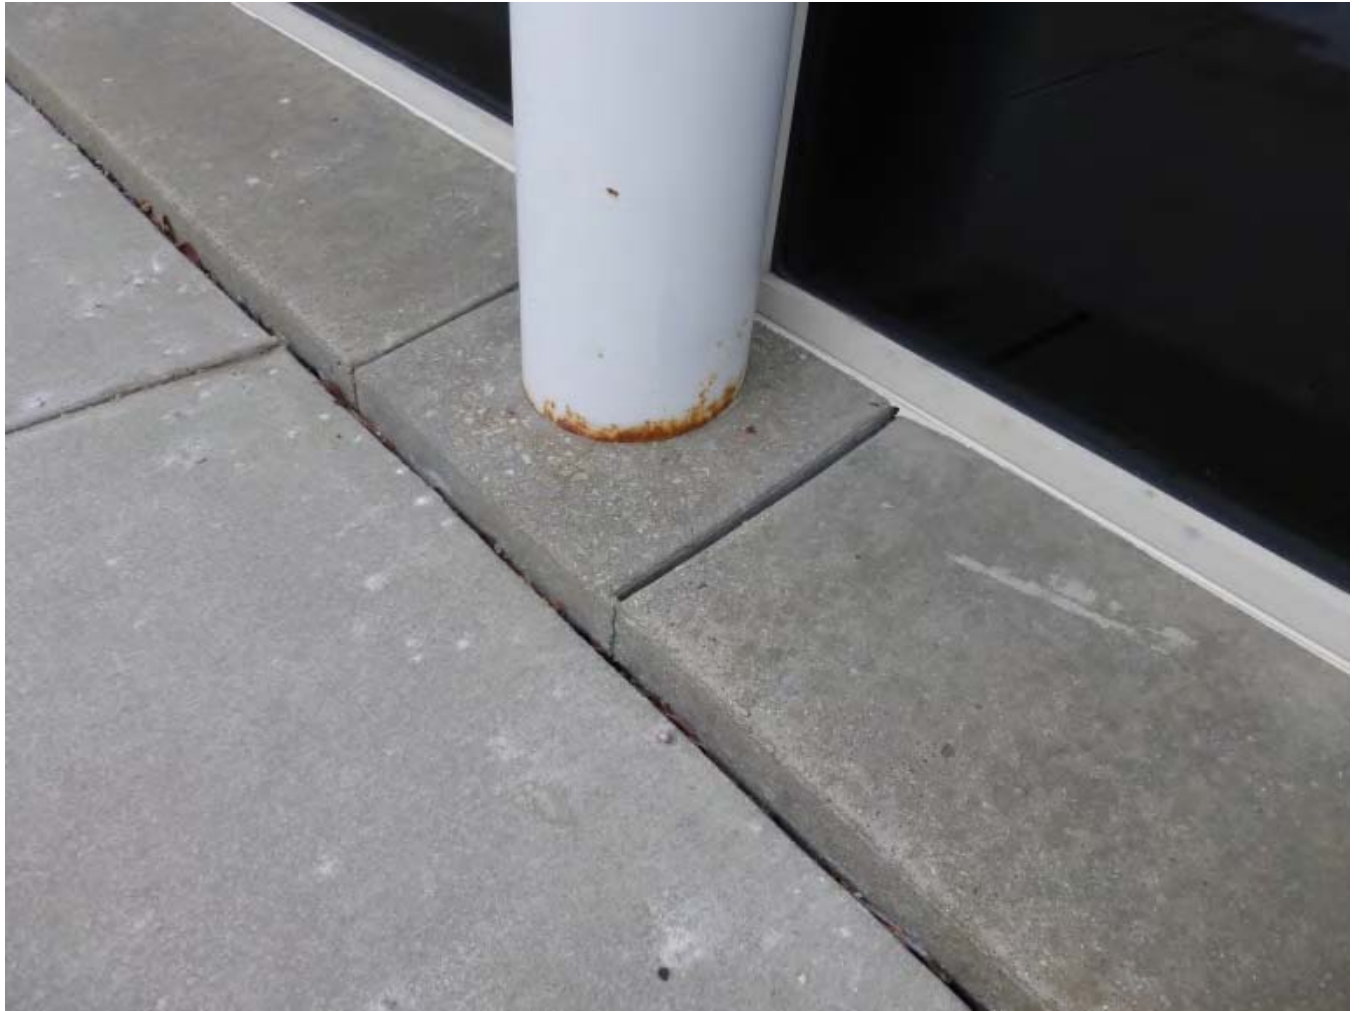
| No. | Item/Description | Location | Photo No. | Cons. | Need | Freq. | Score | Energy | Notes | Action | Qty. | Unit | Architectural | | Mechanical | | Electrical | | 2014 Project Cost |
|---|---|--|---|---|---|---|---|---|---|---|---|---|---|---|---|---|---|---|---|
| BE-11 | Entrance Canopy Columns | Media Center, South and Southeast Entrances | BE-11 | 3 | 3 | 2 | 8 | | Steel is rusted. | Paint columns. | 19 | EA | \$ 75.00 | \$ 1,425 | | | | | \$ 2,149 |

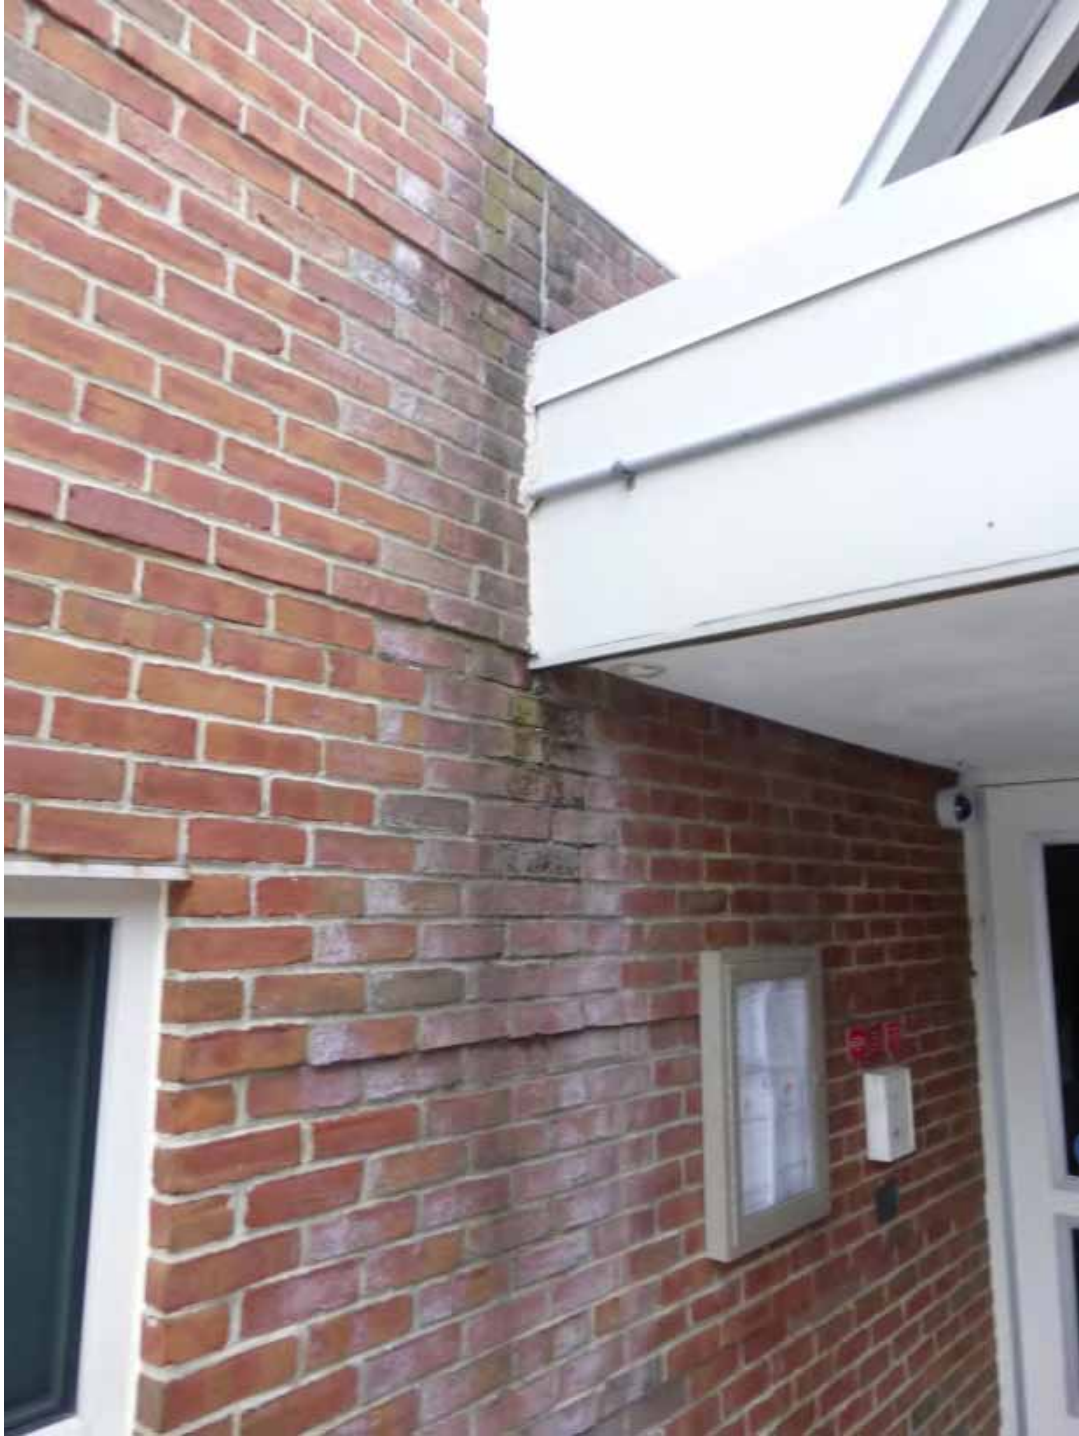
BE-12A

| No. | Item/Description | Location | Photo No. | Cons. | Need | Freq. | Score | Energy | Notes | Action | Qty. | Unit | Architectural | | Mechanical | | Electrical | | 2014 Project Cost |
|---|---|--|---|---|---|---|---|---|---|---|---|---|---|---|---|---|---|---|---|
| BE-12 | Roof Drainage | Various Locations | BE-12A<br>BE-12B | 3 | 3 | 2 | 8 | | Roof drainage spills onto brick causing deterioration. | Correct roof drainage, clean/repair brick. | 2,400 | SF | \$ 10.50 | \$ 25,200 | | | | | \$ 38,002 |

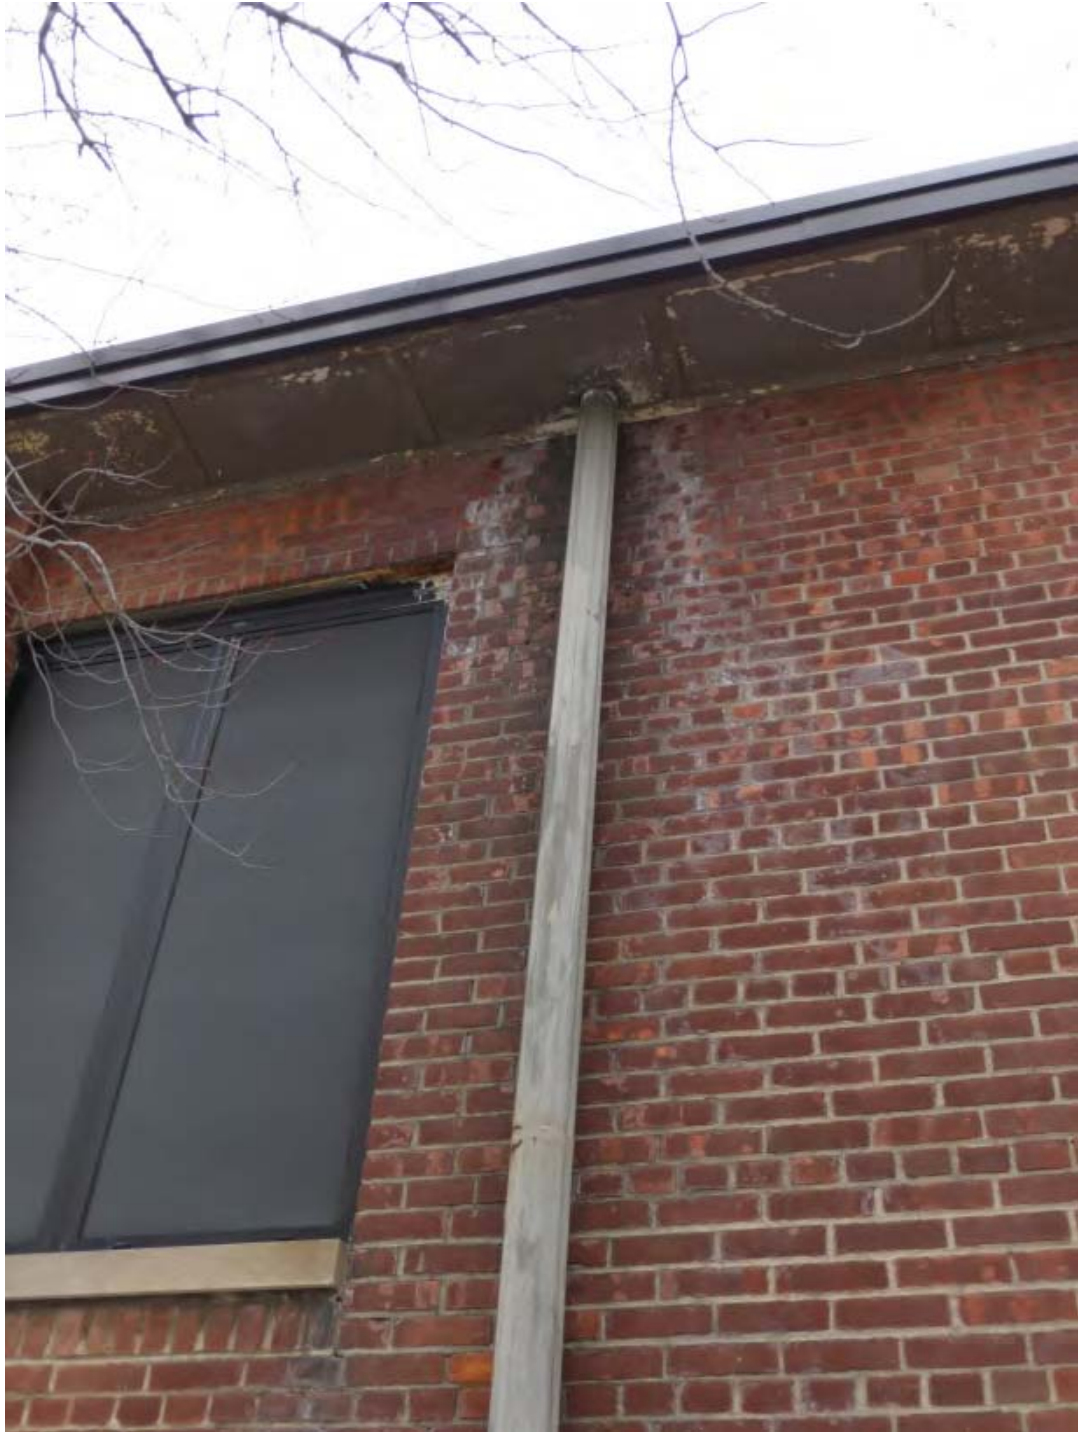
BE-13A

| No. | Item/Description | Location | Photo No. | Cons. | Need | Freq. | Score | Energy | Notes | Action | Qty. | Unit | Architectural | | Mechanical | | Electrical | | 2014 Project Cost |
|---|---|--|---|---|---|---|---|---|---|---|---|---|---|---|---|---|---|---|---|
| BE-13 | Roof Downspout | East Elevation of Gymnasium | BE-13A<br>BE-13B | 3 | 3 | 2 | 8 | | Leaking roof downspout causing damage to brick and interior masonry. | Repair downspout. | 50 | LF | \$ 12.00 | \$ 600 | | | | | \$ 905 |

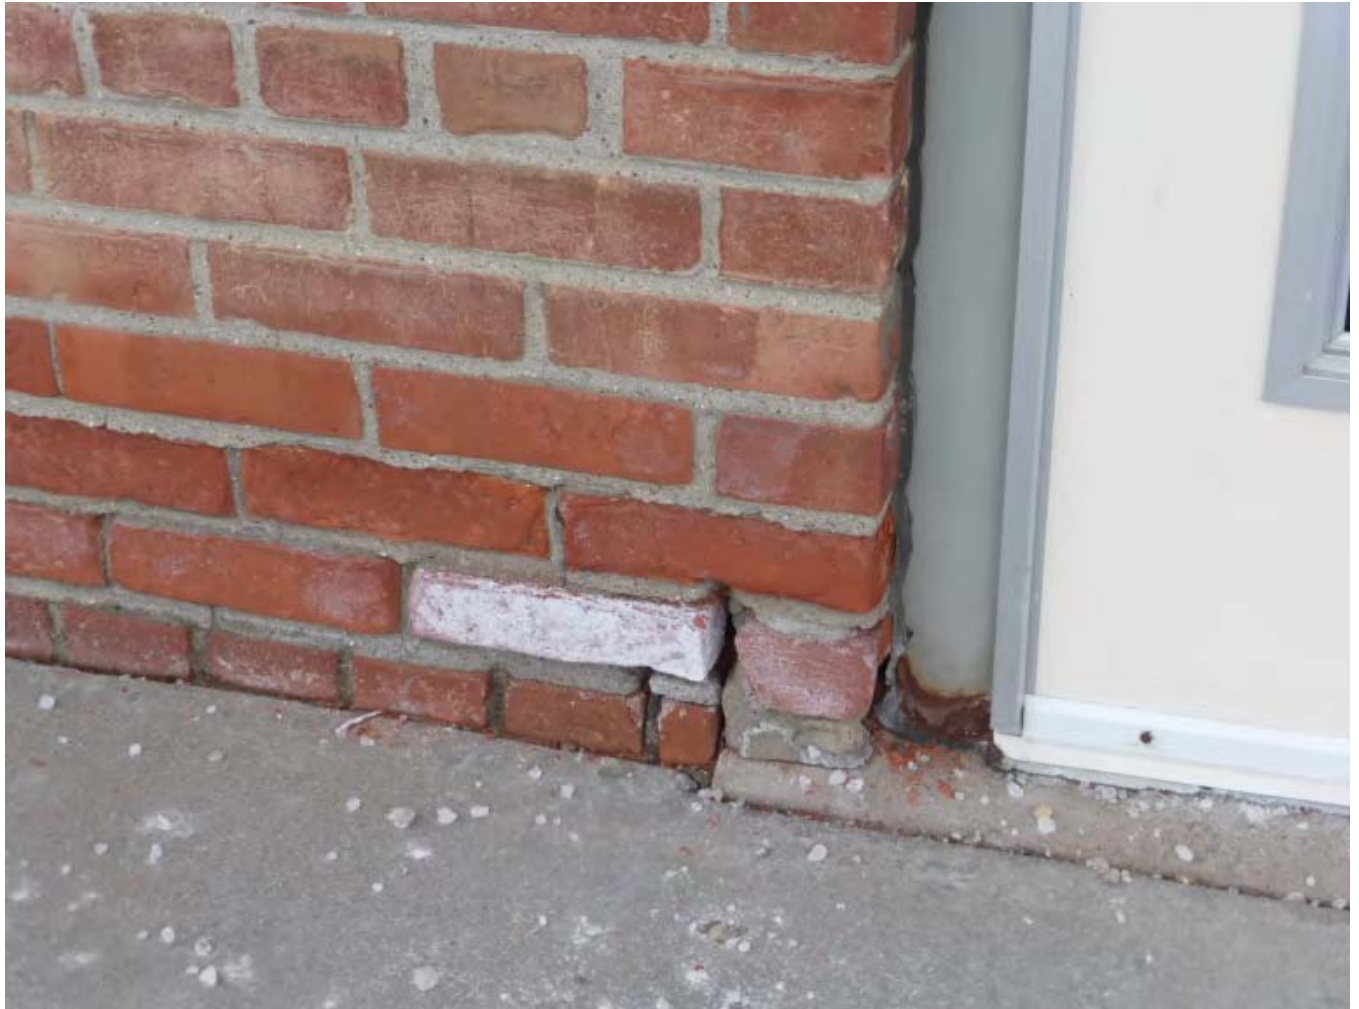
| No. | Item/Description | Location | Photo No. | Cons. | Need | Freq. | Score | Energy | Notes | Action | Qty. | Unit | Architectural | | Mechanical | | Electrical | | 2014 Project Cost |
|---|---|--|---|---|---|---|---|---|---|---|---|---|---|---|---|---|---|---|---|
| BE-15 | Brick Veneer | Various Locations | BE-15 | 3 | 3 | 2 | 8 | | Brick cracked and mortar is missing. | Replace brick and tuckpoint joints. | 100 | SF | \$ 25.00 | \$ 2,500 | | | | | \$ 3,770 |

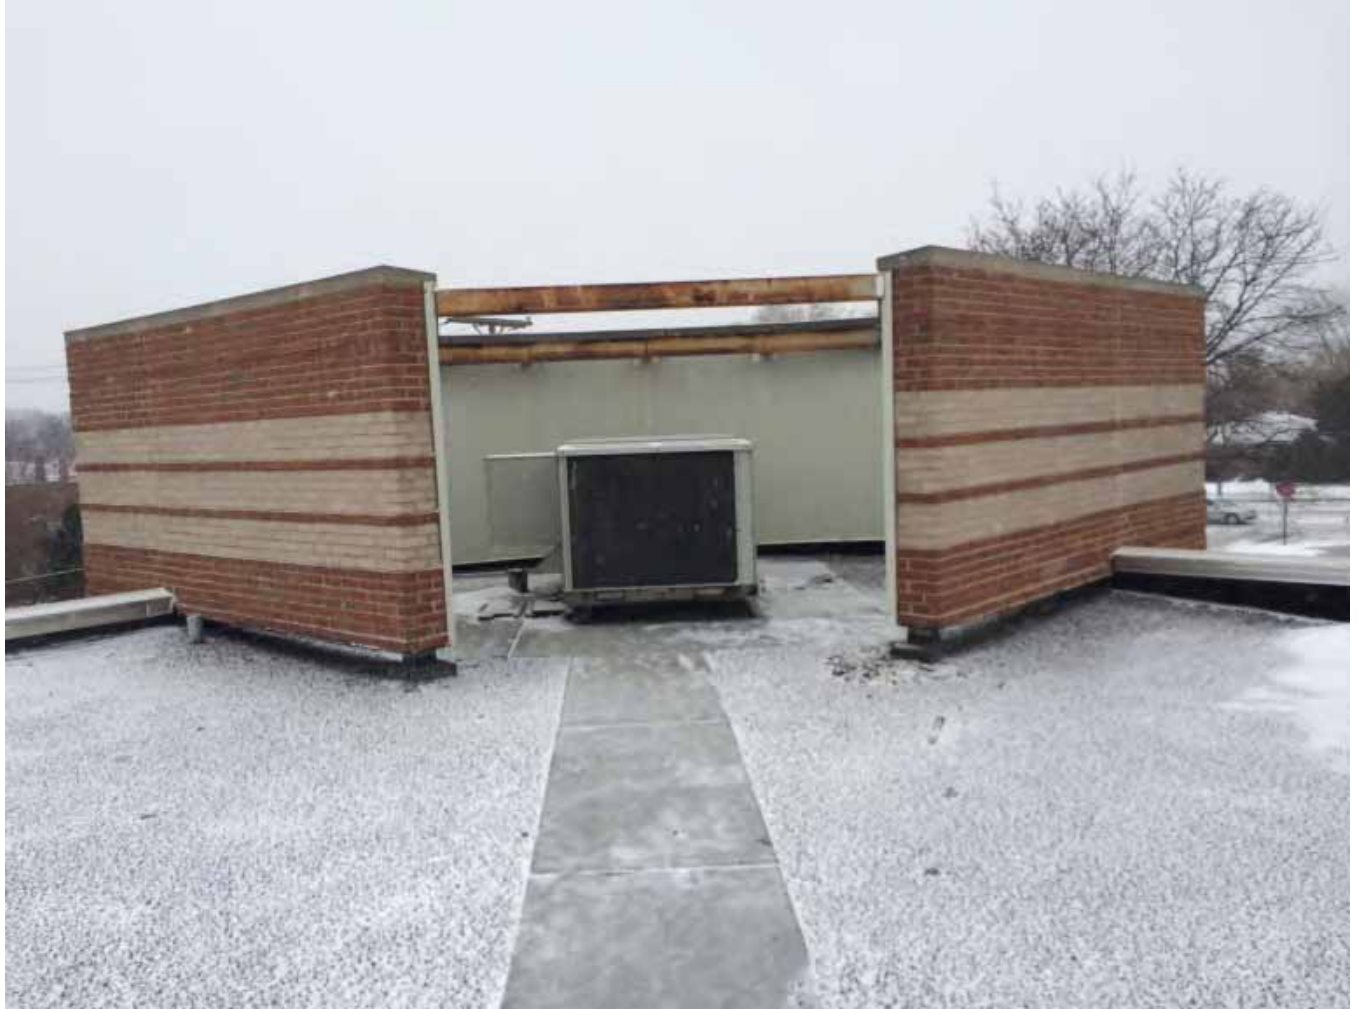
| No. | Item/Description | Location | Photo No. | Cons. | Need | Freq. | Score | Energy | Notes | Action | Qty. | Unit | Architectural | | Mechanical | | Electrical | | 2014 Project Cost |
|---|---|--|---|---|---|---|---|---|---|---|---|---|---|---|---|---|---|---|---|
| BE-16 | Exposed Steel Frames | Media Center Roof | BE-16 | 3 | 2 | 2 | 7 | | Steel is rusting. | Paint steel. | 40 | LF | \$ 10.00 | \$ 400 | | | | | \$ 603 |

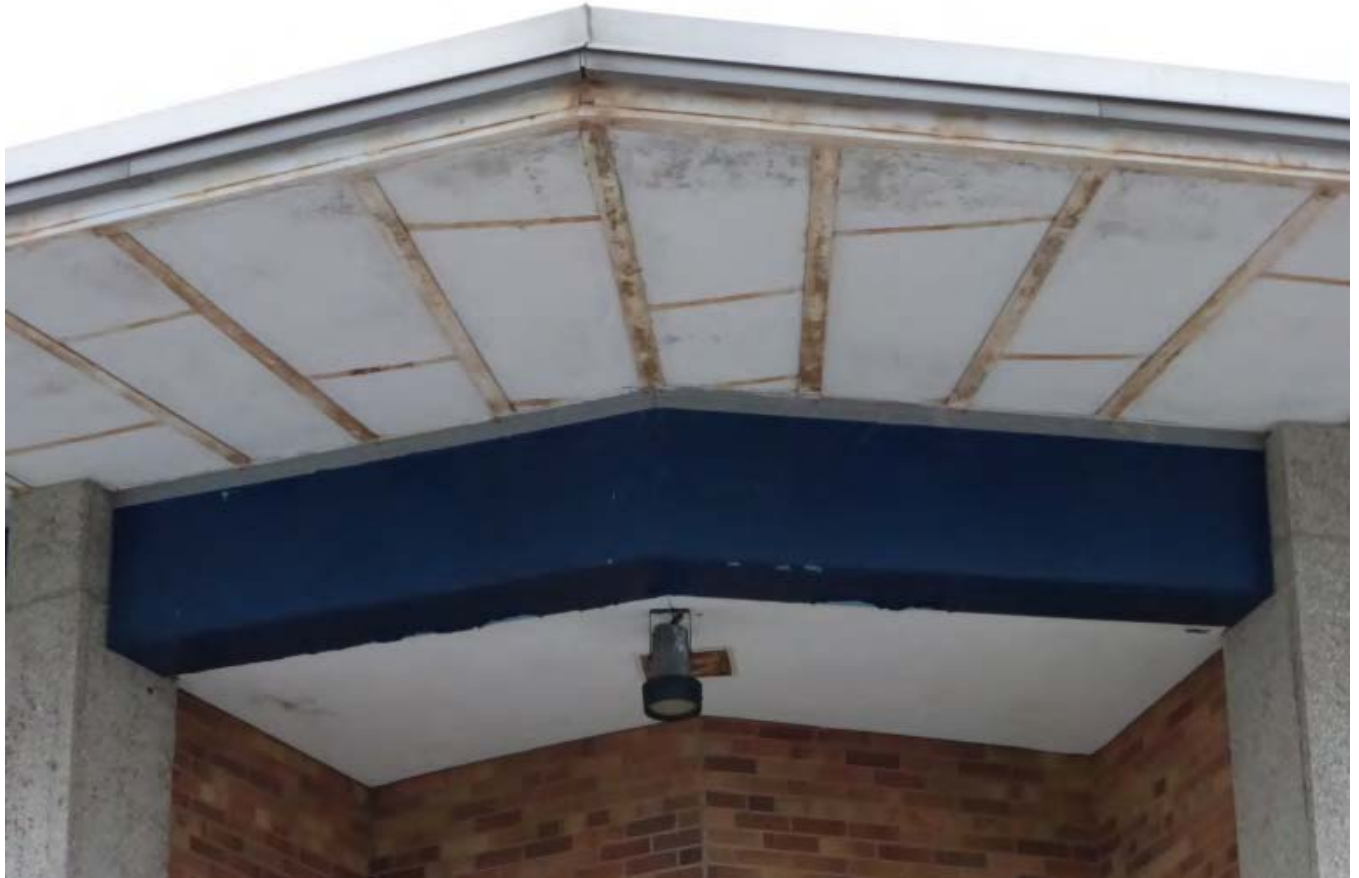
| No. | Item/Description | Location | Photo No. | Cons. | Need | Freq. | Score | Energy | Notes | Action | Qty. | Unit | Architectural | | Mechanical | | Electrical | | 2014 Project Cost |
|---|--|--|---|---|---|---|---|---|---|---|---|---|---|---|---|---|---|---|---|
| BE-1 | Overhangs/Soffits | Band Room, Orchestra/Choir | BE-1 | 3 | 3 | 2 | 8 | | Paint is peeling and steel is rusted. | Provide aluminum soffit panels. | 450 | SF | \$ 6.00 | \$ 2,700 | | | | | \$ 4,072 |

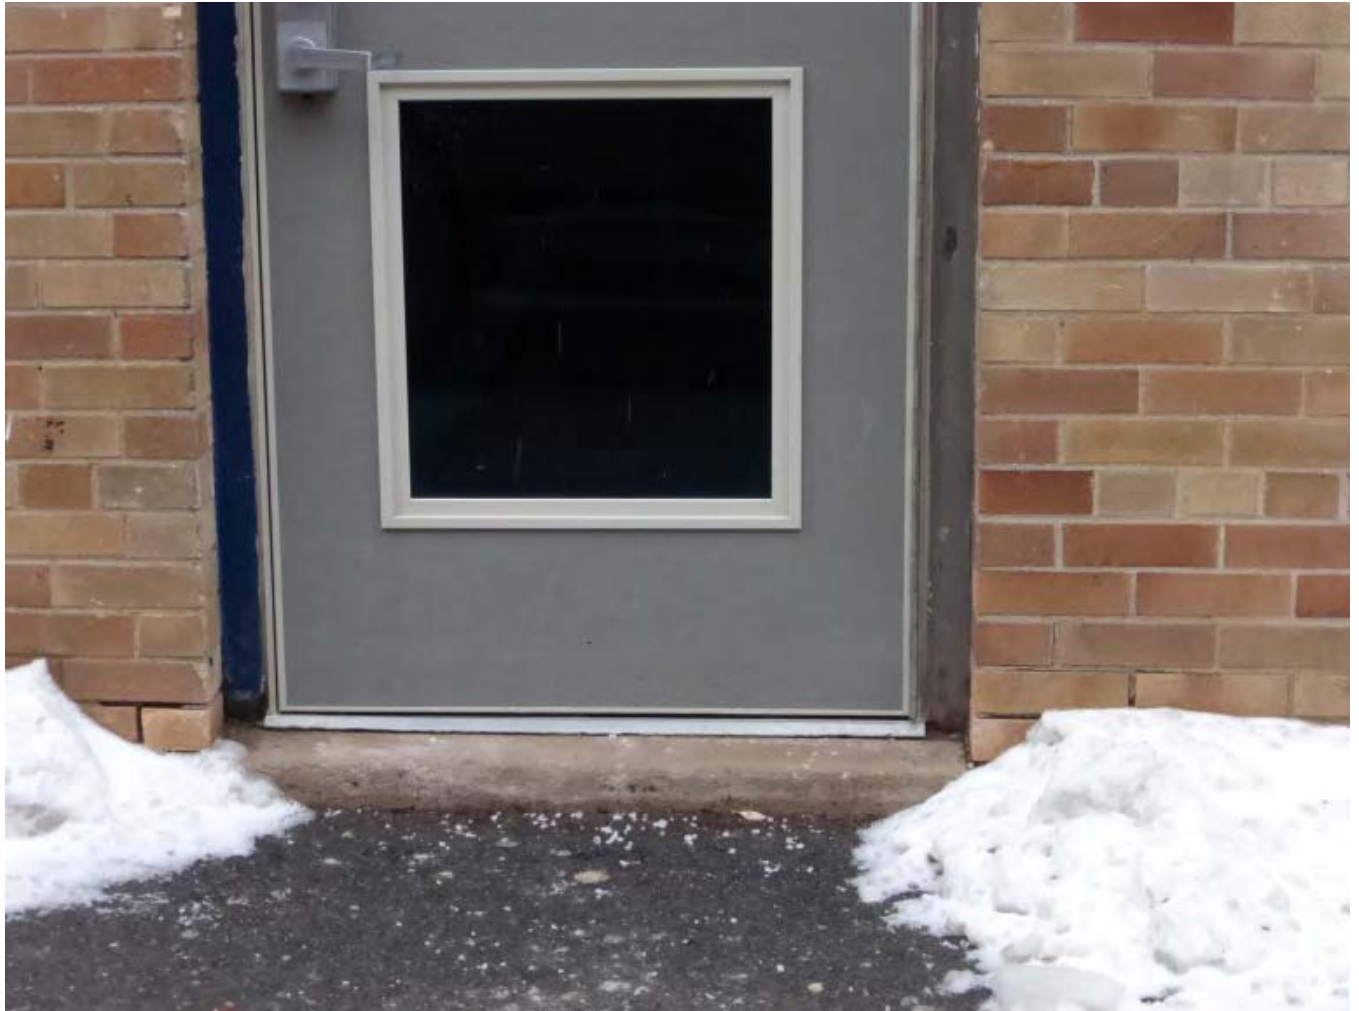
| No. | Item/Description | Location | Photo No. | Cons. | Need | Freq. | Score | Energy | Notes | Action | Qty. | Unit | Architectural | | Mechanical | | Electrical | | 2014 Project Cost |
|---|--|--|---|---|---|---|---|---|---|---|---|---|---|---|---|---|---|---|---|
| BE-2 | Brick Veneer at Base of Walls | Where roofs drains to pavement adjacent to walls and at main entrances | BE-2 | 3 | 3 | 2 | 8 | | Brick and mortar joints deteriorated from roof water drainage. | Control roof drainage where possible and clean/tuck point brick. | 1,000 | SF | \$ 20.50 | \$ 20,500 | | | | | \$ 30,914 |
