# ANDERSON MIDDLE SCHOOL

**BERKLEY SCHOOLS**  
**Comprehensive Academic Spaces, Facilities and Technologies Needs Assessment**

**Anderson Middle School**

| Address: 3205 Catalpa, Berkley, Michigan<br>Bldg. Area: 95,908 GSF<br>No. of Floors: 2<br>Year Built: 1956<br>Evaluation Date: January 2014 | <b>Item No. Codes</b><br>AB: Accessibility Improvement/Building Code<br>AD: Academic/Space Deficiencies<br>BE: Building Exterior<br>BI: Building Interior<br>BS: Building System<br>ES: Electrical System<br>MS: Mechanical System<br>PS: Plumbing System<br>SC: Site Circulation<br>SE: Specialty Equipment/Other<br>IT: Technology | | <b>Building Deficiencies Priorities by Category</b><br><div style="display: flex; justify-content: space-around;"> <div style="background-color: yellow; padding: 5px;"> <b>Consequences of the Problem</b><br/> 1. Hazards<br/> 2. Interruption<br/> 3. Deterioration<br/> 4. Utility<br/> 5. Energy </div> <div style="background-color: lightgreen; padding: 5px;"> <b>Need</b><br/> 1. Critical<br/> 2. Urgent<br/> 3. Necessary<br/> 4. ADA<br/> 5. Desirable </div> <div style="background-color: orange; padding: 5px;"> <b>Frequency of Use</b><br/> 1. Constant<br/> 2. Frequent<

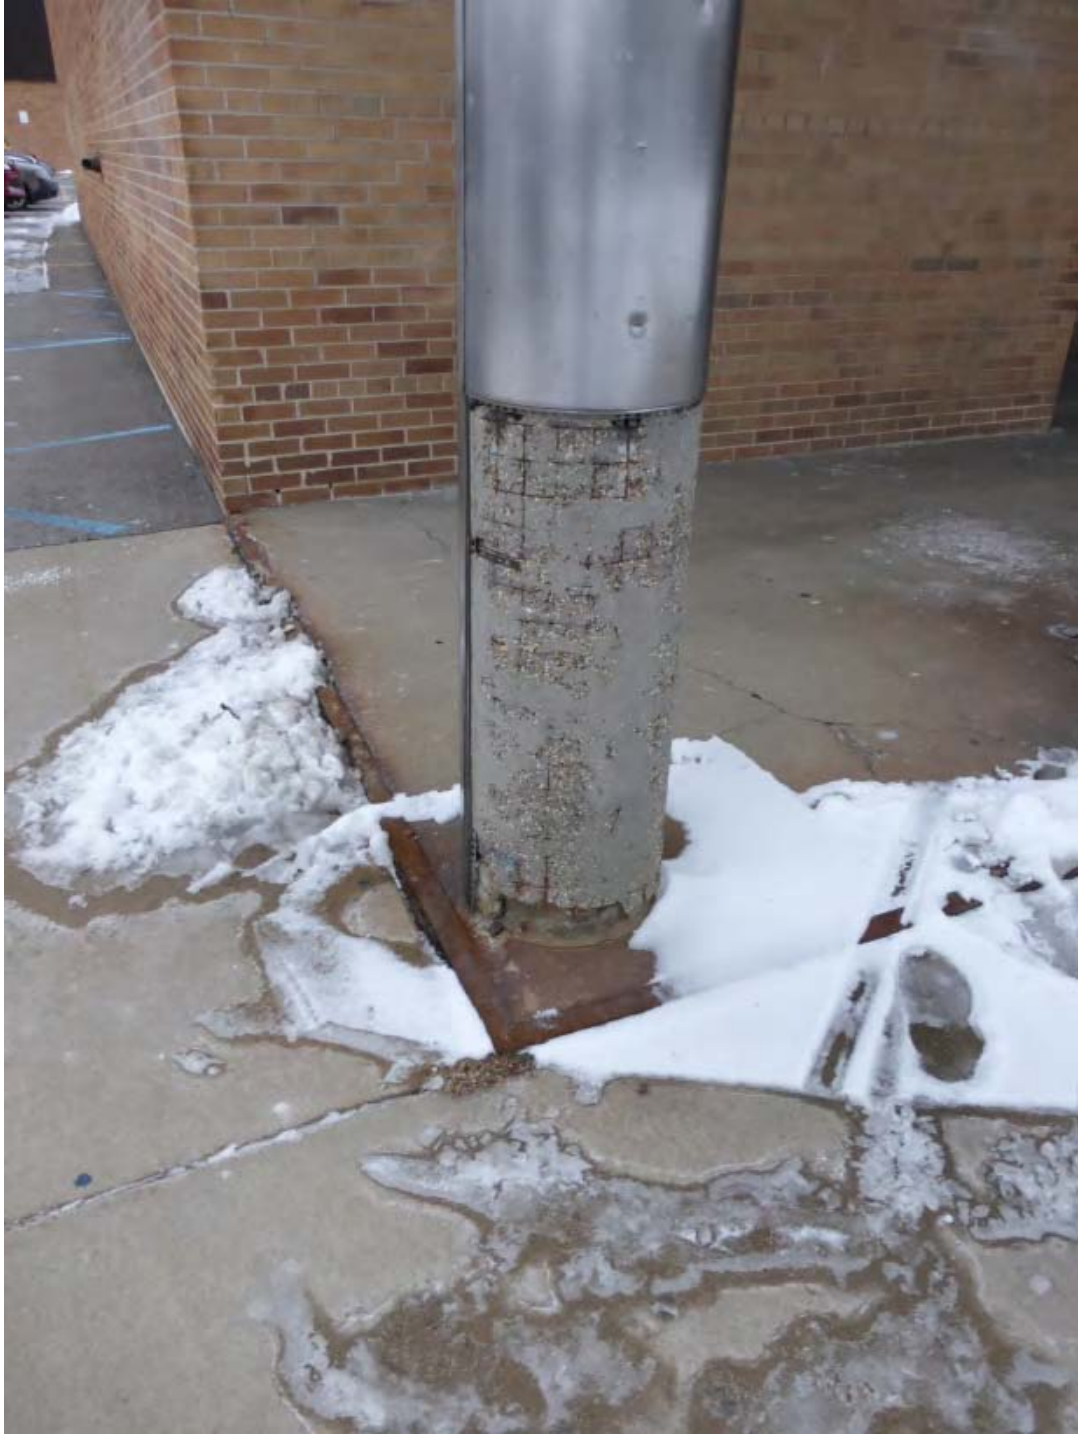
| No. | Item/Description | Location | Photo No. | Cons. | Need | Freq. | Score | Energy | Notes | Action | Qty. | Unit | Architectural | | Mechanical | | Electrical | | 2014 Project Cost |
|---|--|--|---|---|---|---|---|---|---|---|---|---|---|---|---|---|---|---|---|
| BE-4 | Entrance Canopy Column | Southwest Entrance | BE-4 | 3 | 3 | 2 | 8 | | Metal column enclosure is missing. | Replace metal enclosure. | 1 | EA | \$ 250.00 | \$ 250 | | | | | \$ 377 |

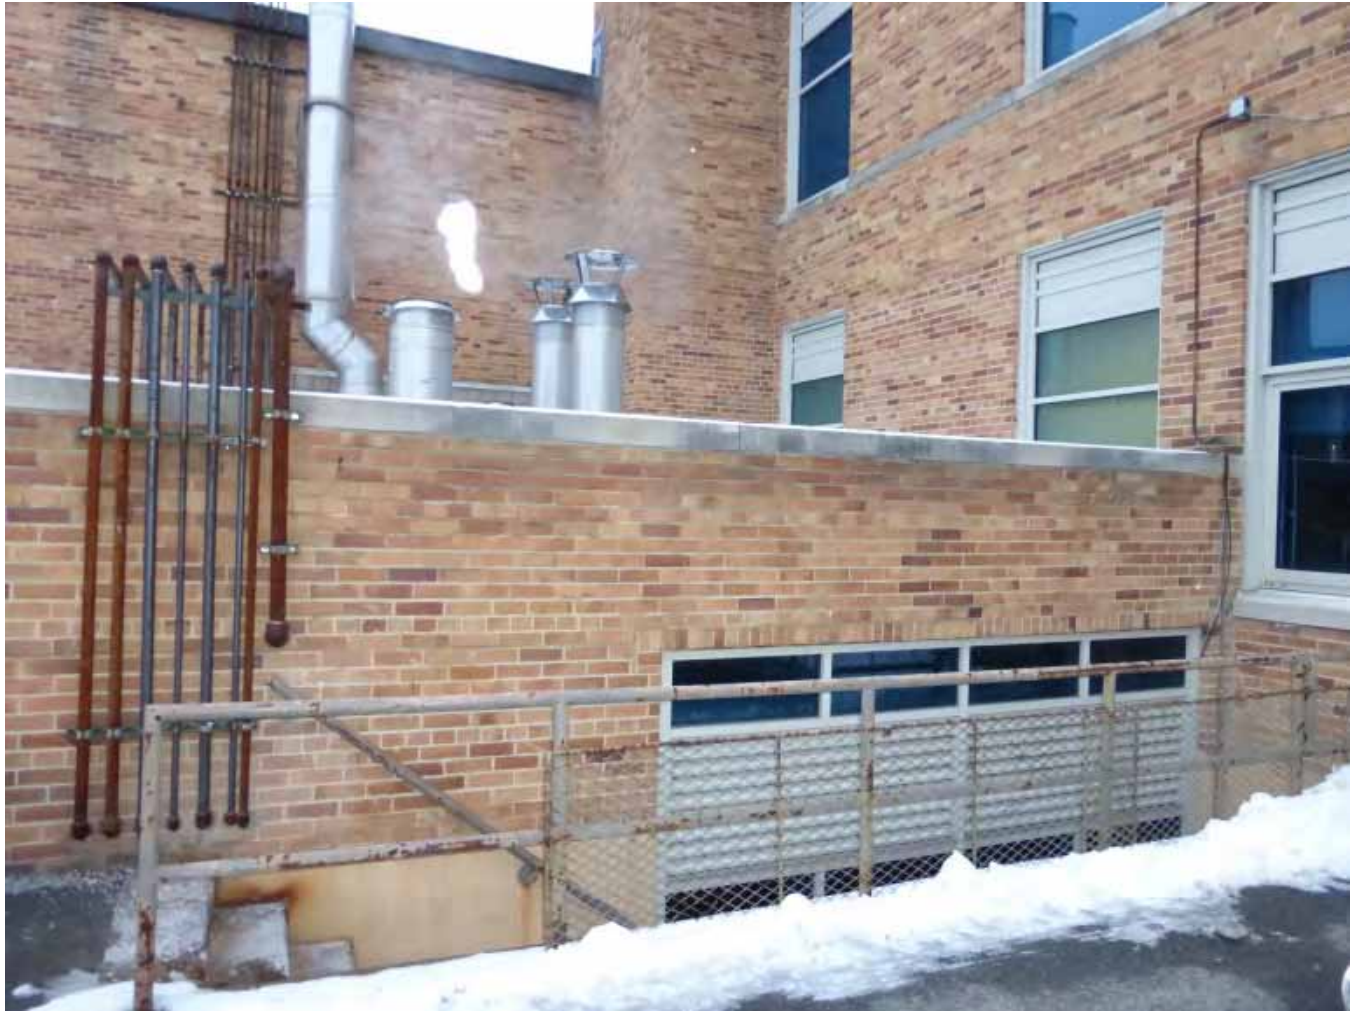
| No. | Item/Description | Location | Photo No. | Cons. | Need | Freq. | Score | Energy | Notes | Action | Qty. | Unit | Architectural | | Mechanical | | Electrical | | 2014 Project Cost |
|---|--|--|---|---|---|---|---|---|---|---|---|---|---|---|---|---|---|---|---|
| BE-5 | Steel Stair Railings | Stair to Basement Mechanical Room | BE-5 | 3 | 3 | 2 | 8 | | Paint is peeling and steel is rusted. | Paint railings. | 35 | LF | \$ 8.00 | \$ 280 | | | | | \$ 422 |

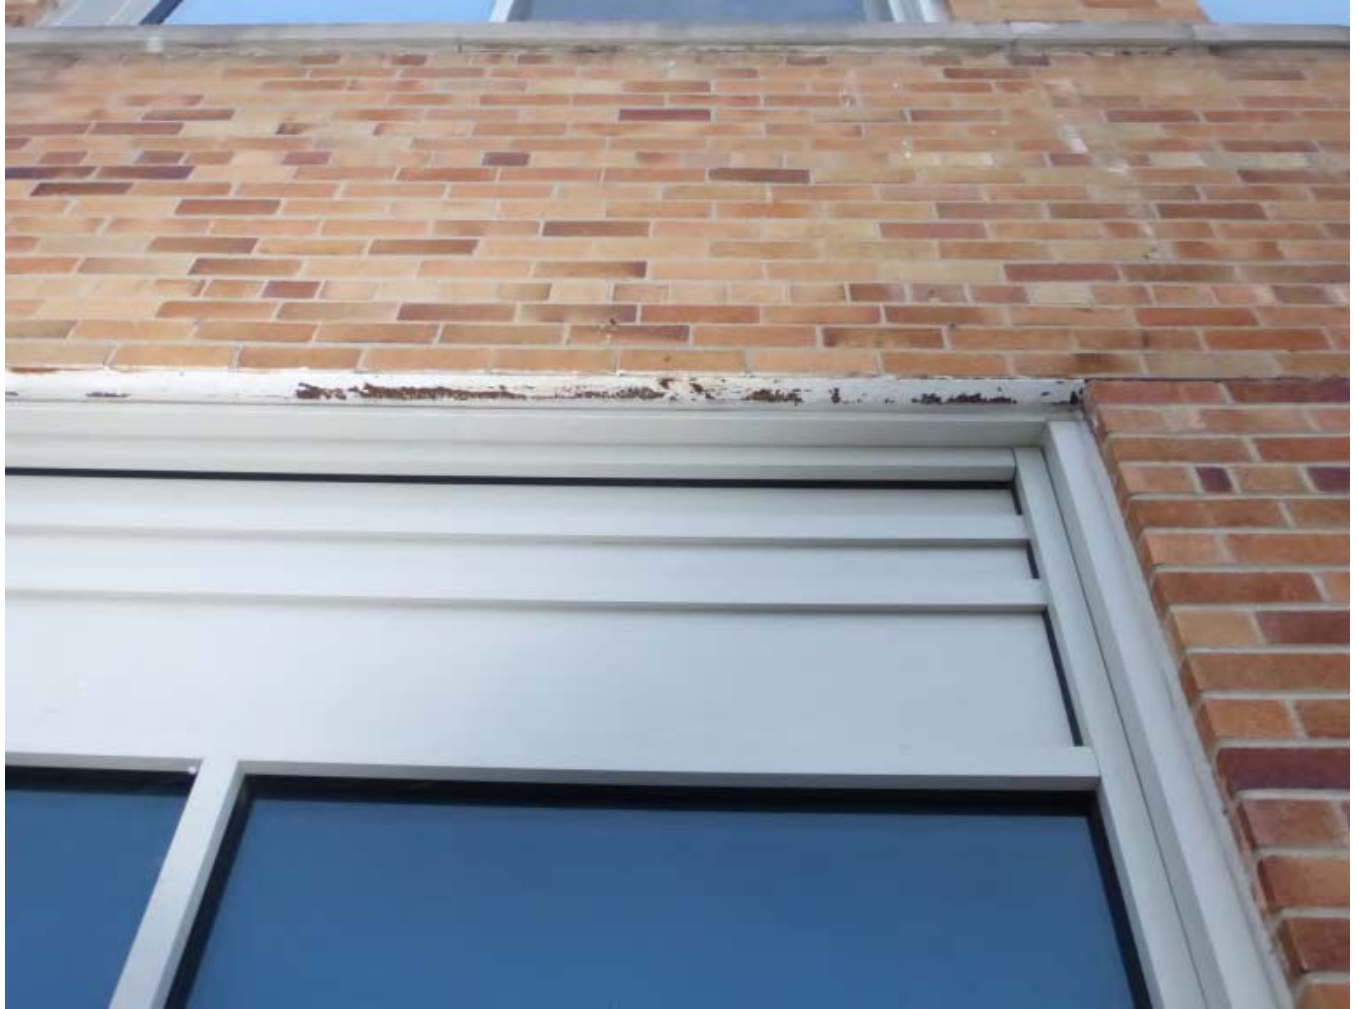
| No. | Item/Description | Location | Photo No. | Cons. | Need | Freq. | Score | Energy | Notes | Action | Qty. | Unit | Architectural | | Mechanical | | Electrical | | 2014 Project Cost |
|---|--|--|---|---|---|---|---|---|---|---|---|---|---|---|---|---|---|---|---|
| BE-6 | Steel Window Lintels | West Elevation 2 story Wing | BE-6 | 3 | 3 | 2 | 8 | | Lintels are rusting. | Repaint lintels. | 250 | LF | \$ 18.00 | \$ 4,500 | | | | | \$ 6,786 |

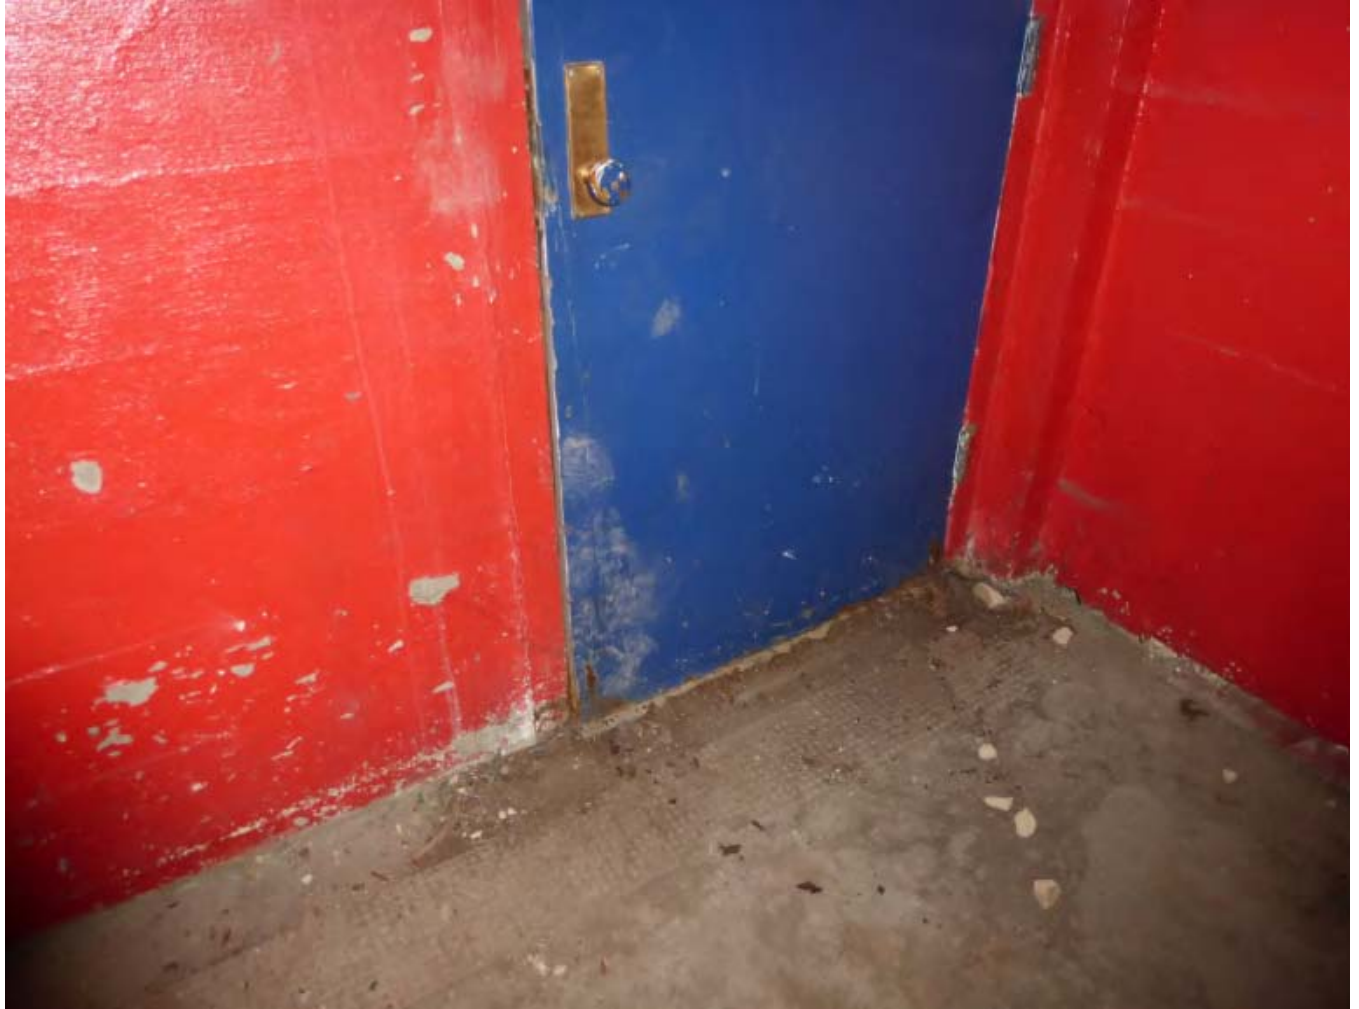
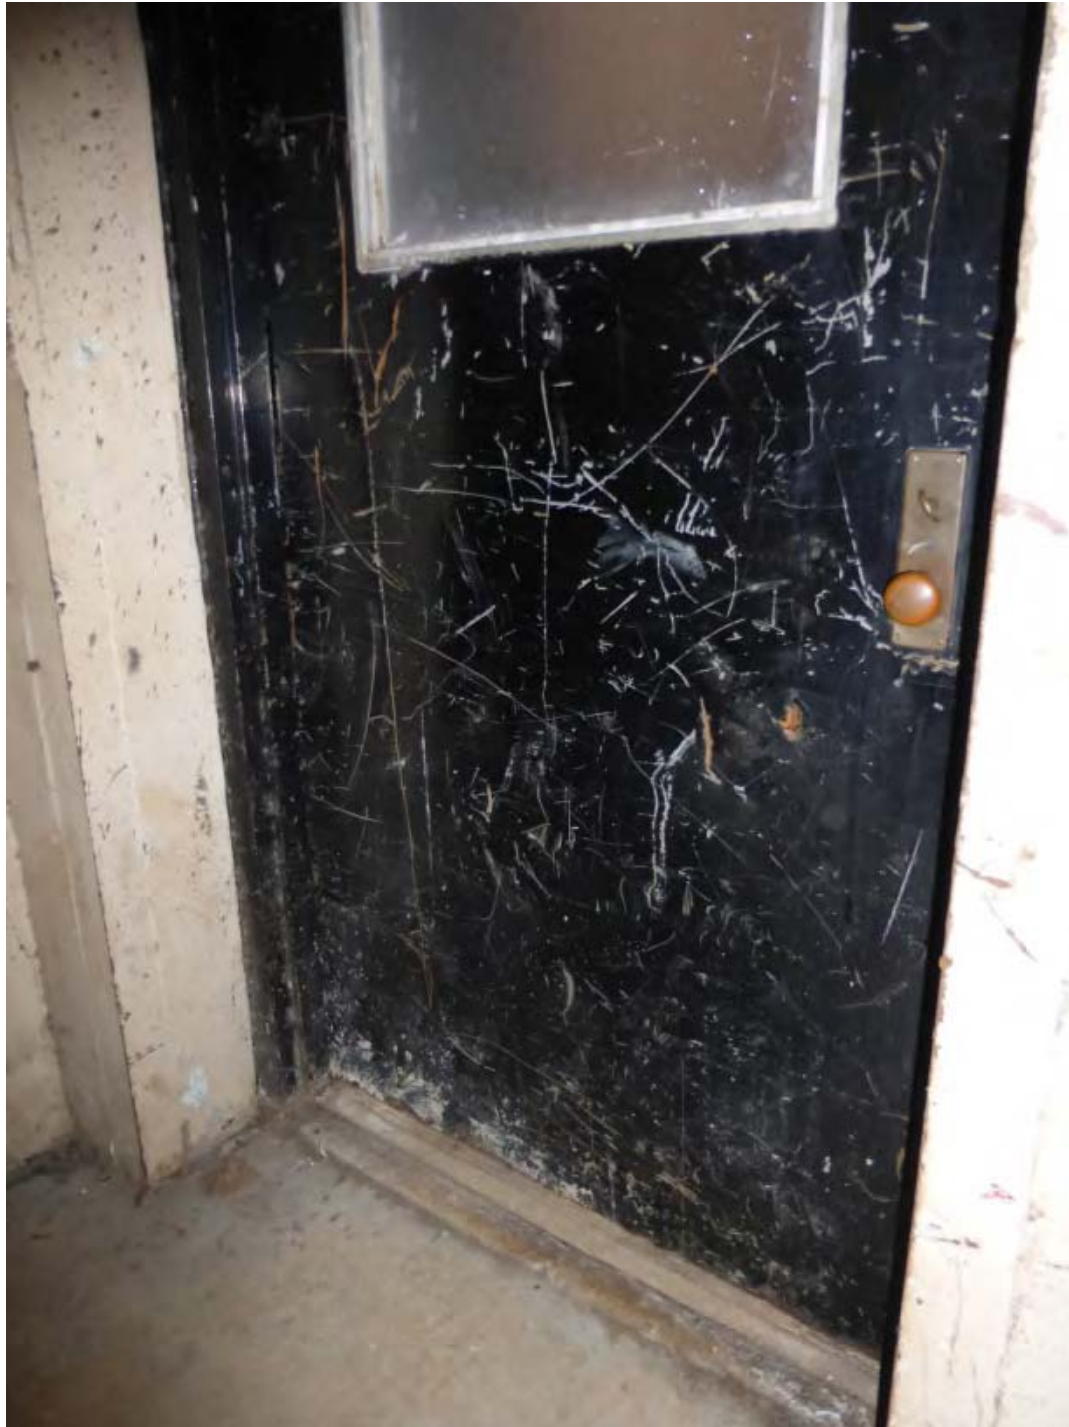
| No. | Item/Description | Location | Photo No. | Cons. | Need | Freq. | Score | Energy | Notes | Action | Qty. | Unit | Architectural | | Mechanical | | Electrical | | 2014 Project Cost |
|---|--|--|---|---|---|---|---|---|---|---|---|---|---|---|---|---|---|---|---|
| BE-7 | Steel Doors and Frames | Basement Mechanical Room and Storage Exits | BE-7A<br>BE-7B | 3 | 3 | 1 | 7 | | Deteriorated and rusted. | Replace with aluminum frames and fiberglass reinforced panel doors. | 2 | EA | \$ 2,800.00 | \$ 5,600 | | | | | \$ 8,445 |

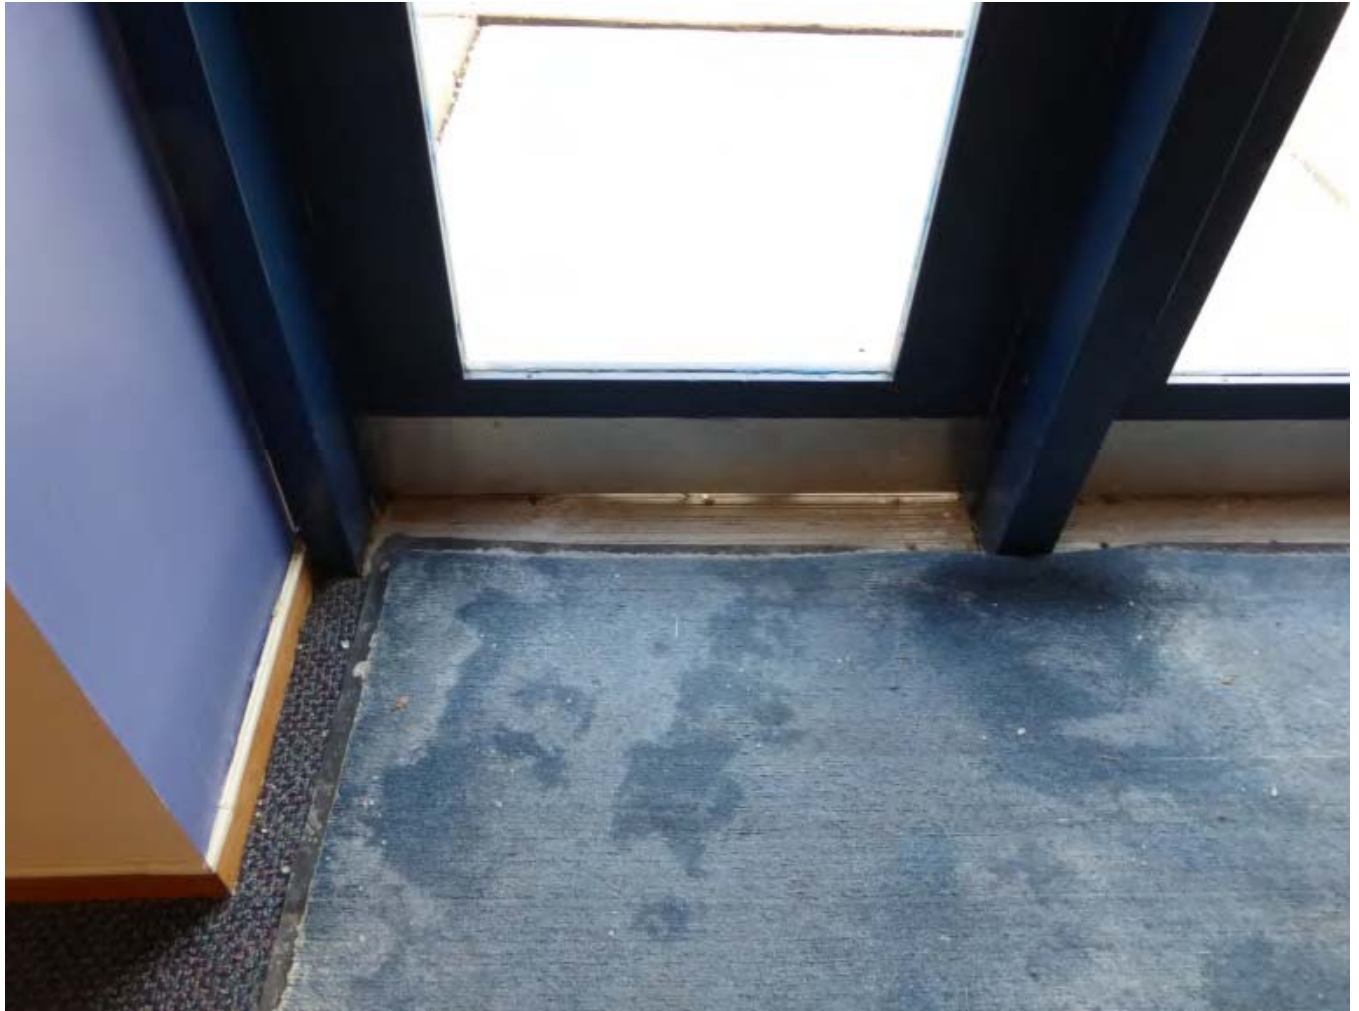
| No. | Item/Description | Location | Photo No. | Cons. | Need | Freq. | Score | Energy | Notes | Action | Qty. | Unit | Architectural | | Mechanical | | Electrical | | 2014 Project Cost |
|---|--|--|---|---|---|---|---|---|---|---|---|---|---|---|---|---|---|---|---|
| BE-10 | Door Seals | Auditorium Lobby Entrance | BE-10 | 4 | 3 | 2 | 9 | | Doors not sealed at sills. | Add/replace door sweeps. | 4 | EA | \$ 100.00 | \$ 400 | | | | | \$ 603 |

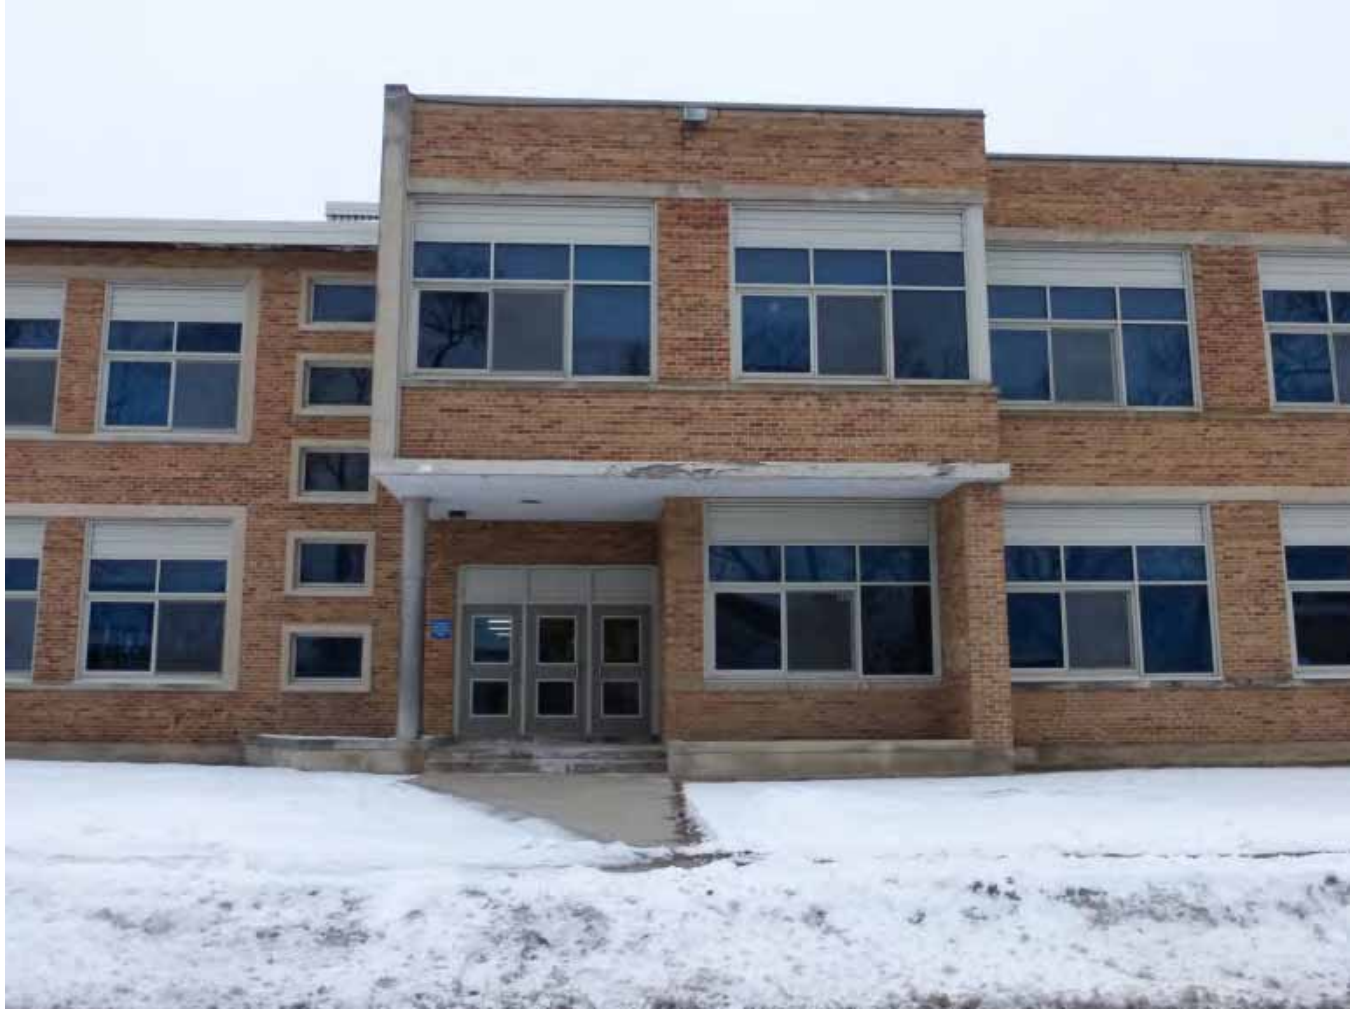
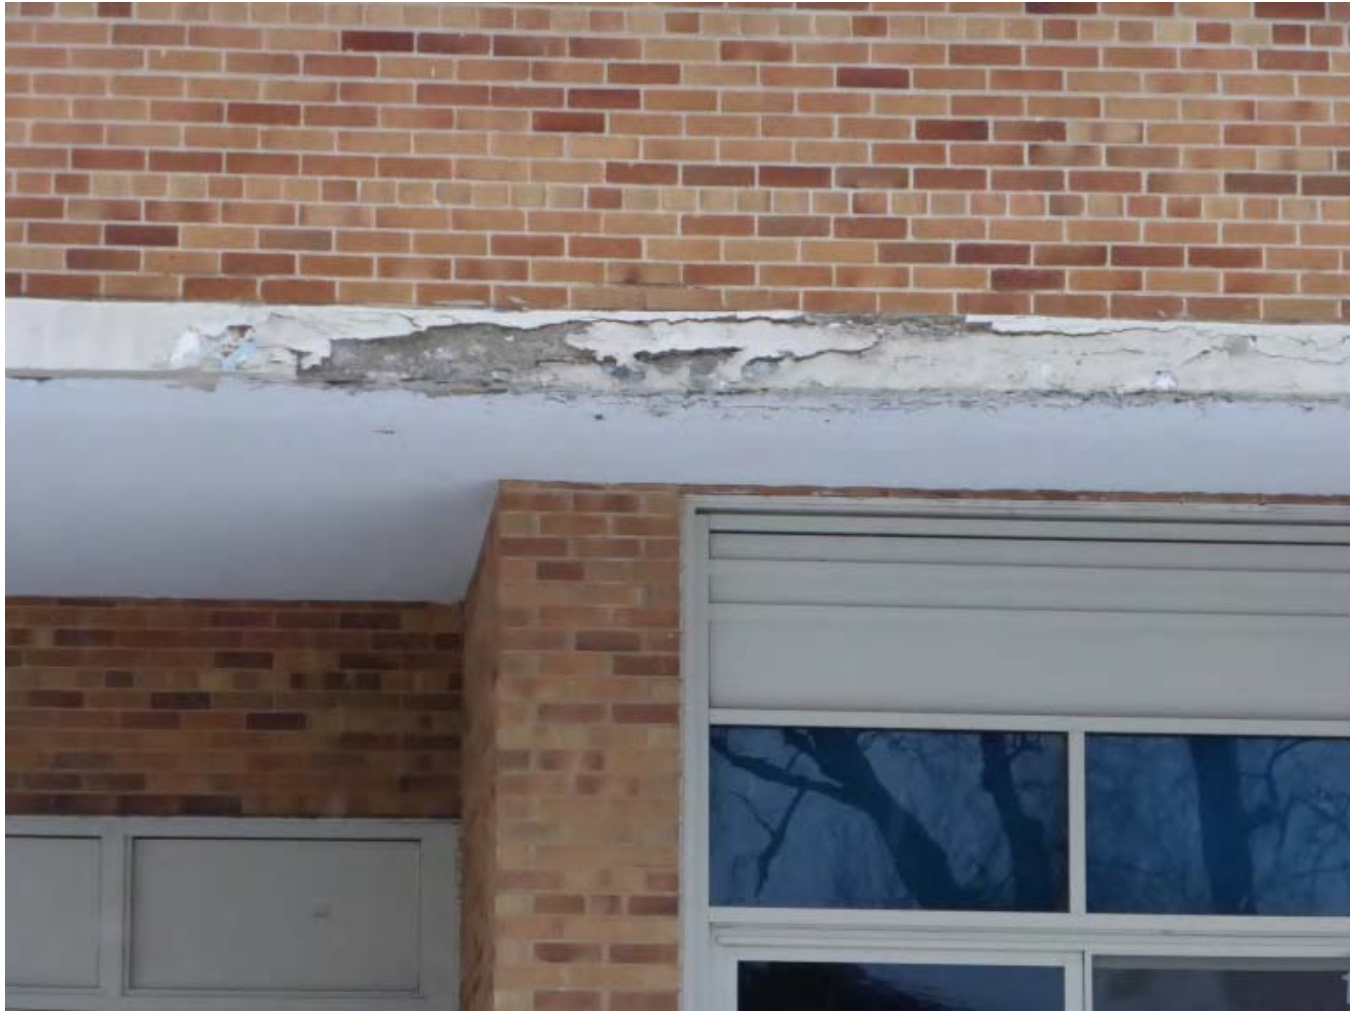
| No. | Item/Description | Location | Photo No. | Cons. | Need | Freq. | Score | Energy | Notes | Action | Qty. | Unit | Architectural | | Mechanical | | Electrical | | 2014 Project Cost |
|---|--|--|---|---|---|---|---|---|---|---|---|---|---|---|---|---|---|---|---|
| BE-11 | Concrete Fascia and Soffit | South Entrance | BE-11A<br>BE-11B | 3 | 3 | 2 | 8 | | Concrete is deteriorated and cracked. | Replace with aluminum fascia and soffit. | 200 | SF | \$ 15.00 | \$ 3,000 | | | | | \$ 4,524 |

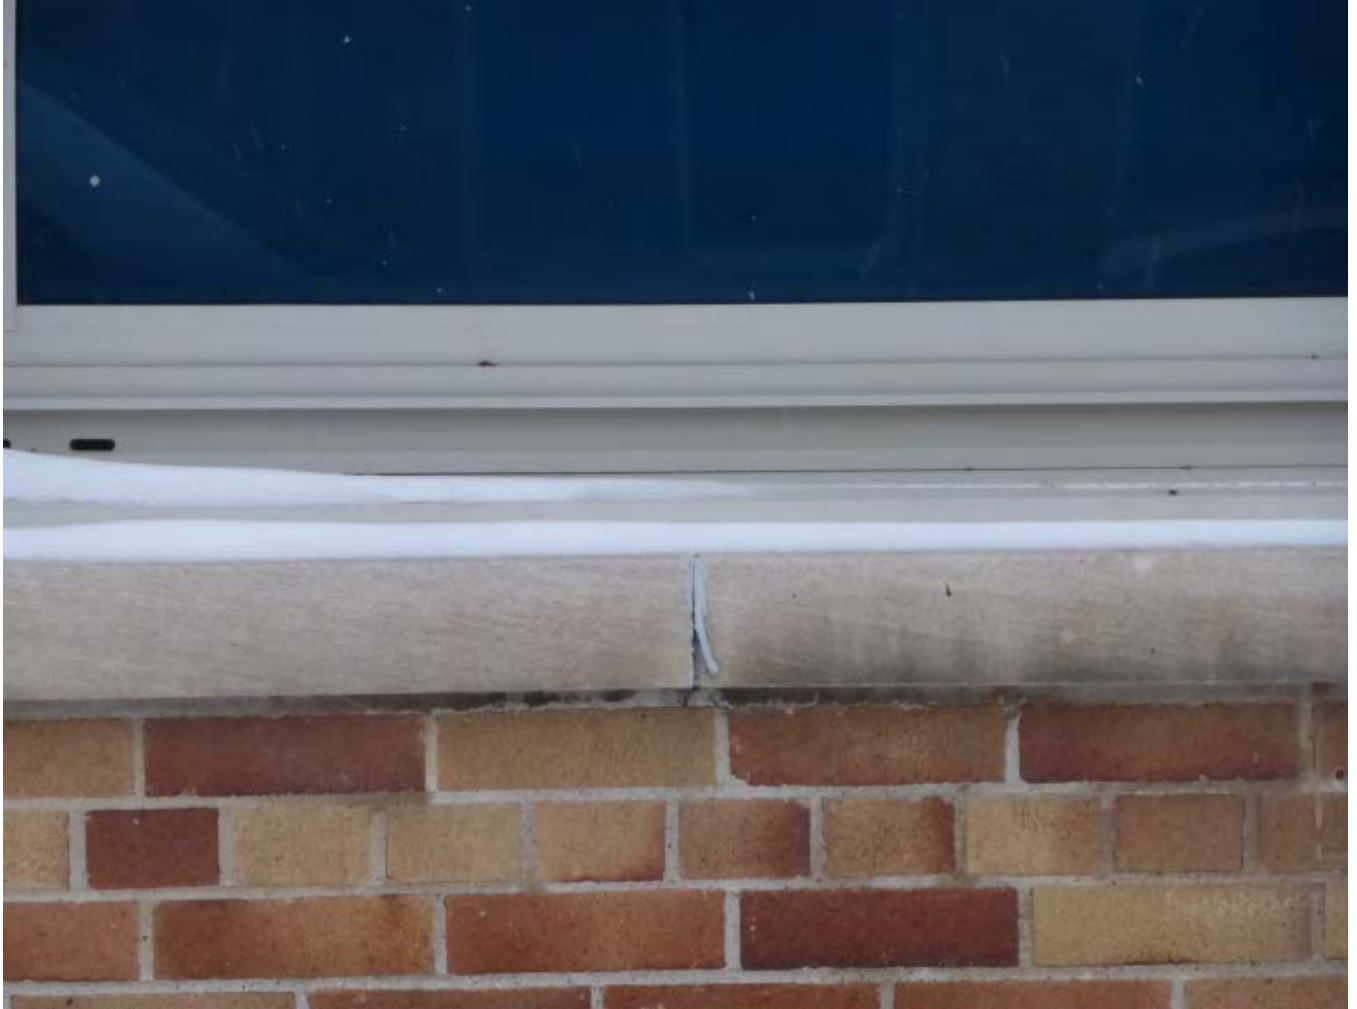
| No. | Item/Description | Location | Photo No. | Cons. | Need | Freq. | Score | Energy | Notes | Action | Qty. | Unit | Architectural | | Mechanical | | Electrical | | 2014 Project Cost |
|---|--|--|---|---|---|---|---|---|---|---|---|---|---|---|---|---|---|---|---|
| BE-12 | Stone Window Sills | Various Locations | BE-12 | 4 | 3 | 2 | 9 | | Sealant missing at joints, some sills are cracked and deteriorated. | Provide sealant and/or replace stone sill. | 250 | LF | \$ 30.00 | \$ 7,500 | | | | | \$ 11,310 |

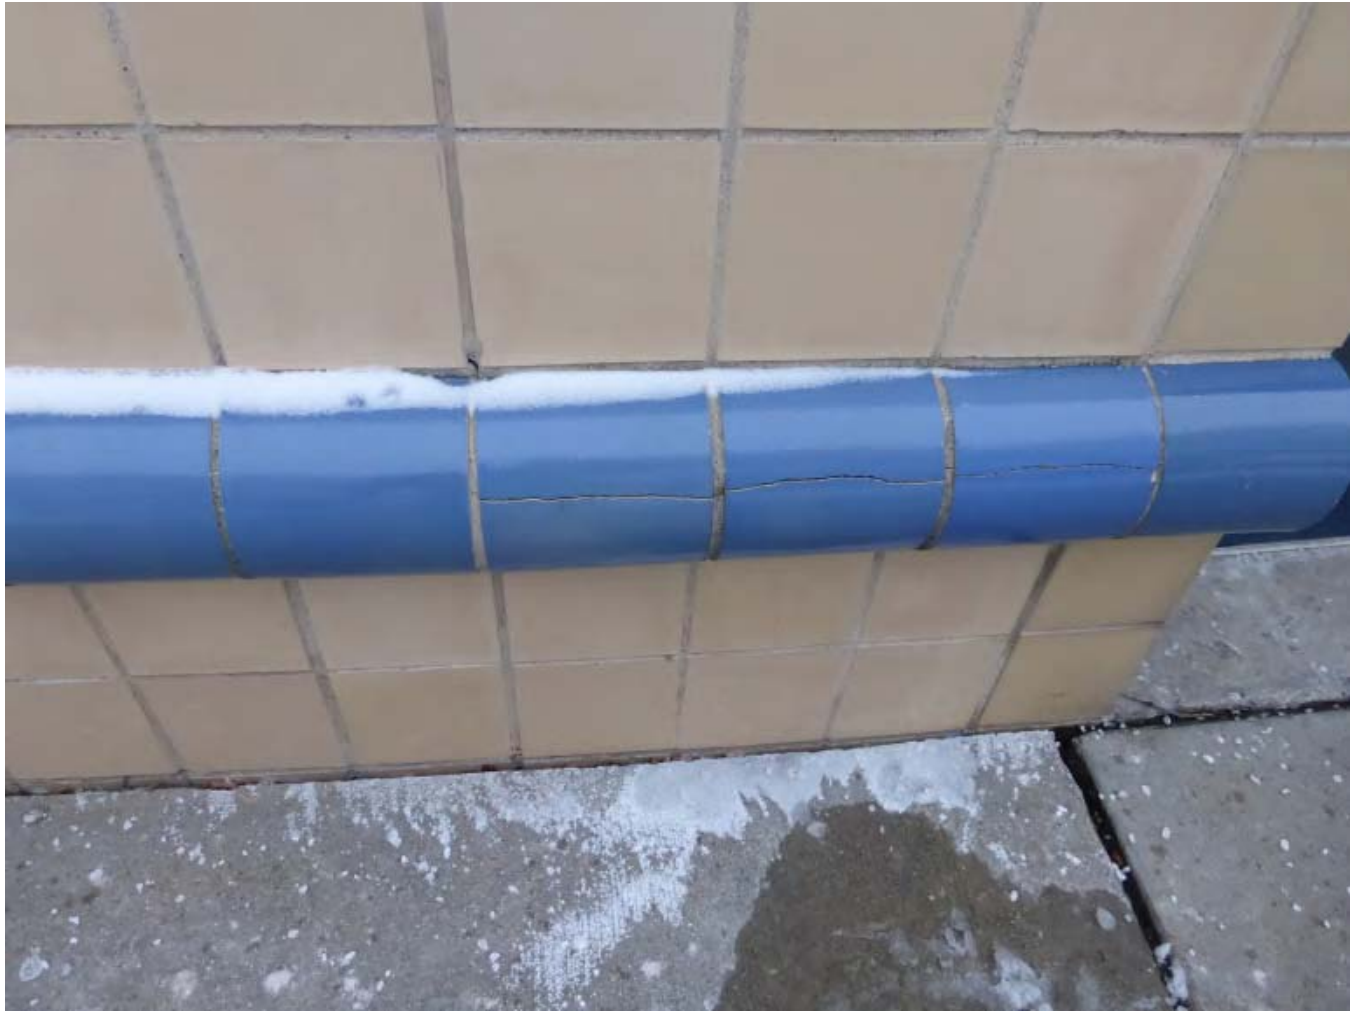
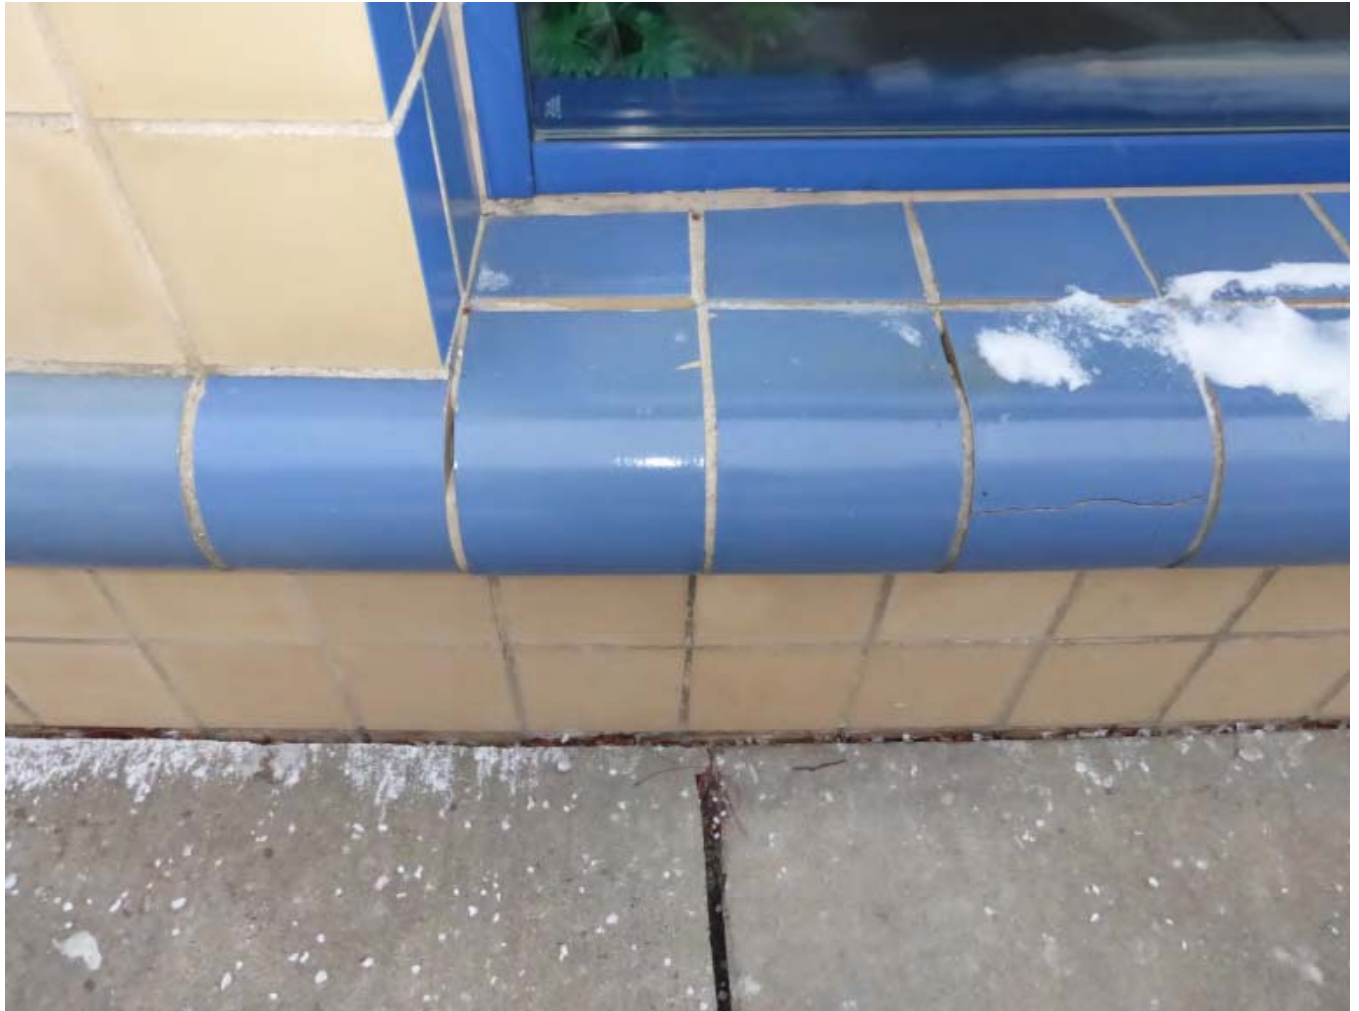
| No. | Item/Description | Location | Photo No. | Cons. | Need | Freq. | Score | Energy | Notes | Action | Qty. | Unit | Architectural | | Mechanical | | Electrical | | 2014 Project Cost |
|---|--|--|---|---|---|---|---|---|---|---|---|---|---|---|---|---|---|---|---|
| BE-14 | Glazed Masonry Window Sills | Auditorium Lobby Entrance | BE-14A<br>BE-14B | 3 | 3 | 2 | 8 | | Masonry is cracked and sealant joints are missing. | Replace masonry sills. | 40 | LF | \$ 75.00 | \$ 3,000 | | | | | \$ 4,524 |

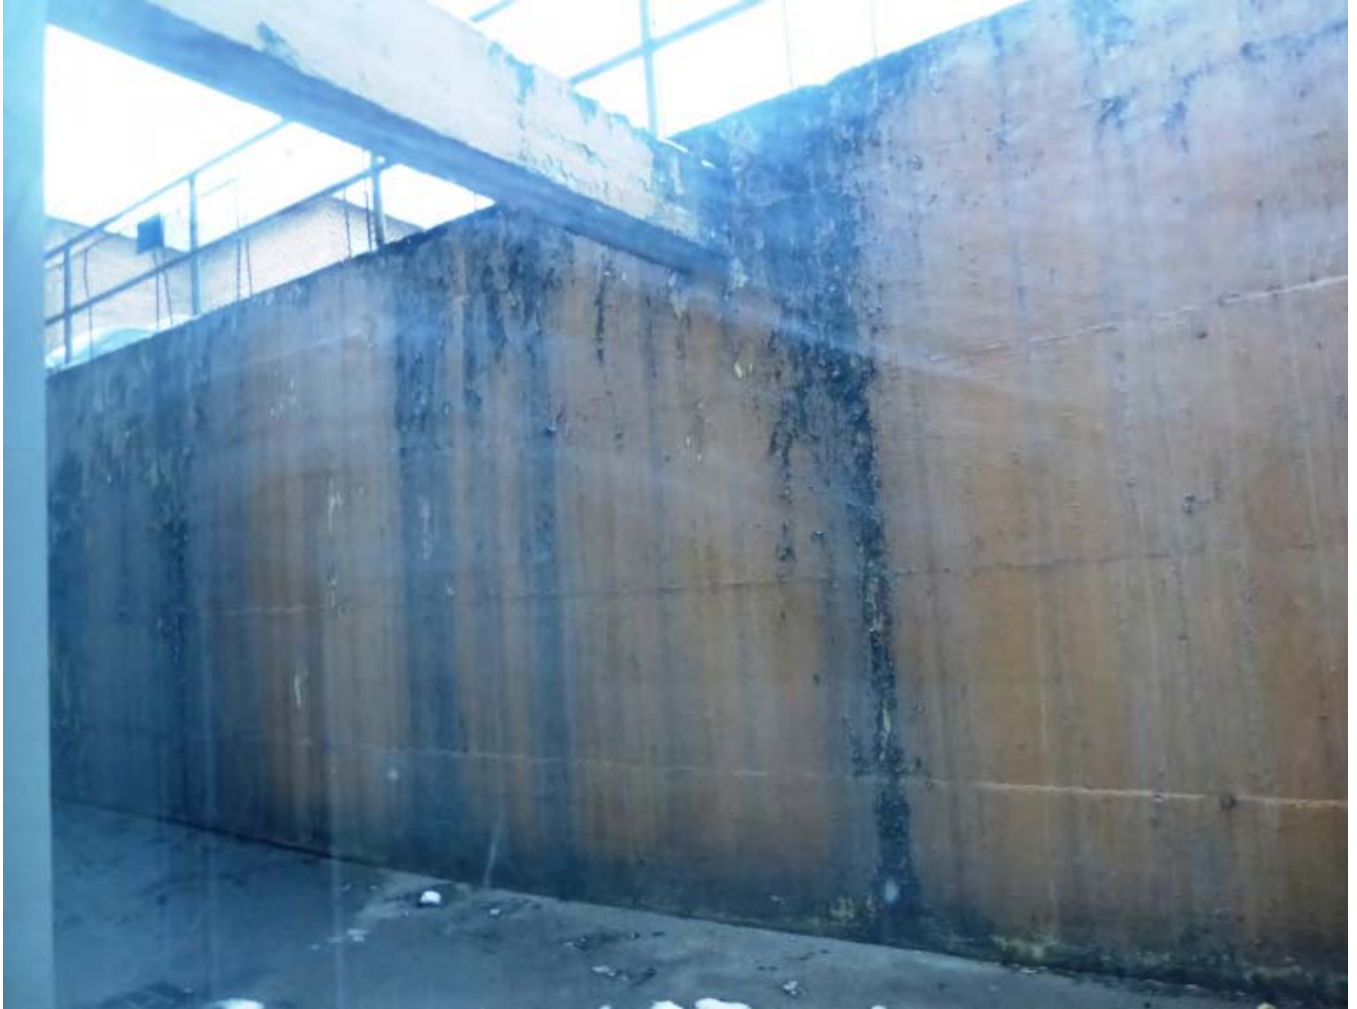
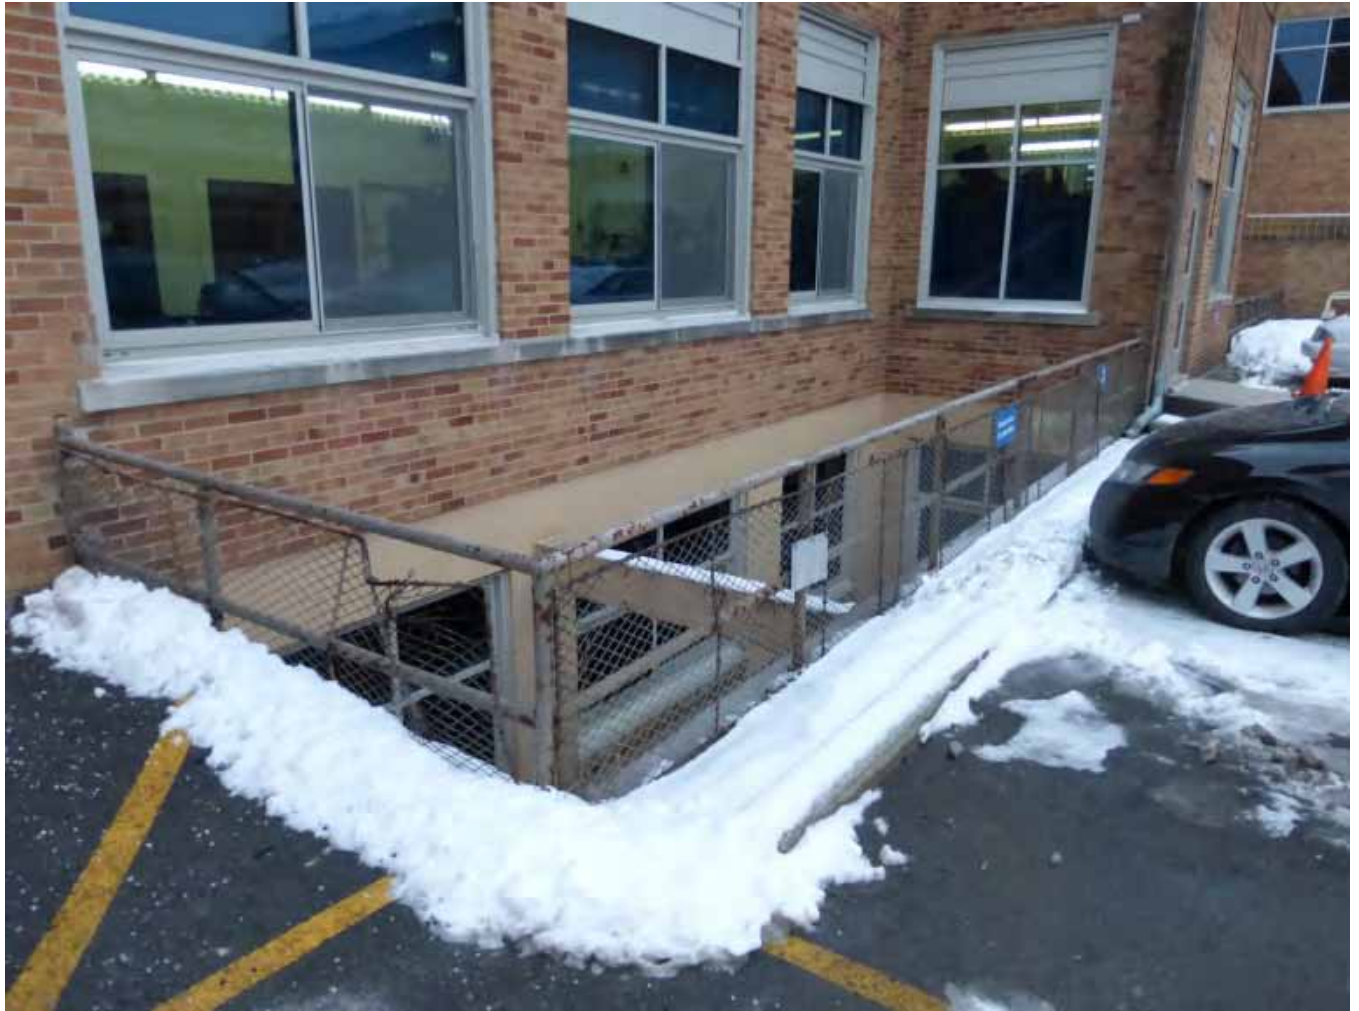
| No. | Item/Description | Location | Photo No. | Cons. | Need | Freq. | Score | Energy | Notes | Action | Qty. | Unit | Architectural | | Mechanical | | Electrical | | 2014 Project Cost |
|---|--|--|---|---|---|---|---|---|---|---|---|---|---|---|---|---|---|---|---|
| BE-15 | Basement Areaway | Adjacent to Receiving Entrance | BE-15A<br>BE-15B | 4 | 5 | 5 | 14 | | Leaks water into basement, fence and railing at grade level deteriorated. | Add knee walls and sloped roof over areaway. | 280 | SF | \$ 35.00 | \$ 9,800 | | | | | \$ 14,778 |

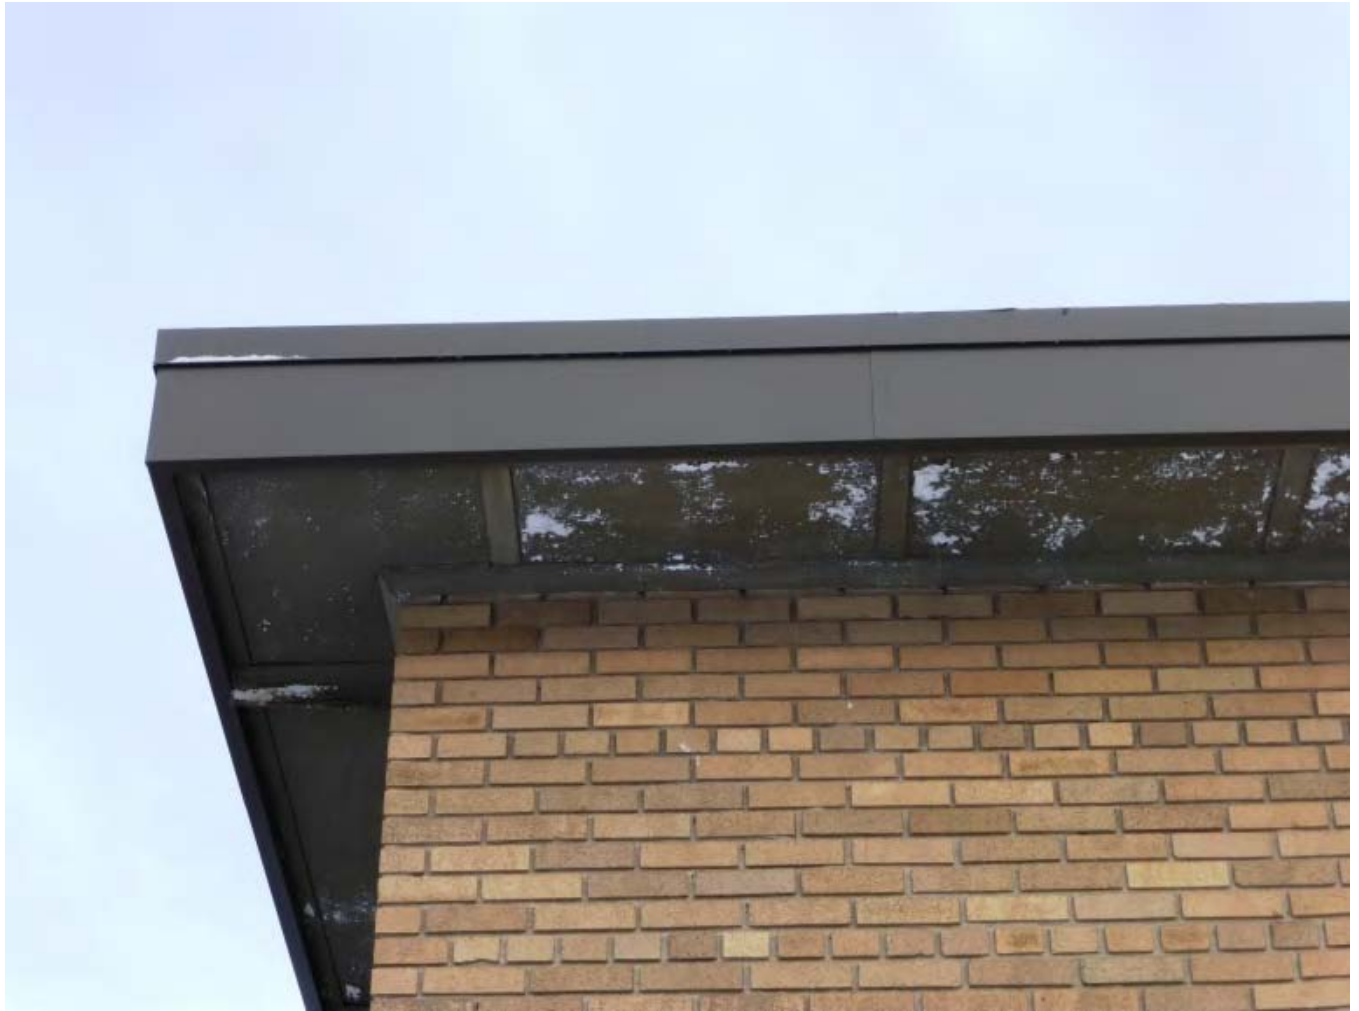
| No. | Item/Description | Location | Photo No. | Cons. | Need | Freq. | Score | Energy | Notes | Action | Qty. | Unit | Architectural | | Mechanical | | Electrical | | 2014 Project Cost |
|--|--|---|---|---|---|---|---|---|---|--|---|---|---|---|---|---|---|---|---|
| BE-1 | Overhangs/Soffits | Entire Building | BE-1 | 3 | 3 | 2 | 8 | | Paint is peeling and steel is rusted. | Provide aluminum soffit panels. | 1,270 | SF | \$ 6.00 | \$ 7,620 | | | | | \$ 11,491 |
