# NORUP INTERNATIONAL SCHOOL

**BERKLEY SCHOOLS**  
**Comprehensive Academic Spaces, Facilities and Technologies Needs Assessment**

Address: 14450 Manhattan, Oak Park, Michigan Bldg. Area: 89,603 GSF No. of Floors: 2 Year Built: 1956 Evaluation Date: January 2014	<b>Item No. Codes</b> AB: Accessibility Improvement/Building Code AD: Academic/Space Deficiencies BE: Building Exterior BI: Building Interior BS: Building System ES: Electrical System MS: Mechanical System PS: Plumbing System SC: Site Circulation SE: Specialty Equipment/Other IT: Technology		<b>Building Deficiencies Priorities by Category</b> <div style="display: flex; justify-content: space-around;"> <div style="background-color: yellow; padding: 5px;"> <b>Consequences of the Problem</b>            1. Hazards            2. Interruption            3. Deterioration            4. Utility            5. Energy         </div> <div style="background-color: lightgreen; padding: 5px;"> <b>Need</b>            1. Critical            2. Urgent            3. Necessary            4. ADA            5. Desirable         </div> <div style="background-color: orange; padding: 5px;"> <b>Frequency of Use</b>            1. Constant

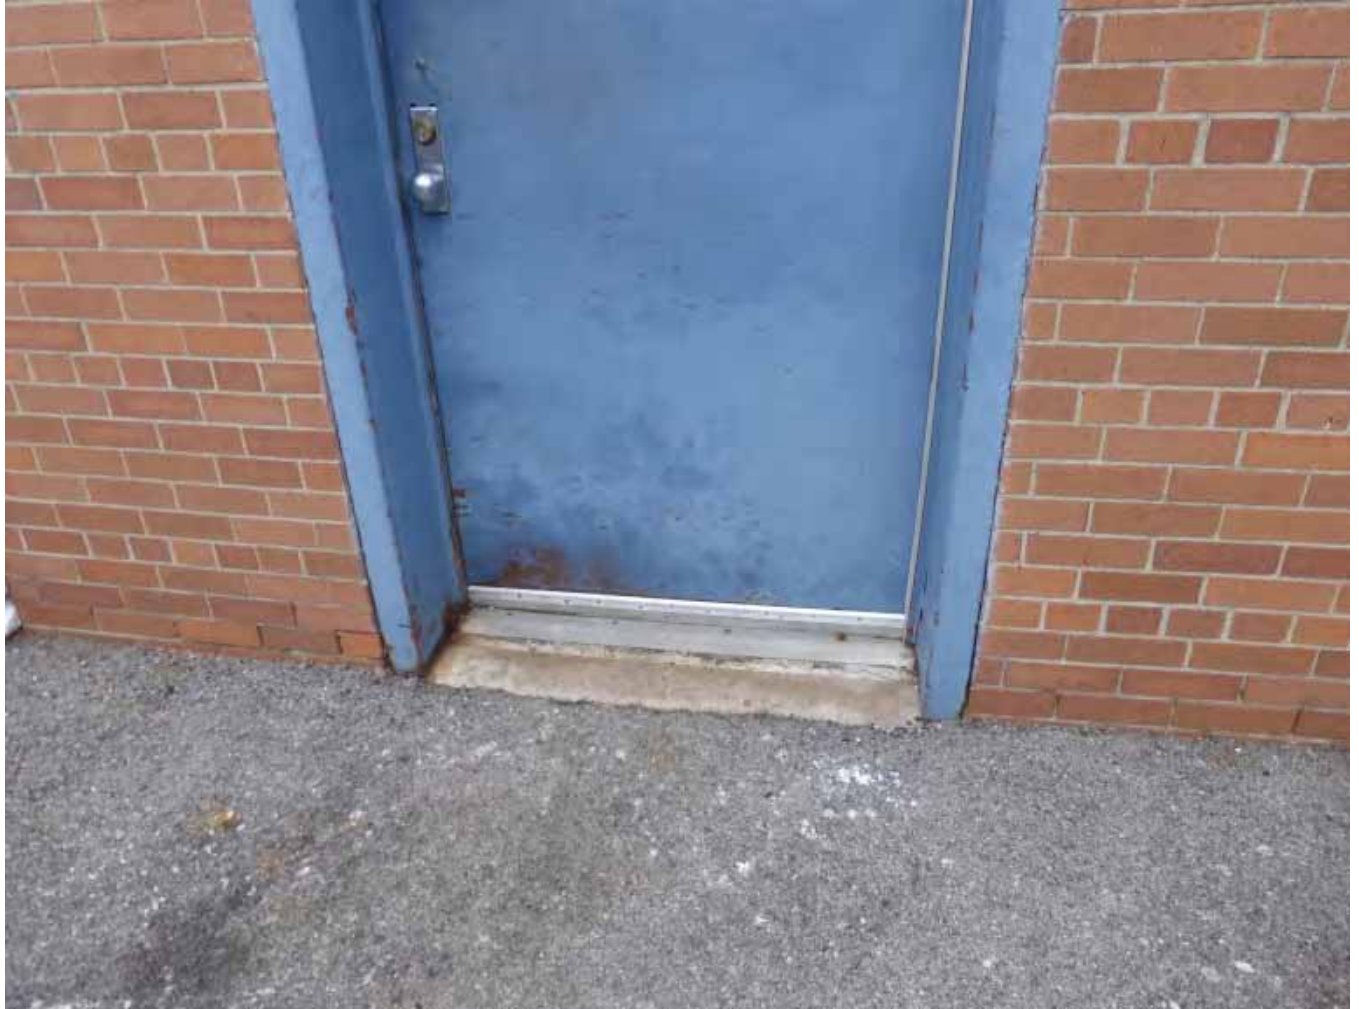
No.	Item/Description	Location	Photo No.	Cons.	Need	Freq.	Score	Energy	Notes	Action	Qty.	Unit	Architectural		Mechanical		Electrical		2014 Project Cost	
													Unit Cost	Subtotal	Unit Cost	Subtotal	Unit Cost	Subtotal		
<b>BUILDING EXTERIOR</b>																				
BE-1	Overhangs/Soffits	Entire Building	BE-1	3	3	2	8		Paint is peeling and steel is rusted.	Provide aluminum soffit panels.	1,630	SF	\$ 6.00	\$ 9,780					\$ 14,748	
BE-2	Brick Veneer at Base of Walls	Various Locations	BE-2	3	3	2	8		Brick cracked or missing.	Repair brick.	75	SF	\$ 25.00	\$ 1,875					\$ 2,828	
BE-3	Sealant at Door and Window Openings	Entire Building	BE-3	3	3	2	8		Sealant deteriorated and cracked.	Replace sealant.	3,400	LF	\$ 4.75	\$ 16,150					\$ 24,354	
BE-4	Steel Doors and Frames	Locker Room Exit Doors	BE-4	3	3	1	7		Deteriorated and rusted.	Replace with aluminum frames and fiberglass reinforced panel doors.	4	EA	\$ 2,800.00	\$ 11,200					\$ 16,890

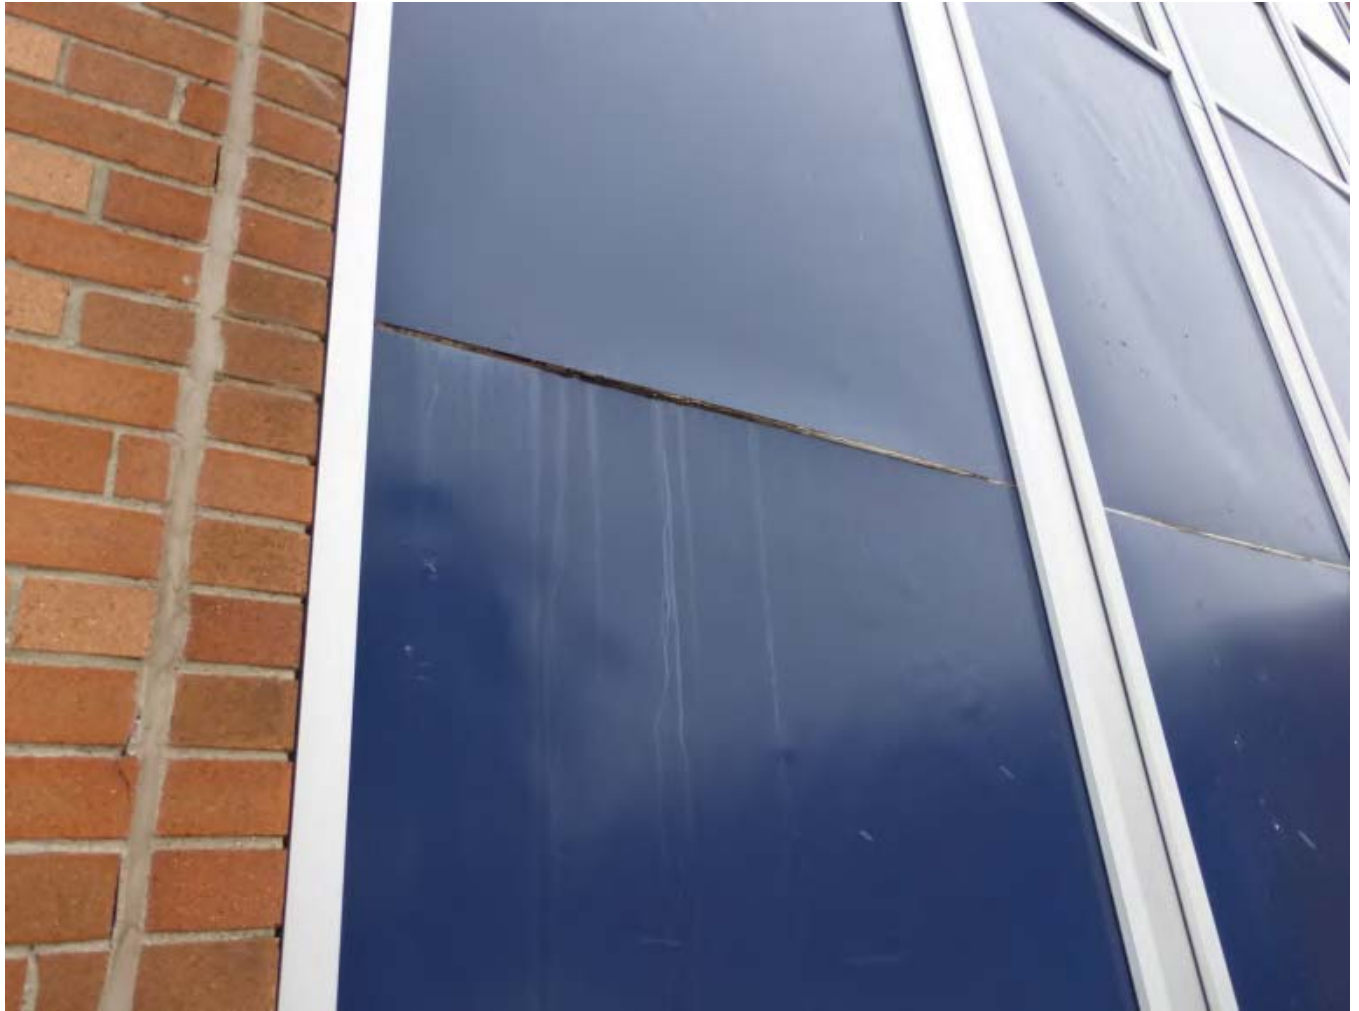
BE-5	Curtainwall Panels	North Elevation of Two-Story Wing	BE-5	3	3	2	8		Delaminating, poor condition.	Replace panels.	50	SF	\$ 25.00	\$ 1,250					\$ 1,885	
BE-6	Brick Flashing/Weeps	South Elevation at Boy's Locker Room	BE-6	3	3	2	8		Weeps at window head blocked by sealant.	Remove sealant and clear weeps.	40	LF	\$ 7.50	\$ 300					\$ 452	
BE-7	Site Drainage	North Elevation	BE-7	2	3	1	6		Roof drainage ponds along face of building.	Add landscape drain tile to storm system.	4,000	SF	\$ 15.00	\$ 60,000					\$ 90,480	
													<b>Subtotal - Building Exterior</b>							\$ 151,637
<b>BUILDING INTERIOR</b>																				
BI-1	Original Hollow Metal, Wood Doors and Frames	Entire Building	BI-1	4	3	1	8		Deteriorated, nonfunctional and do not meet current code requirements.	Replace with wood doors and hollow metal frames.	110	EA	\$ 2,350.00	\$ 258,500					\$ 389,818	
BI-2	Carpet	Corridors	BI-2	3	3	1	7		Carpet reaching life expectancy.	Replace carpet and resilient base.	17,800	SF	\$ 7.00	\$ 124,600					\$ 187,897

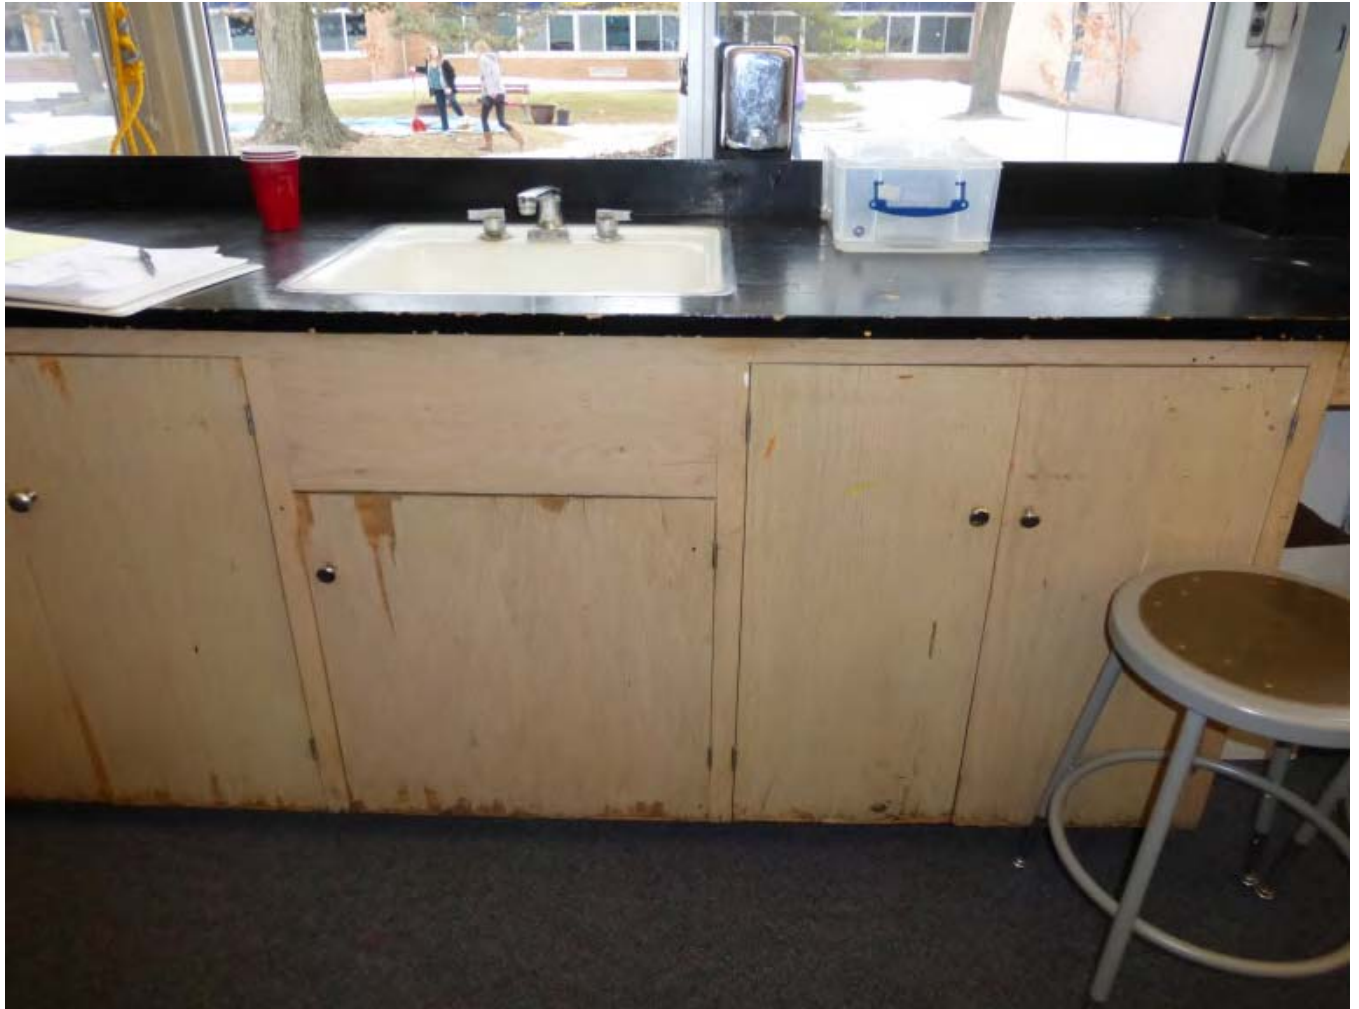
BI-3	Casework Cabinets and Countertops	Classrooms	BI-3	3	3	2	8		Poor condition.	Replace cabinets, counter tops and sinks.	350	LF	\$ 300.00	\$ 105,000	\$ 21.00	\$ 7,350			\$ 169,424	
BI-4	Lockers	Boy's, Girl's and Team Locker Rooms	BI-4A BI-4B	4	5	2	11		Poor condition.	Replace lockers and benches.	600	LF	\$ 550.00	\$ 330,000					\$ 497,640	
BI-5	Masonry Wall	Boy's Locker Room	BI-5	3	3	2	8		Horizontal crack in exterior masonry wall.	Repair masonry.	1	LS	\$ 1,000.00	\$ 1,000						
BI-6	Shower Rooms	Boy's and Girl's Locker Rooms	BI-6	4	5	2	11		Rooms are abandoned and in need of updating and repair.	Reduce/replace number of shower heads, add barrier free shower stall and repair floor, wall and ceiling finishes.	544	SF	\$ 40.00	\$ 21,760	\$ 34.00	\$ 18,496	\$ 5.00	\$ 2,720	\$ 64,808	
BI-7	Below Stage Storage	Gymnasium	BI-7	4	3	2	9		Doors are in poor condition.	Replace doors.	8	EA	\$ 150.00	\$ 1,200					\$ 1,810

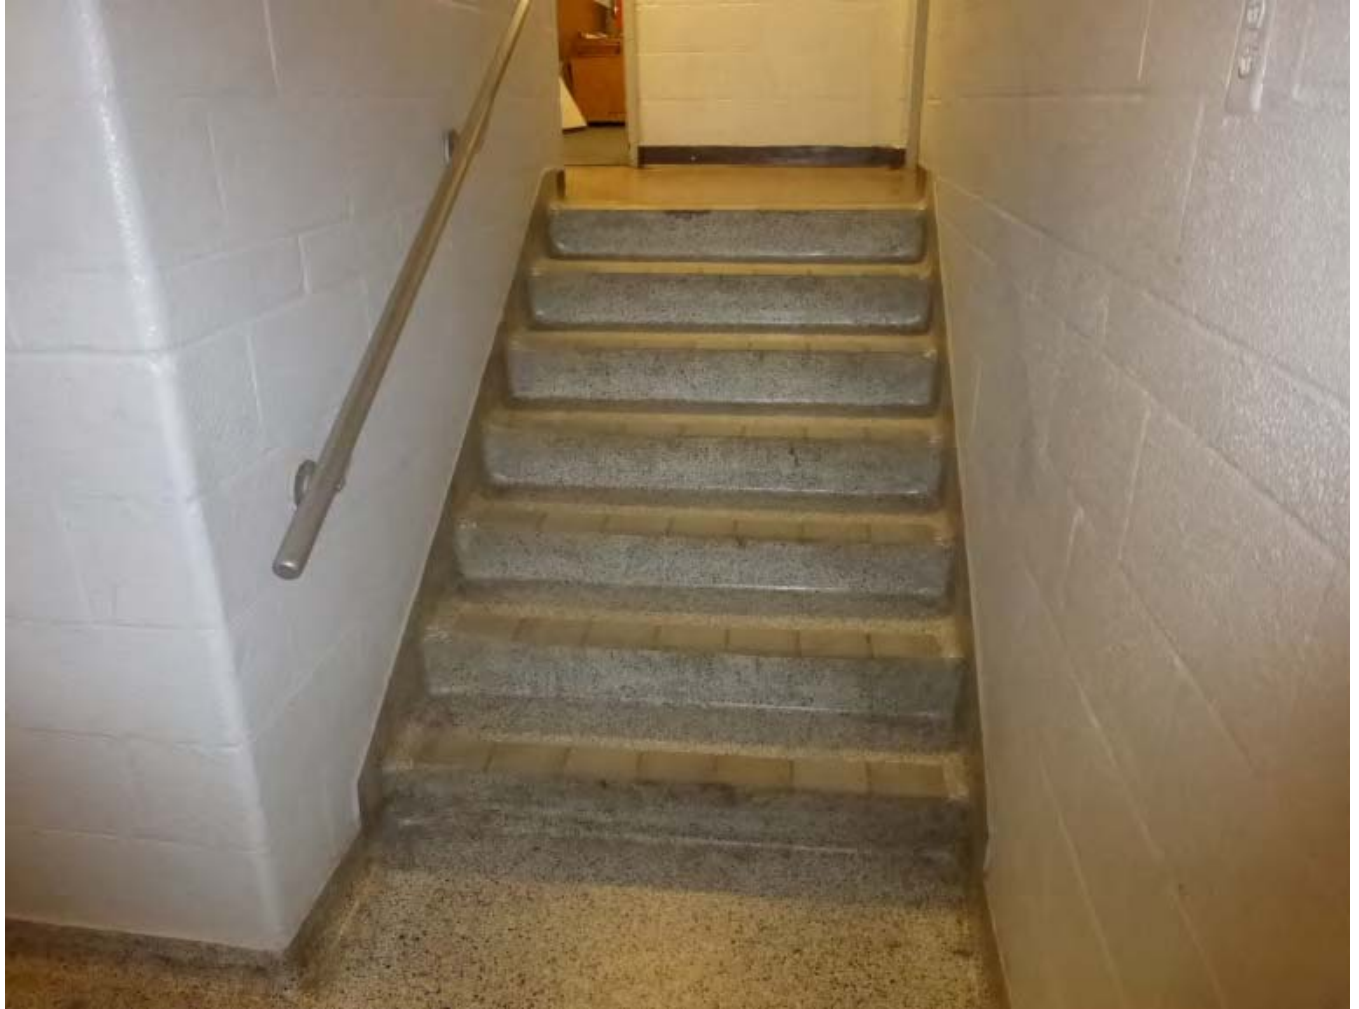
AB-12	Stair Handrail	Stairs to Gymnasium Balcony Boy's Locker Room	AB-12A AB-12B	1	4	2	7		Handrail missing from one side of stair (required on both sides).	Add handrail at wall.	26	LF	\$ 50.00	\$ 1,300					\$ 1,960
AB-13	Boy's and Girl's Toilet Rooms	Various Locations	AB-13	1	4	2	7		Toilet rooms do not meet current accessibility requirements.	Provide new plumbing fixtures, lighting, floor/wall/ceiling finishes, stalls and automatic door operators.	1,800	SF	\$ 55.00	\$ 99,000			\$ 3,300.00	\$ 5,940,000	\$ 9,106,812
AB-14	Boy's and Girl's Toilet Rooms	Locker Rooms	AB-14	1	4	2	7		Toilet rooms do not meet current accessibility requirements.	Provide new plumbing fixtures, lighting, floor/wall/ceiling finishes and stalls.	225	SF	\$ 55.00	\$ 12,375			\$ 3,300.00	\$ 742,500	\$ 1,138,352
AB-15	Bleacher Guardrails	Gymnasium	--	1	3	2	6		Open ends of wood bleachers do not have guardrails.	Add removable guardrails to open ends of retractable bleachers.	136	LF	\$ 80.00	\$ 10,880					\$ 16,407

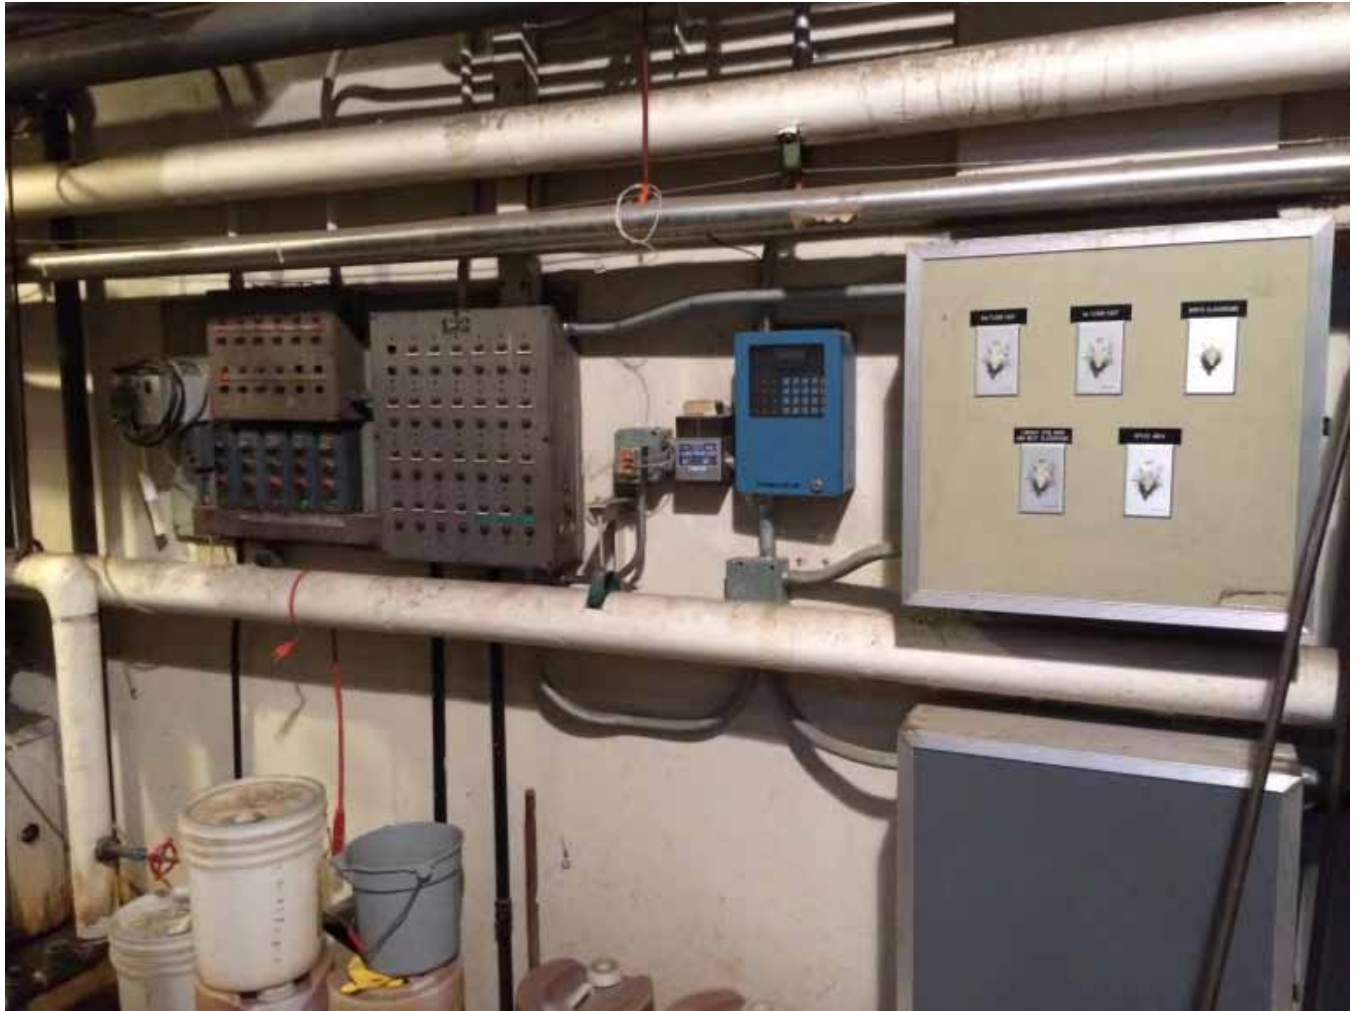
MS-1	Building Controls	Entire Building	MS-1	2	2	1	5	X	Existing controls are outdated.	Provide new DDC controls throughout.	90,000	SF			\$ 3.32	\$ 298,800			\$ 450,590
MS-2	Domestic Water Heater HTR-1	Boiler Room	MS-2	2	2	1	5	X	Existing Ruud water heater is beyond its useful life.	Replace with 199 MBH, 80 gallon standalone unit and stack.	1	LS			\$ 5,000.00	\$ 5,000			\$ 7,540
MS-3	Domestic Water Heater HTR-2	Boiler Room	MS-3	3	3	1	7	X	Existing Lochinvar water heater is beyond its useful life.	Replace with like and kind; 399 MBH unit and new stack.	1	LS			\$ 7,300.00	\$ 7,300			\$ 11,008
MS-4	Condensate Return System	Boiler Room	MS-4	4	3	1	8	X	Receiver tank and pumps are in poor condition.	Replace with packaged receiver system.	1	LS			\$ 9,800.00	\$ 9,800	\$ 1,350.00	\$ 1,350	\$ 16,814
MS-5	Sump Pump	Boiler Room	MS-5	3	3	1	7		Existing duplex sump system is in disrepair.	Rebuild entire duplex sump system.	1	LS			\$ 5,000.00	\$ 5,000	\$ 1,350.00	\$ 1,350	\$ 9,576

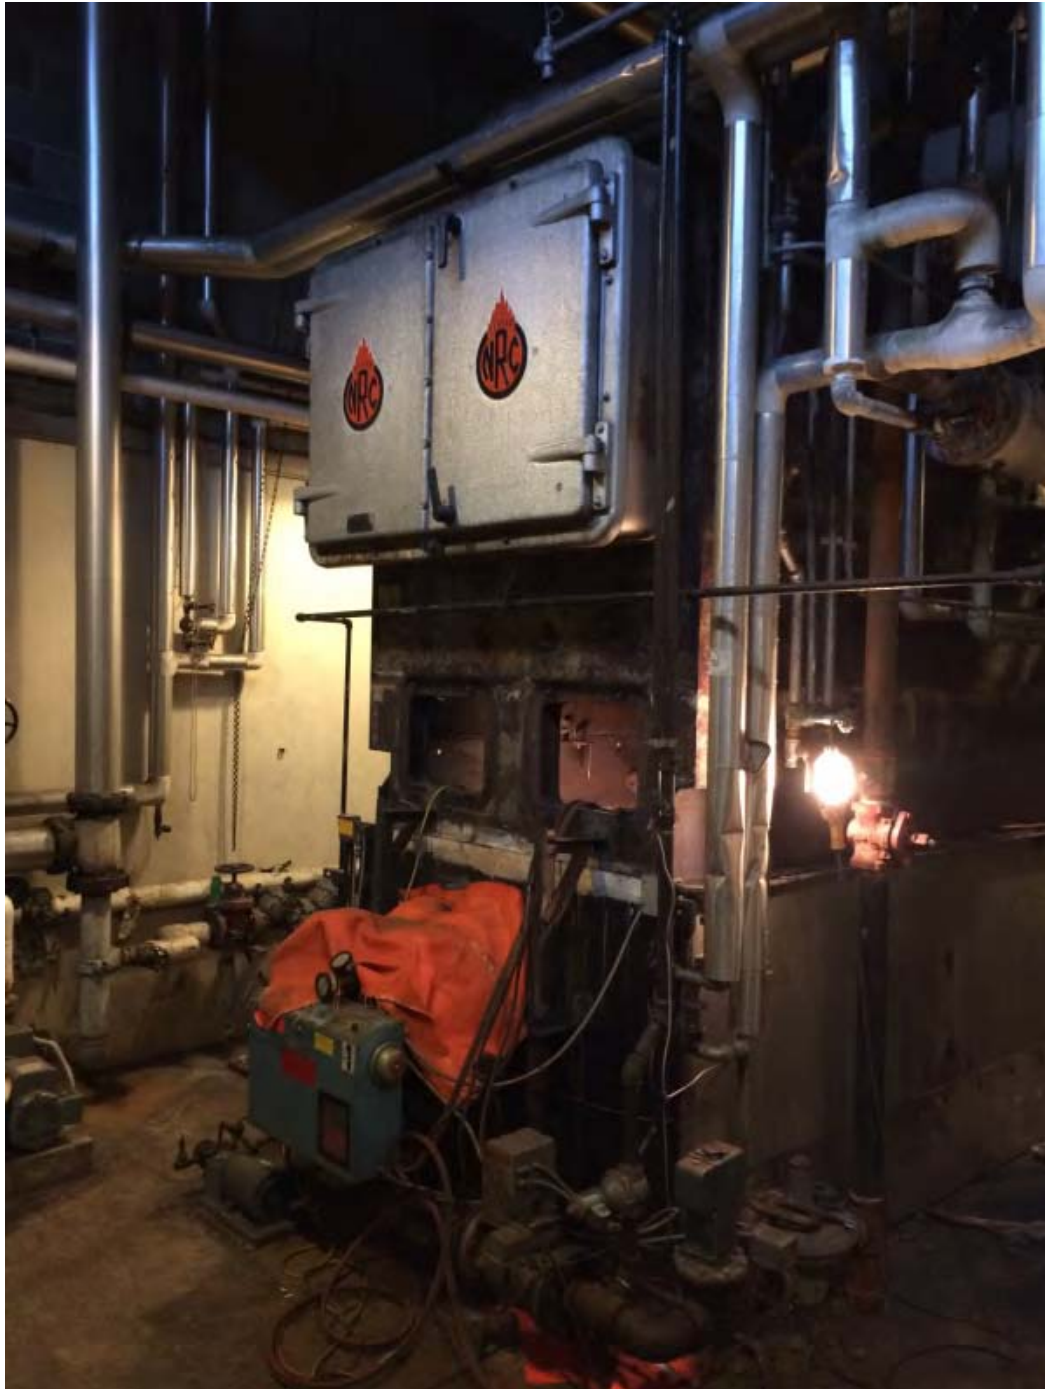
MS-6	Boilers	Boiler Room	MS-6	2	2	1	5	X	Existing boilers are beyond their useful life; circa 1956.	Two (2) new boilers at 6,000 MBH each and all associated trim, new stacks and combustion damper control.	1	LS			\$ 351,000.00	\$ 351,000	\$ 900.00	\$ 900	\$ 530,665
MS-7	Convectors	Vestibules/Entrances	MS-7	4	4	1	9	X	Existing convectors are in fair condition.	Replace with like and kind.	6	EA			\$ 2,250.00	\$ 13,500	\$ 185.00	\$ 1,110	\$ 22,032
MS-8	Unit Ventilators - Heating and Ventilating	Entire Building	MS-8	3	2	1	6	X	Existing heating and ventilating only horizontal unit ventilators are beyond their useful life.	Replace with new vertical ducted units.	35	EA			\$ 23,000.00	\$ 805,000	\$ 235.00	\$ 8,225	\$ 1,226,343
MS-8A	Unit Ventilators - HVAC	Entire Building	--	5	5	1	11	X	Existing unit ventilators are heating and ventilating only.	Install new vertical ducted DX HVAC unit ventilators.	35	EA	\$ 7,500.00	\$ 262,500	\$ 27,000.00	\$ 945,000	\$ 2,373.00	\$ 83,055	\$ 1,946,157

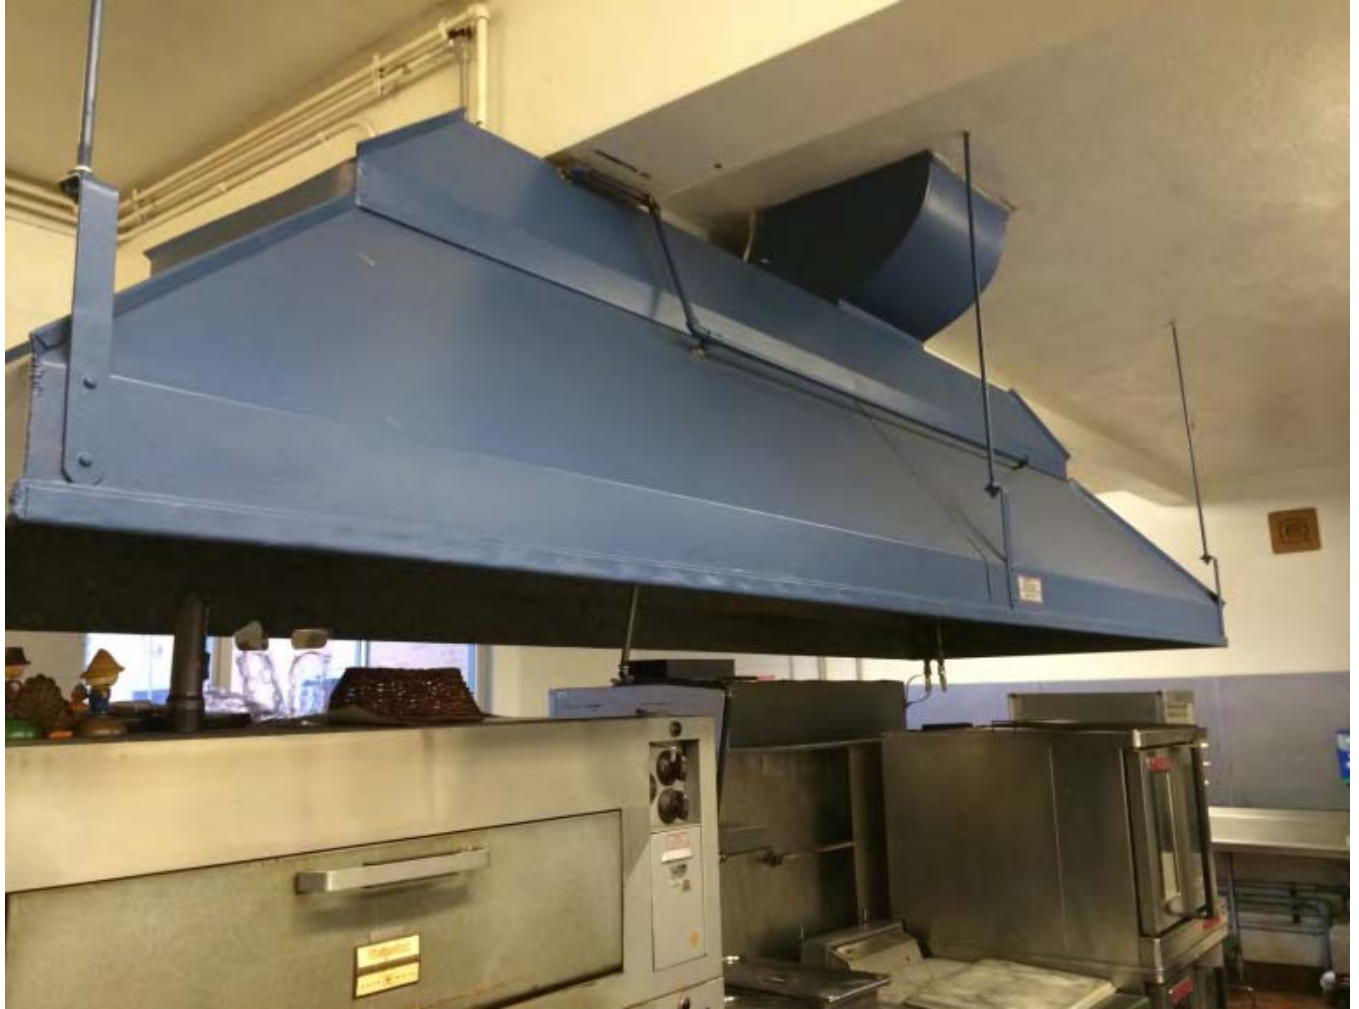
MS-9	Kitchen Hood	Kitchen	MS-9	4	4	1	9		Main kitchen hood is beyond its useful life.	Replace with new stainless steel hood and chemical fire suppression system.	1	LS			\$ 14,500.00	\$ 14,500	\$ 400.00	\$ 400	\$ 22,469
MS-10	Refrigeration Compressors	Kitchen	MS-10	2	2	1	5	X	Existing compressors use domestic water and are not code compliant.	Replace with new air-cooled units.	3	EA			\$ 6,500.00	\$ 19,500	\$ 350.00	\$ 1,050	\$ 30,989
MS-11	Locker Rooms Heating and Ventilating Units	Boy's and Girl's Locker Rooms	MS-11	4	4	4	12		Existing ceiling hung units are in fair condition.	Replace with like and kind; new distribution ductwork.	2	EA			\$ 9,500.00	\$ 19,000	\$ 185.00	\$ 370	\$ 29,210
MS-12	Rooftop Unit RTU-1	Roof	MS-12	4	4	1	9	X	Existing unit is beyond its useful life.	Replace with like and kind; 7,000 CFM HVAC unit.	1	EA			\$ 28,800.00	\$ 28,800	\$ 6,212.00	\$ 6,212	\$ 52,798
MS-13	Rooftop Units RTU-2 and RTU-3	Roof	MS-13	4	4	2	10	X	Existing unit is beyond its useful life.	Replace with like and kind; average size of 1,800 and 3,000 CFM.	1	EA			\$ 13,000.00	\$ 13,000	\$ 3,230.00	\$ 3,230	\$ 24,475

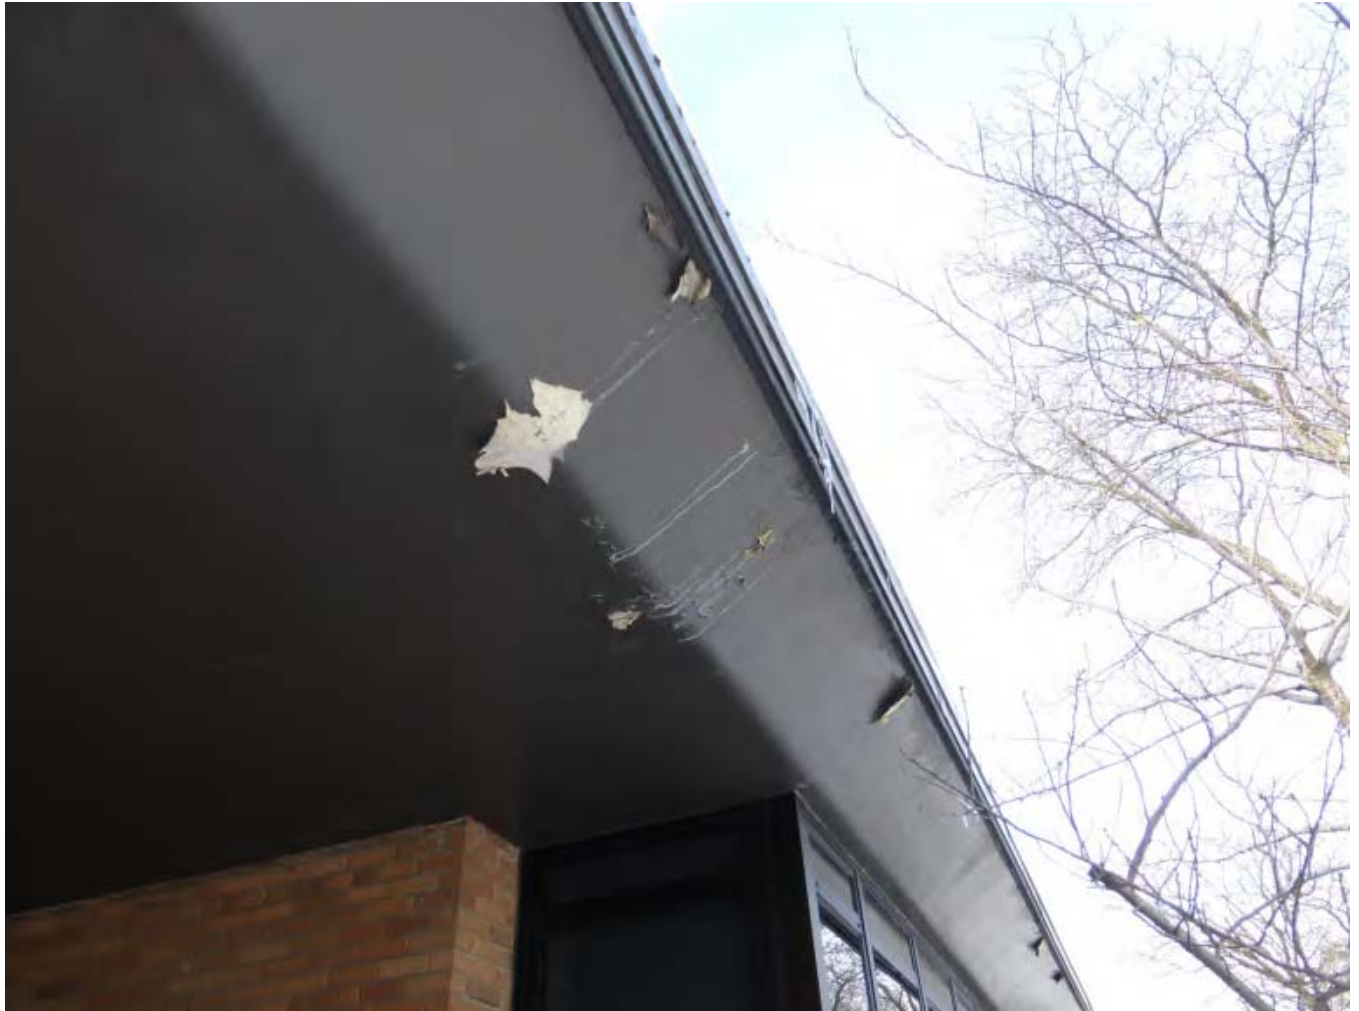
No.	Item/Description	Location	Photo No.	Cons.	Need	Freq.	Score	Energy	Notes	Action	Qty.	Unit	Architectural		Mechanical		Electrical		2014 Project Cost
													Unit Cost	Subtotal	Unit Cost	Subtotal	Unit Cost	Subtotal	
<b>BUILDING EXTERIOR</b>																			
BE-1	Overhangs/Soffits	Entire Building	BE-1	3	3	2	8		Paint is peeling and steel is rusted.	Provide aluminum soffit panels.	1,450	SF	\$ 6.00	\$ 8,700					\$ 13,120
BE-2	Stone Veneer	South Building Entrance	BE-2	3	3	2	8		Deteriorated and cracked.	Replace stone.	50	SF	\$ 75.00	\$ 3,750					\$ 5,655
BE-3	Sealant at Door and Window Openings	Entire Building	BE-3	3	3	2	8		Sealant deteriorated and cracked.	Replace sealant.	3,500	LF	\$ 4.75	\$ 16,625					\$ 25,071
BE-4	Roof Fascia	West Elevation at Boiler Room	BE-4	2	2	2	6		Poor condition, deteriorated, water draining from roof causing leak in Boiler Room.	Repair/replace fascia, correct roof drainage, repair wall in Boiler Room, clean brick.	1	LS	\$ 2,000.00	\$ 2,000					\$ 3,016

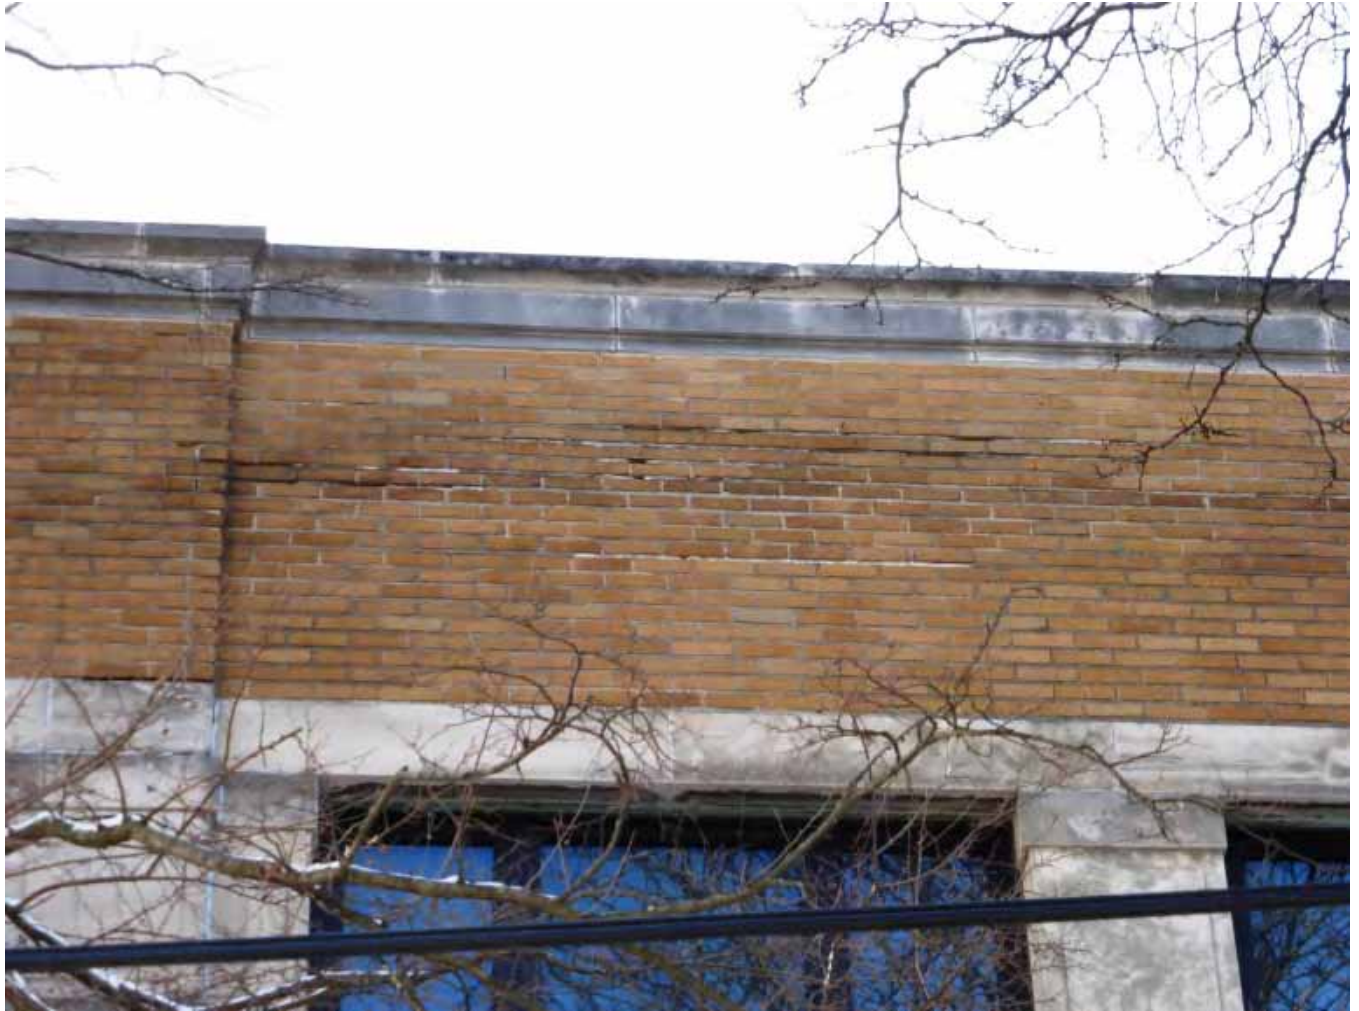
BE-5	Brick Veneer at Parapet	East Elevation	BE-5	3	3	2	8		Brick mortar joints missing and cracked.	Tuck point mortar joints.	350	SF	\$ 25.00	\$ 8,750					\$ 13,195
BE-6	Entrance Canopy Soffits	Building Entrances	BE-6	3	3	2	8		Deteriorated and paint is peeling.	Provide aluminum soffit panels.	950	SF	\$ 7.50	\$ 7,125					\$ 10,745
BE-7	Brick Veneer	Various Locations	BE-7	3	3	2	8		Brick and mortar joints deteriorated from roof water drainage onto wall.	Control roof drainage where possible and clean/tuck point brick.	100	SF	\$ 10.50	\$ 1,050					\$ 1,583
BE-8	Steel Stair/Ramp Railings	Media Center Stair and Ramp, West Gym Exit Stair	BE-8A BE-8B	3	3	2	8		Paint is peeling and steel is rusted.	Paint railings.	100	LF	\$ 8.00	\$ 800					\$ 1,206
BE-9	Metal Stair Treads	East Building Entrance	BE-9	1	2	2	5		Treads are rusted and concrete is deteriorated.	Replace with aluminum treads and repair concrete.	36	LF	\$ 60.00	\$ 2,160					\$ 3,257

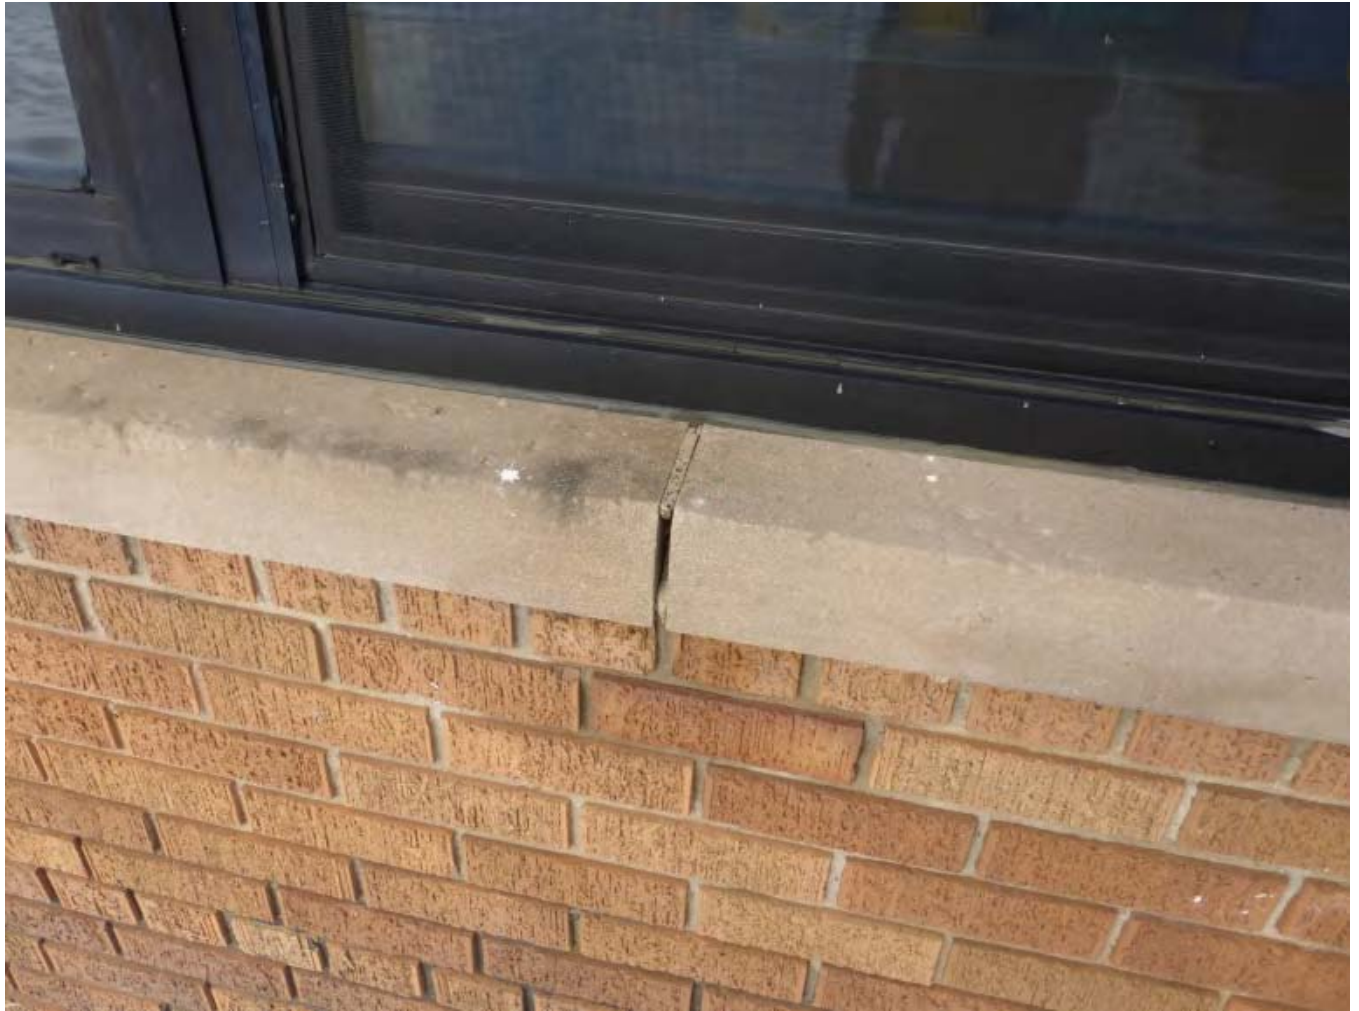
BE-10	Stone Window Sills	Various Locations	BE-10	4	3	2	9		Deteriorated, sealant missing.	Replace sills and sealant.	75	LF	\$ 30.00	\$ 2,250					\$ 3,393
BE-11	Site Drainage	West and North Elevations	BE-11	2	3	1	6		Roof drainage ponds along face of building.	Add landscape drain file to storm system.	2,640	SF	\$ 15.00	\$ 39,600					\$ 59,717
<b>Subtotal - Building Exterior</b>																			<b>\$ 139,957</b>
<b>BUILDING INTERIOR</b>																			
BI-1	Original Wood Doors and Frames	Entire Building	BI-1	4	3	1	8		Deteriorated, nonfunctional and do not meet current code requirements.	Replace with wood doors and hollow metal frames.	70	EA	\$ 2,350.00	\$ 164,500					\$ 248,066
BI-2	Plastic Laminate Counter Tops	Classrooms	BI-2	4	3	2	9		Delaminating.	Replace with solid surface material.	300	LF	\$ 150.00	\$ 45,000	\$ 69.00	\$ 20,700			\$ 99,076
BI-3	Carpet	Corridors	BI-3	3	3	1	7		Carpet reaching life expectancy.	Replace carpet and resilient base.	6,340	SF	\$ 1.00	\$ 6,340					\$ 9,561

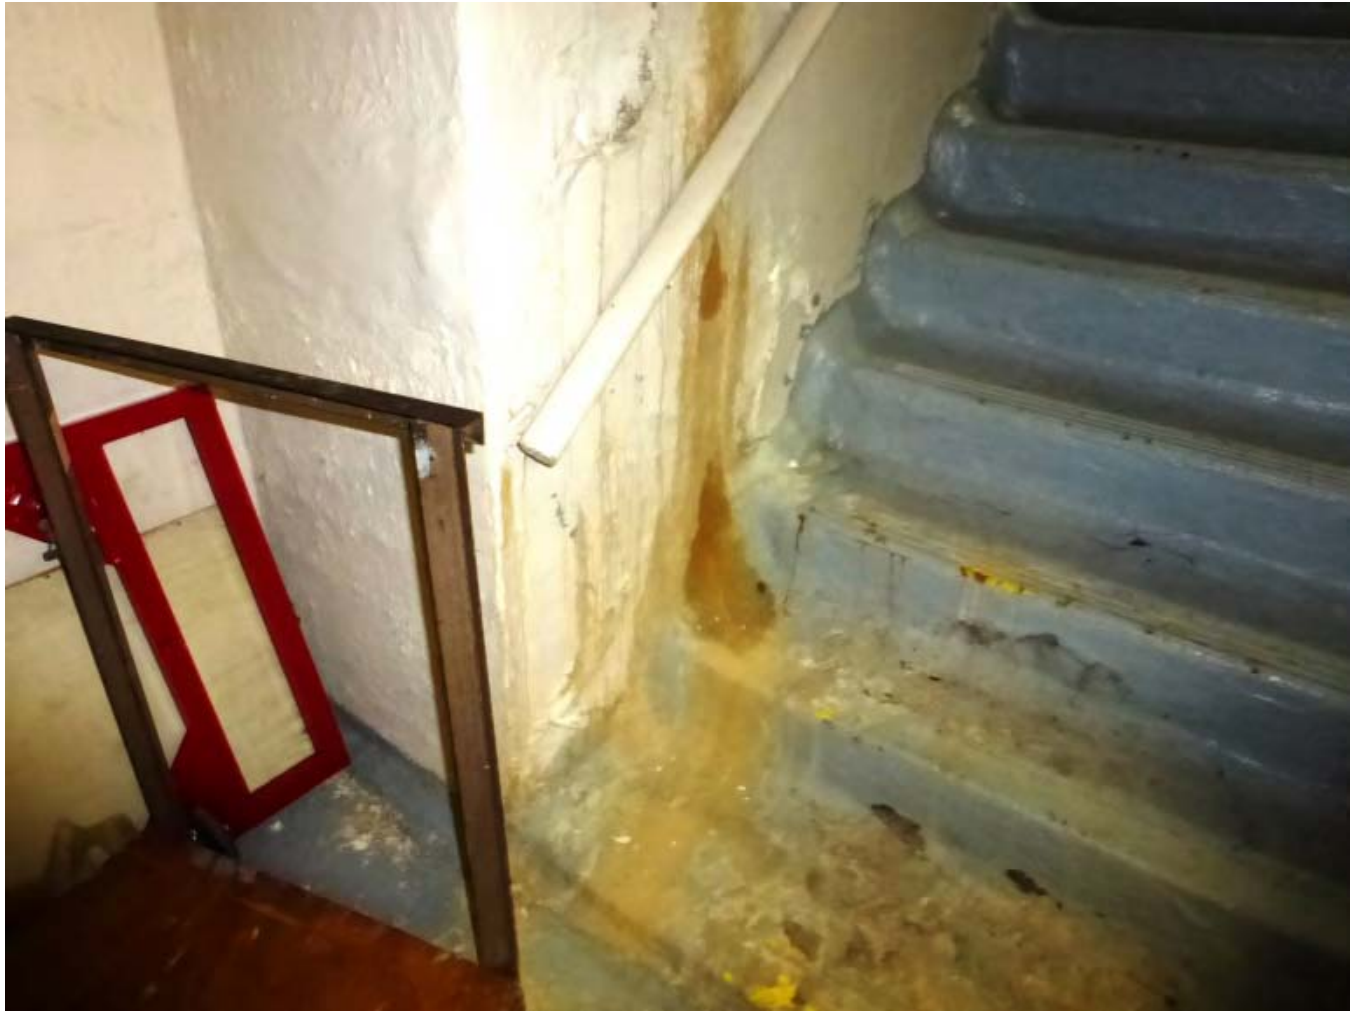
BI-4	Water Leak	Basement Stair	BI-4A BI-4B	3	3	3	9		Water leaking through wall deteriorating wall and steps.	Repair water leak.	1	LS	\$ 1,500.00	\$ 1,500					\$ 2,262
BI-5	Room Security	Head End Room	--	1	1	1	3		Key type is not unique to authorized staff (typical for all buildings).	Recore door lock.	1	EA	\$ 75.00	\$ 75					\$ 113
<b>Subtotal - Building Interior</b>																			<b>\$ 359,077</b>
<b>ACCESSIBILITY IMPROVEMENTS/BUILDING CODE</b>																			
AB-1	Built-in Storage Cabinet	Corridor	AB-1	1	4	1	6		Cabinet do not have required fire rated doors.	Provide fire rated door and frame.	1	EA	\$ 2,350.00	\$ 2,350					\$ 3,544
AB-2	Classroom Exits	B113 and B115, A124 and A123, A119	AB-2	1	4	1	6		Combined rooms with folding partition open requires 2 exits. Doors are not remote enough from each other.	Provide additional exit door to corridor.	5	EA	\$ 7,500.00	\$ 37,500			\$ 300.00	\$ 1,500	\$ 58,812

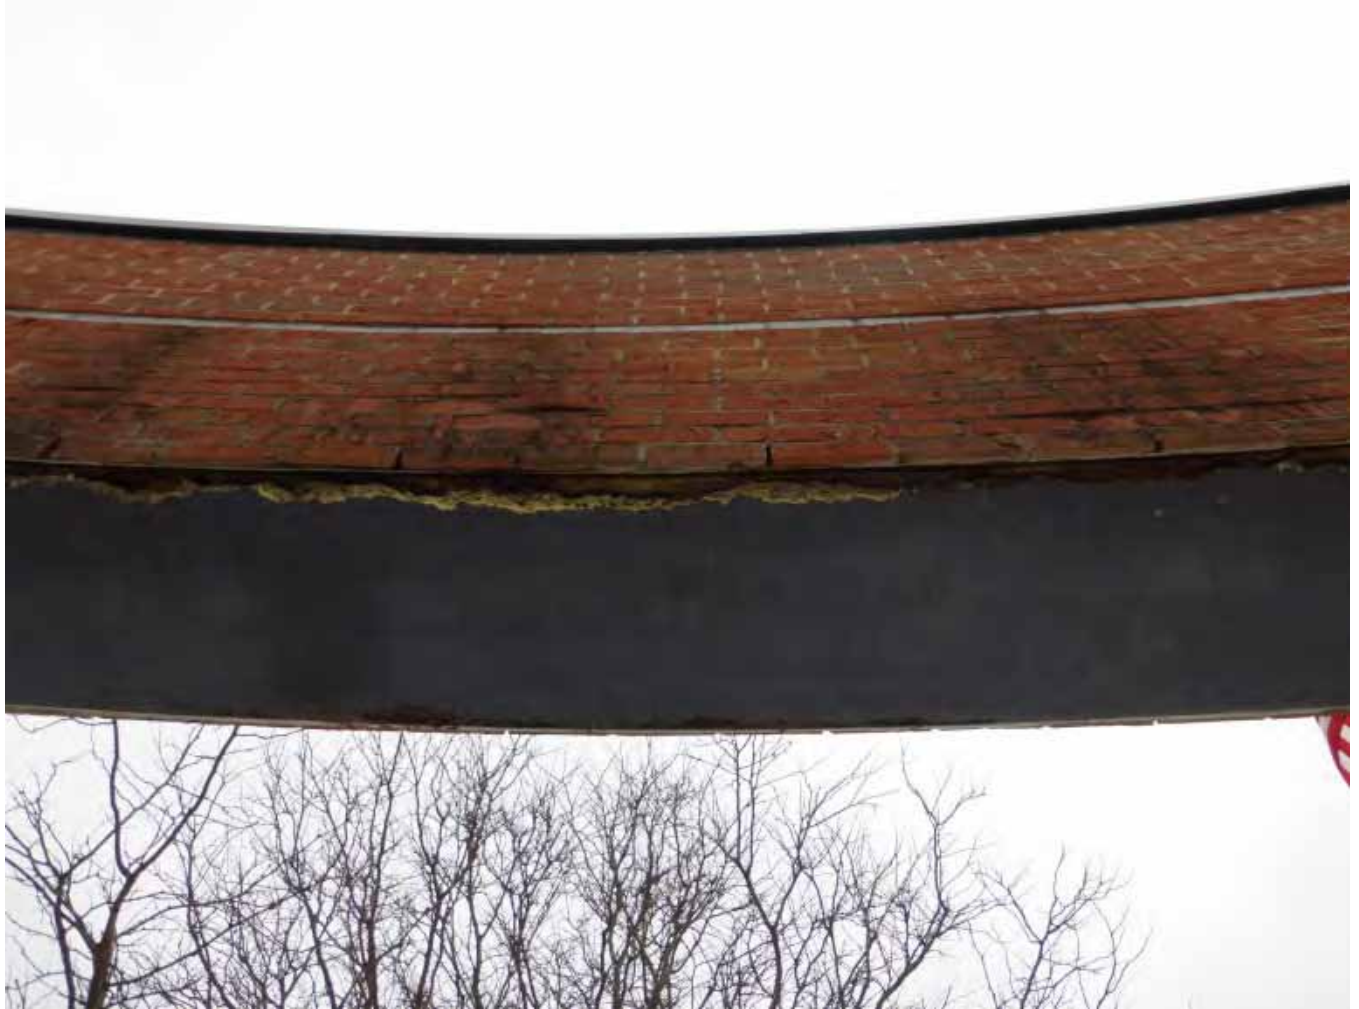
No.	Item/Description	Location	Photo No.	Cons.	Need	Freq.	Score	Energy	Notes	Action	Qty.	Unit	Architectural		Mechanical		Electrical		2014 Project Cost
													Unit Cost	Subtotal	Unit Cost	Subtotal	Unit Cost	Subtotal	
<b>BUILDING EXTERIOR</b>																			
BE-1	Overhangs/Soffits	Entire Building	BE-1	3	3	2	8		Paint is peeling and steel is rusted.	Provide aluminum soffit panels.	4,070	SF	\$ 6.00	\$ 24,420					\$ 36,825
BE-2	Brick Veneer at Base of Walls	Where roofs drain to pavement adjacent to walls	BE-2	3	3	2	8		Brick and mortar joints deteriorated from roof water drainage.	Control roof drainage where possible and tuck point brick.	250	SF	\$ 10.50	\$ 2,625					\$ 3,959
BE-3	Sealant a Door and Window Openings	Entire Building	--	3	3	2	8		Sealant deteriorated and cracked.	Replace sealant.	2,700	LF	\$ 4.75	\$ 12,825					\$ 19,340
BE-4	Steel Lintels at Wall Openings	Media Center	BE-4	3	3	2	8		Steel is rusted.	Paint lintels.	120	SF	\$ 10.50	\$ 1,260					\$ 1,900

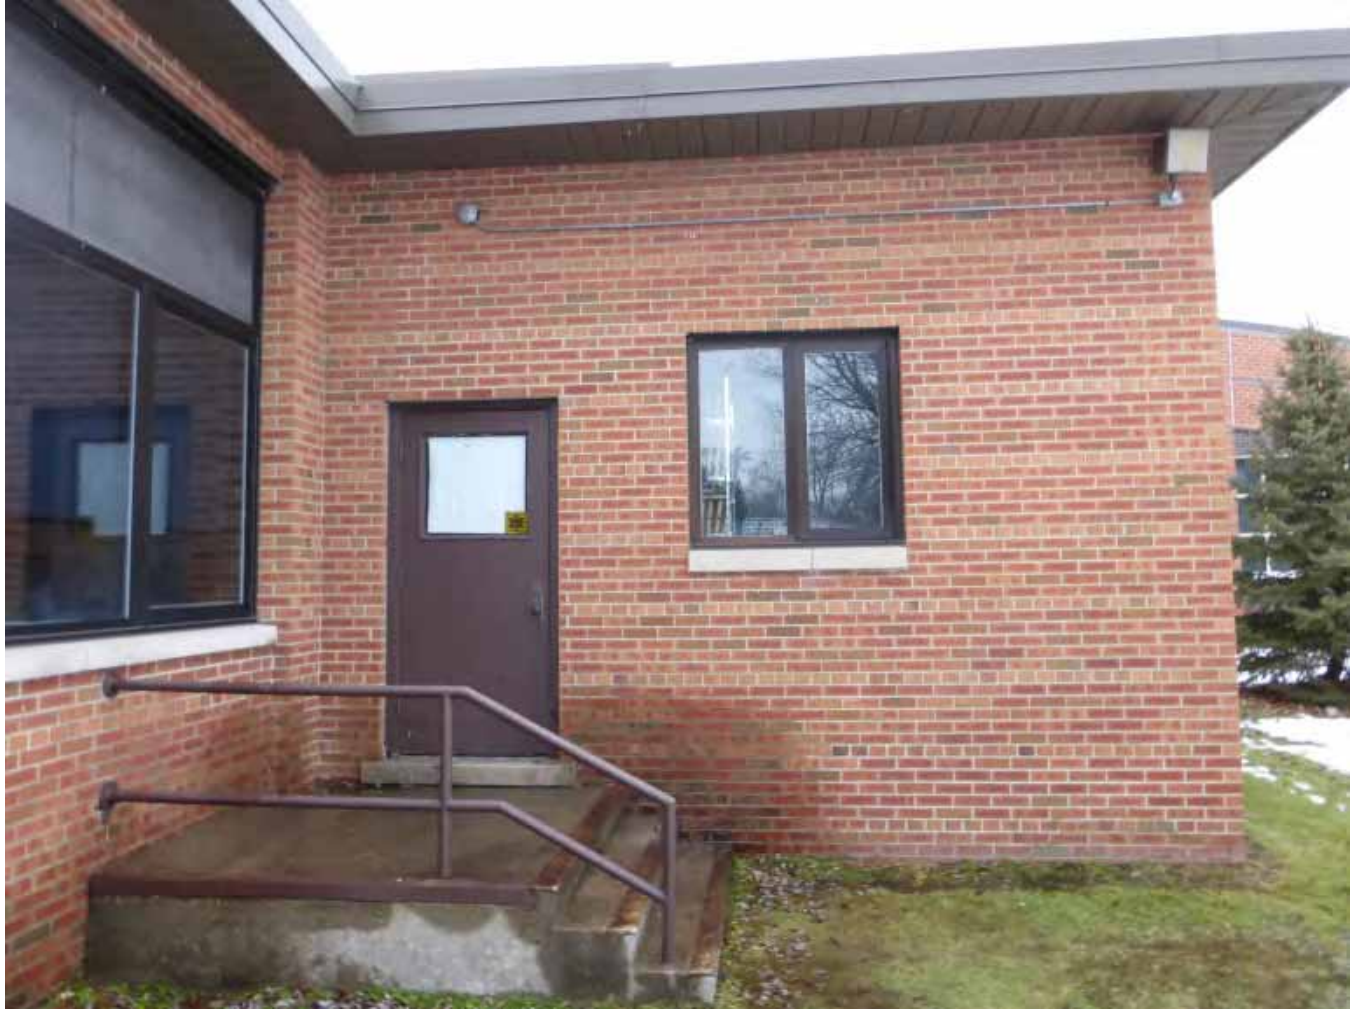
BE-5	Steel Stair/Ramp Railings	Kitchen Exit	BE-5	3	3	2	8		Paint is peeling and steel is rusted.	Paint railings.	10	LF	\$ 10.00	\$ 100					\$ 151
BE-6	Metal Stair Treads	Kitchen Exit	BE-6	1	1	2	4		Treads are missing and rusted.	Replace with aluminum treads.	15	LF	\$ 60.00	\$ 900					\$ 1,357
BE-7	Steel Doors and Frames	Entire Building	BE-7	3	3	1	7		Deteriorated and rusted.	Replace with aluminum frames and fiberglass reinforced panel doors.	16	EA	\$ 2,800.00	\$ 44,800					\$ 67,558
BE-8	Entrance Canopy Soffits	Building Entrances	BE-8	3	3	2	8		Wood is deteriorated and paint is peeling.	Provide aluminum soffit panels.	585	SF	\$ 7.50	\$ 4,388					\$ 6,616
BE-9	Clerestory Windows	Classrooms - South Wing	BE-9	4	4	2	10		Single glazed glass.	Replace with aluminum frames and insulating glass.	250	SF	\$ 80.00	\$ 20,000					\$ 30,160
BE-10	Site Drainage	Building Perimeter	BE-10	2	3	1	6		Roof drainage ponds along building face.	Add landscape drain tile system.	7,500	LF	\$ 15.00	\$ 112,500					\$ 169,650
