# NORUP INTERNATIONAL SCHOOL

**BERKLEY SCHOOLS**  
**Comprehensive Academic Spaces, Facilities and Technologies Needs Assessment**

Address: 14450 Manhattan, Oak Park, Michigan Bldg. Area: 89,603 GSF No. of Floors: 2 Year Built: 1956 Evaluation Date: January 2014	<b>Item No. Codes</b> AB: Accessibility Improvement/Building Code AD: Academic/Space Deficiencies BE: Building Exterior BI: Building Interior BS: Building System ES: Electrical System MS: Mechanical System PS: Plumbing System SC: Site Circulation SE: Specialty Equipment/Other IT: Technology		<b>Building Deficiencies Priorities by Category</b> <div style="display: flex; justify-content: space-around;"> <div style="background-color: yellow; padding: 5px;"> <b>Consequences of the Problem</b>            1. Hazards            2. Interruption            3. Deterioration            4. Utility            5. Energy         </div> <div style="background-color: lightgreen; padding: 5px;"> <b>Need</b>            1. Critical            2. Urgent            3. Necessary            4. ADA            5. Desirable         </div> <div style="background-color: orange; padding: 5px;"> <b>Frequency of Use</b>            1. Constant

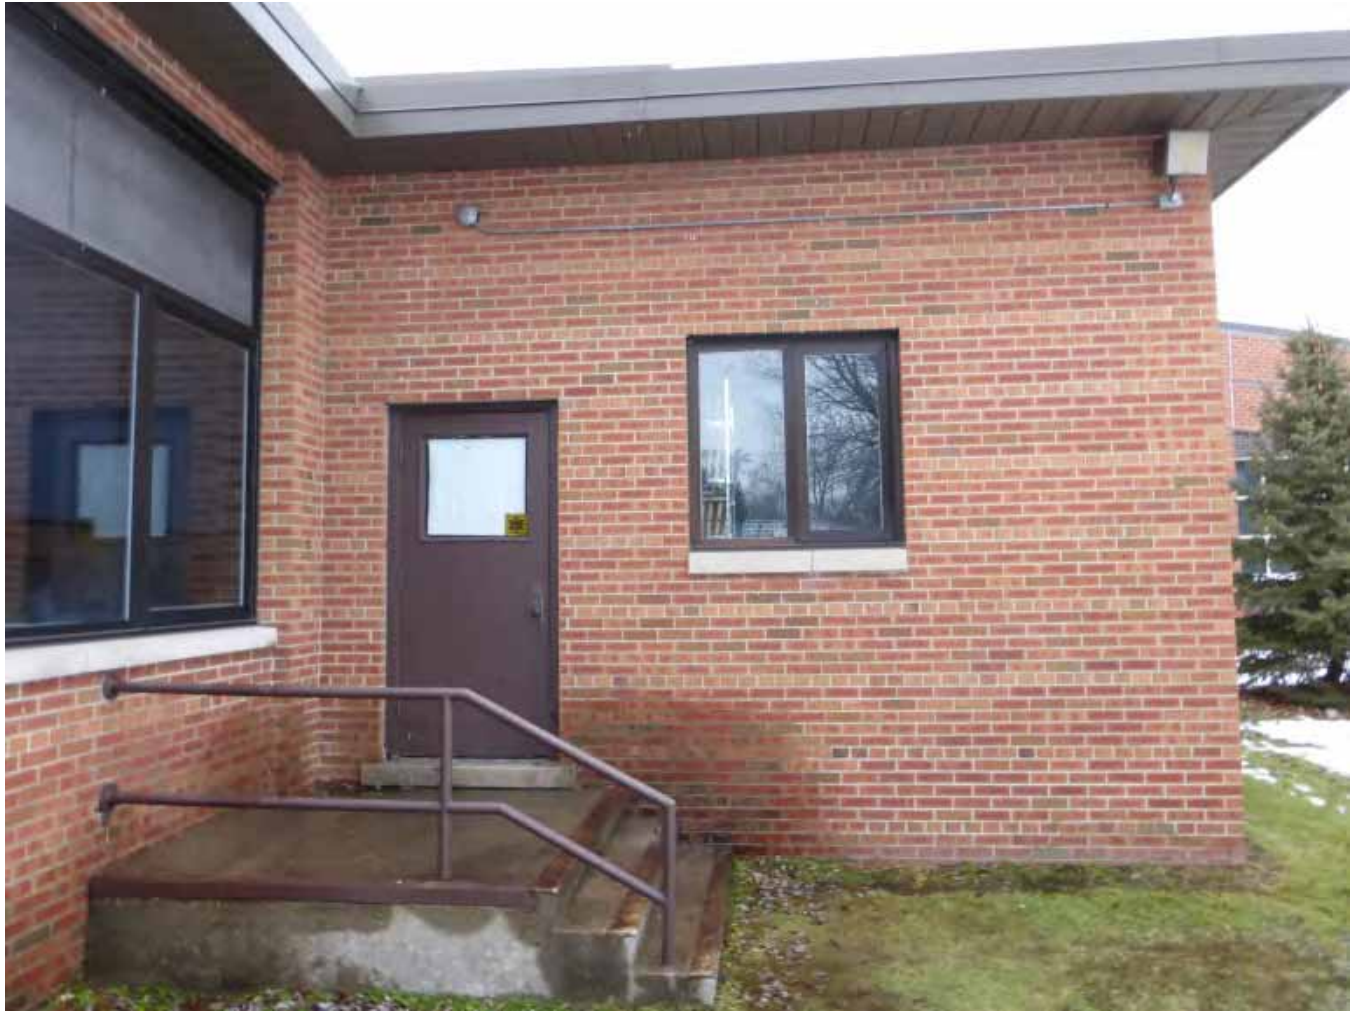
BE-5	Steel Stair/Ramp Railings	Kitchen Exit	BE-5	3	3	2	8		Paint is peeling and steel is rusted.	Paint railings.	10	LF	\$ 10.00	\$ 100					\$ 151
BE-6	Metal Stair Treads	Kitchen Exit	BE-6	1	1	2	4		Treads are missing and rusted.	Replace with aluminum treads.	15	LF	\$ 60.00	\$ 900					\$ 1,357
BE-7	Steel Doors and Frames	Entire Building	BE-7	3	3	1	7		Deteriorated and rusted.	Replace with aluminum frames and fiberglass reinforced panel doors.	16	EA	\$ 2,800.00	\$ 44,800					\$ 67,558
BE-8	Entrance Canopy Soffits	Building Entrances	BE-8	3	3	2	8		Wood is deteriorated and paint is peeling.	Provide aluminum soffit panels.	585	SF	\$ 7.50	\$ 4,388					\$ 6,616
BE-9	Clerestory Windows	Classrooms - South Wing	BE-9	4	4	2	10		Single glazed glass.	Replace with aluminum frames and insulating glass.	250	SF	\$ 80.00	\$ 20,000					\$ 30,160
BE-10	Site Drainage	Building Perimeter	BE-10	2	3	1	6		Roof drainage ponds along building face.	Add landscape drain tile system.	7,500	LF	\$ 15.00	\$ 112,500					\$ 169,650

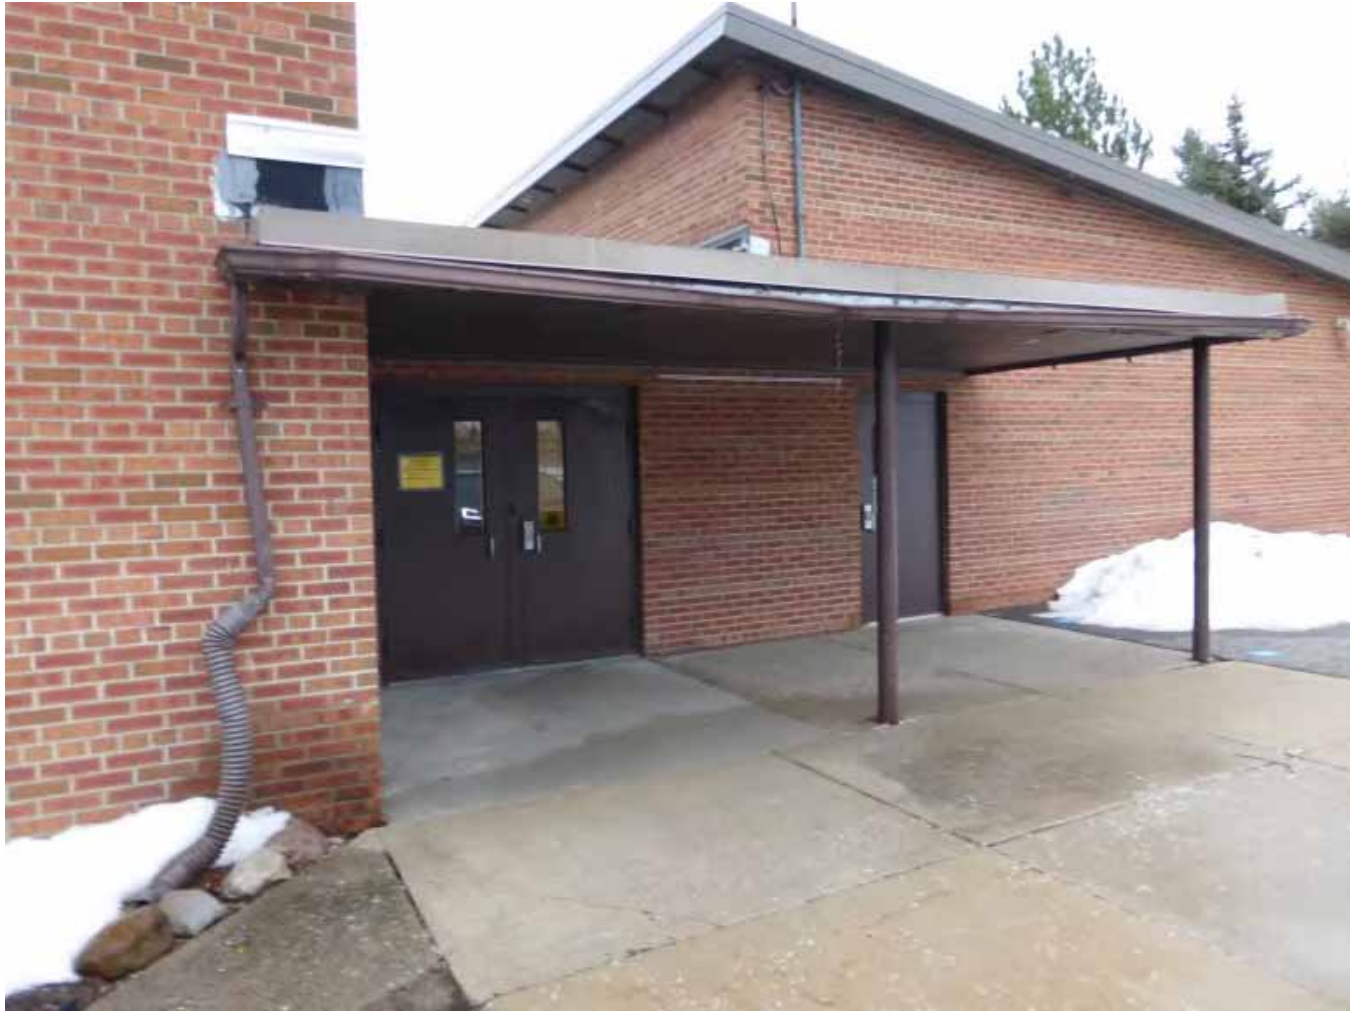
BE-11	Canopy Gutter	West Entrance	BE-11	3	3	2	8		Gutter is damaged.	Replace gutter and downspout.	1	LS	\$ 600.00	\$ 600					\$ 905
BE-12	Aluminum Windows	Entire Building Excluding Media Center	--	4	5	2	11		Windows have operational issues and hardware is difficult to obtain.	Remove and replace aluminum windows.	5,040	SF	\$ 80.00	\$ 403,200					\$ 608,026
<b>Subtotal - Building Exterior</b>																			<b>\$ 946,447</b>
<b>BUILDING INTERIOR</b>																			
BI-1	Original Wood Doors and Frames	Entire Building	BI-1	4	3	1	8		Deteriorated, nonfunctional and do not meet current code requirements.	Replace with wood doors and hollow metal frames.	60	EA	\$ 2,350.00	\$ 141,000					\$ 212,628
BI-2	Plastic Laminate Counter Tops	Classrooms	--	4	3	2	9		Delaminating.	Replace with solid surface material and new sinks with point of use TMV.	290	LF	\$ 150.00	\$ 43,500	\$ 74.00	\$ 21,460			\$ 97,960
BI-3	Carpet	Corridors	BI-3	3	3	1	7		Carpet reaching life expectancy.	Replace carpet and resilient base.	7,130	SF	\$ 7.00	\$ 49,910					\$ 75,264

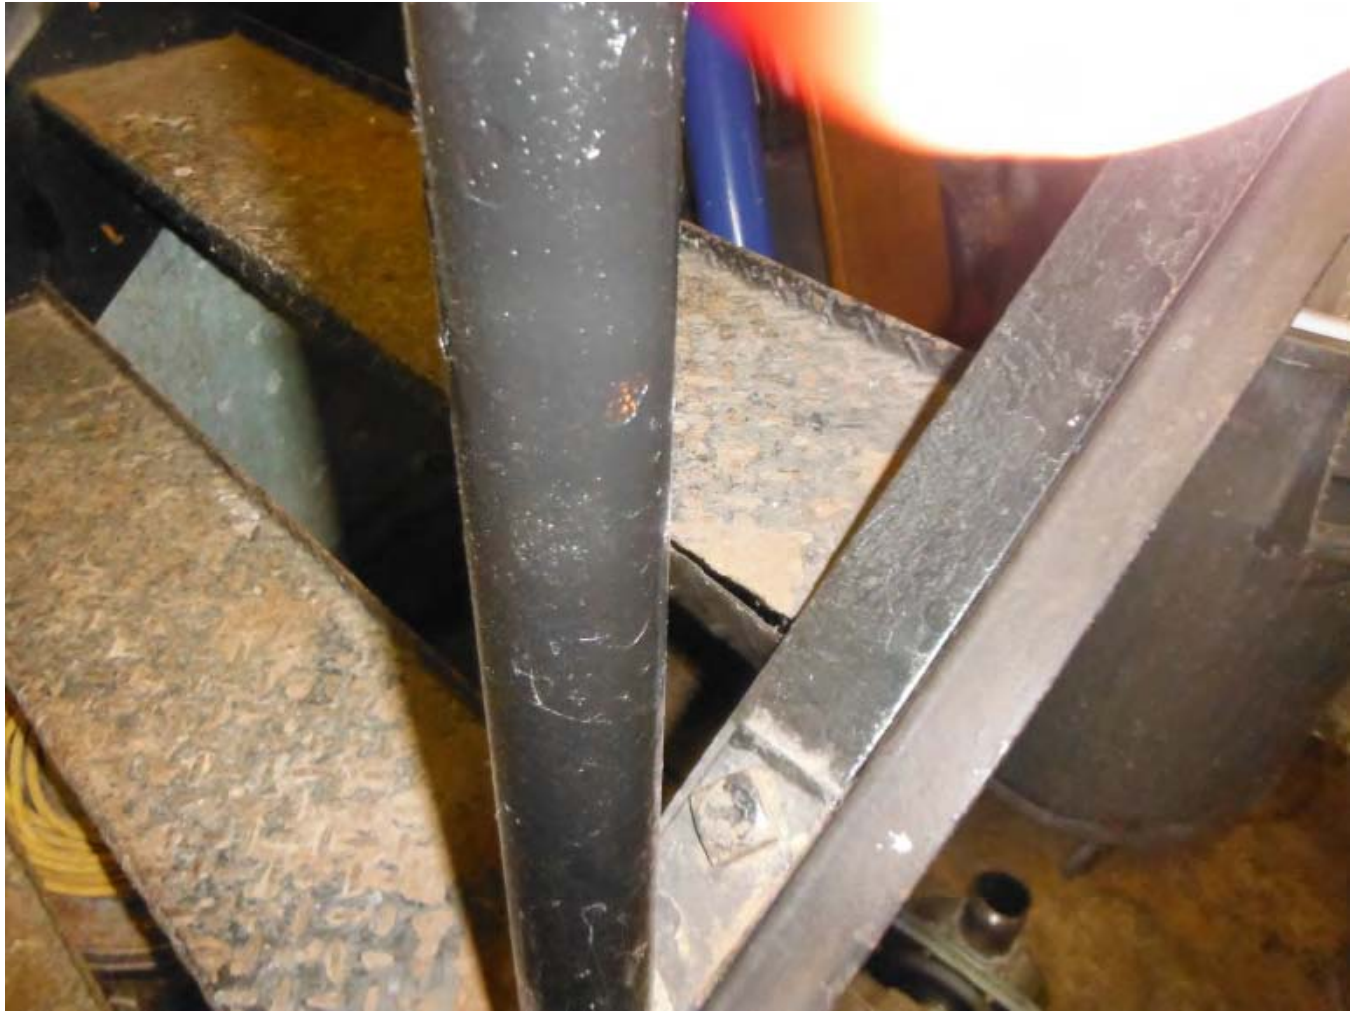
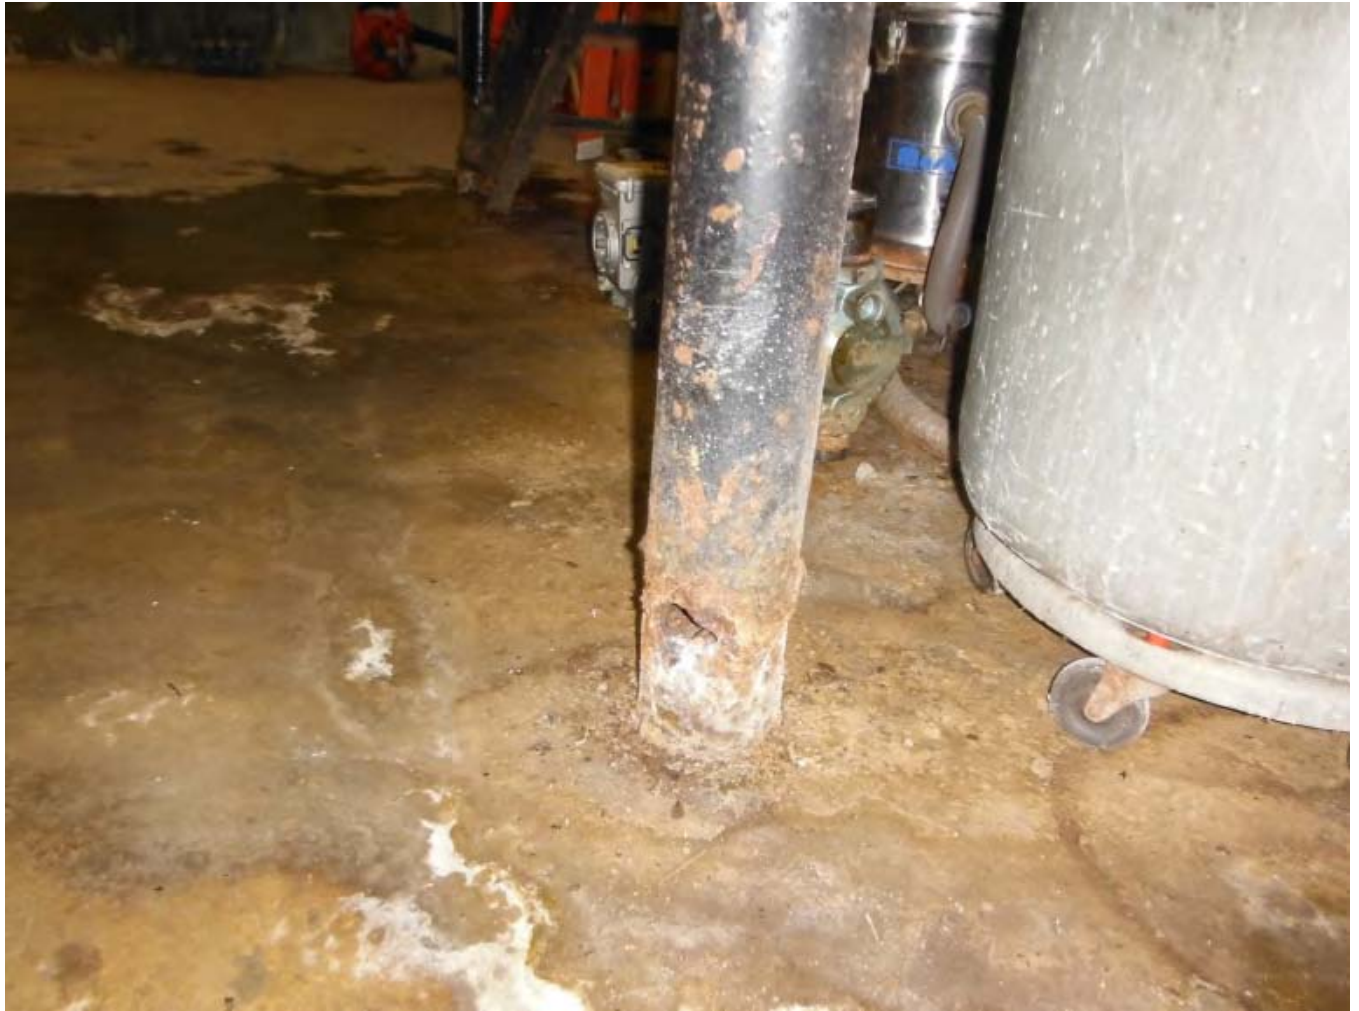
BI-4	Steel Stair	Boiler Room	BI-4	1	3	1	5		Stair treads and post are rusted.	Replace treads and post.	1	LS	\$ 750.00	\$ 750					\$ 1,131
BI-5	Room Security	Head End Room	--	1	1	1	3		Key type is not unique to authorized staff (typical for all buildings).	Recore door lock.	1	EA	\$ 75.00	\$ 75					\$ 113
<b>Subtotal - Building Interior</b>																			<b>\$ 387,096</b>
<b>ACCESSIBILITY IMPROVEMENTS/BUILDING CODE</b>																			
AB-1	Furniture and Equipment	Corridors	AB-1	1	4	1	6		Loose furniture and equipment not permitted in corridors.	Remove furniture and equipment.	--	--							
AB-2	Boy's and Girl's Toilet Rooms	Various locations	AB-2	1	4	2	7		Toilet rooms do not meet current accessibility requirements.	Provide new plumbing fixtures, lighting, floor/wall/ceiling finishes, stalls and automatic door operators.	700	SF	\$ 40.00	\$ 28,000	\$ 27.00	\$ 18,900	\$ 4.20	\$ 2,940	\$ 75,159
AB-3	Chair and Table Storage Under Stage	Gymnasium	AB-3	1	4	2	7		Code violation considering current construction of stage.	Limit storage to non-combustible items.	--	--

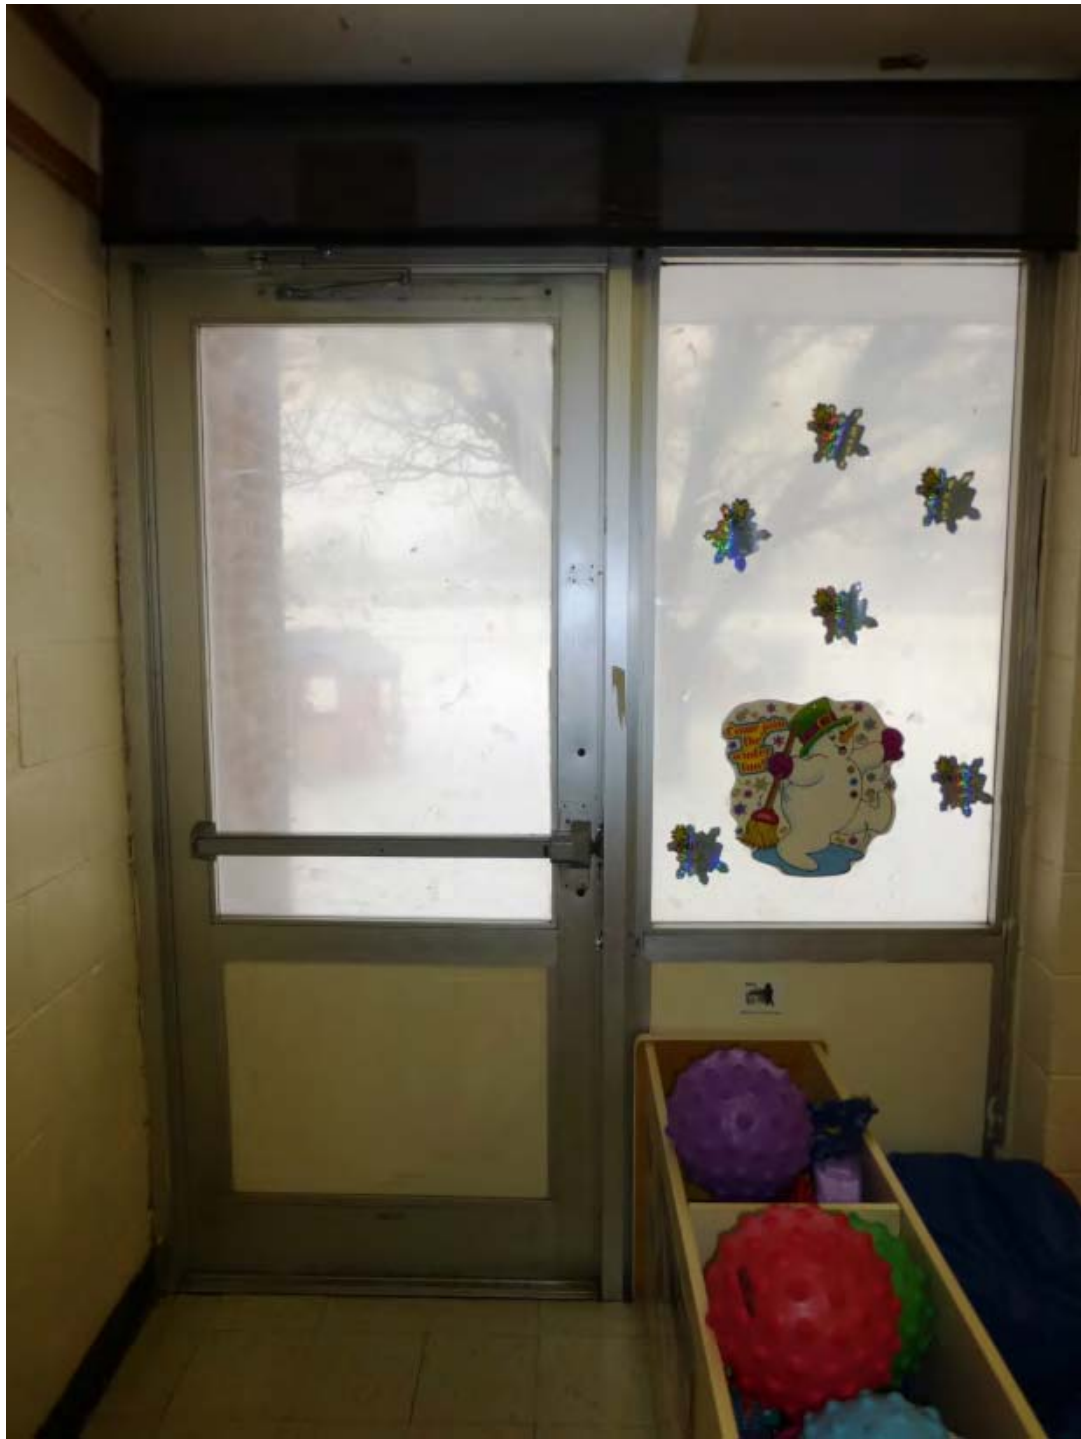
BE-1	Aluminum Storefront and Doors	Classrooms	BE-1	3	3	2	8		System offers minimal thermal resistance (single glazing) and doors are in poor condition.	Replace with a better quality, higher thermal resistance storefront system with doors.	1,350	SF	\$ 75.00	\$ 101,250					\$ 152,685
BE-2	Foundation Wall	Building Perimeter	BE-2	2	2	2	6		Void in perimeter foundation wall allows rodents to burrow under floor slab.	Add concrete sill wall or slab at building perimeter.	600	SF	\$ 22.00	\$ 13,200					\$ 19,906
BE-3	Fascias	Entire Building	BE-3	3	3	2	8		Stone faced cement fascia panels are cracked and delaminated.	Replace fascia panels with a more durable material.	900	SF	\$ 25.00	\$ 22,500					\$ 33,930
BE-4	Soffits	Entire Building	BE-4	3	3	2	8		Cement plaster soffits are cracked and delaminated.	Replace soffits with a more durable material.	1,100	SF	\$ 525.00	\$ 577,500					\$ 870,870
BE-4	Steel Doors and Frames	Entire Building	BE-4	3	3	1	7		Deteriorated and rusted.	Replace with aluminum frames and FRP doors.	12	EA	\$ 2,800.00	\$ 33,600					\$ 50,669

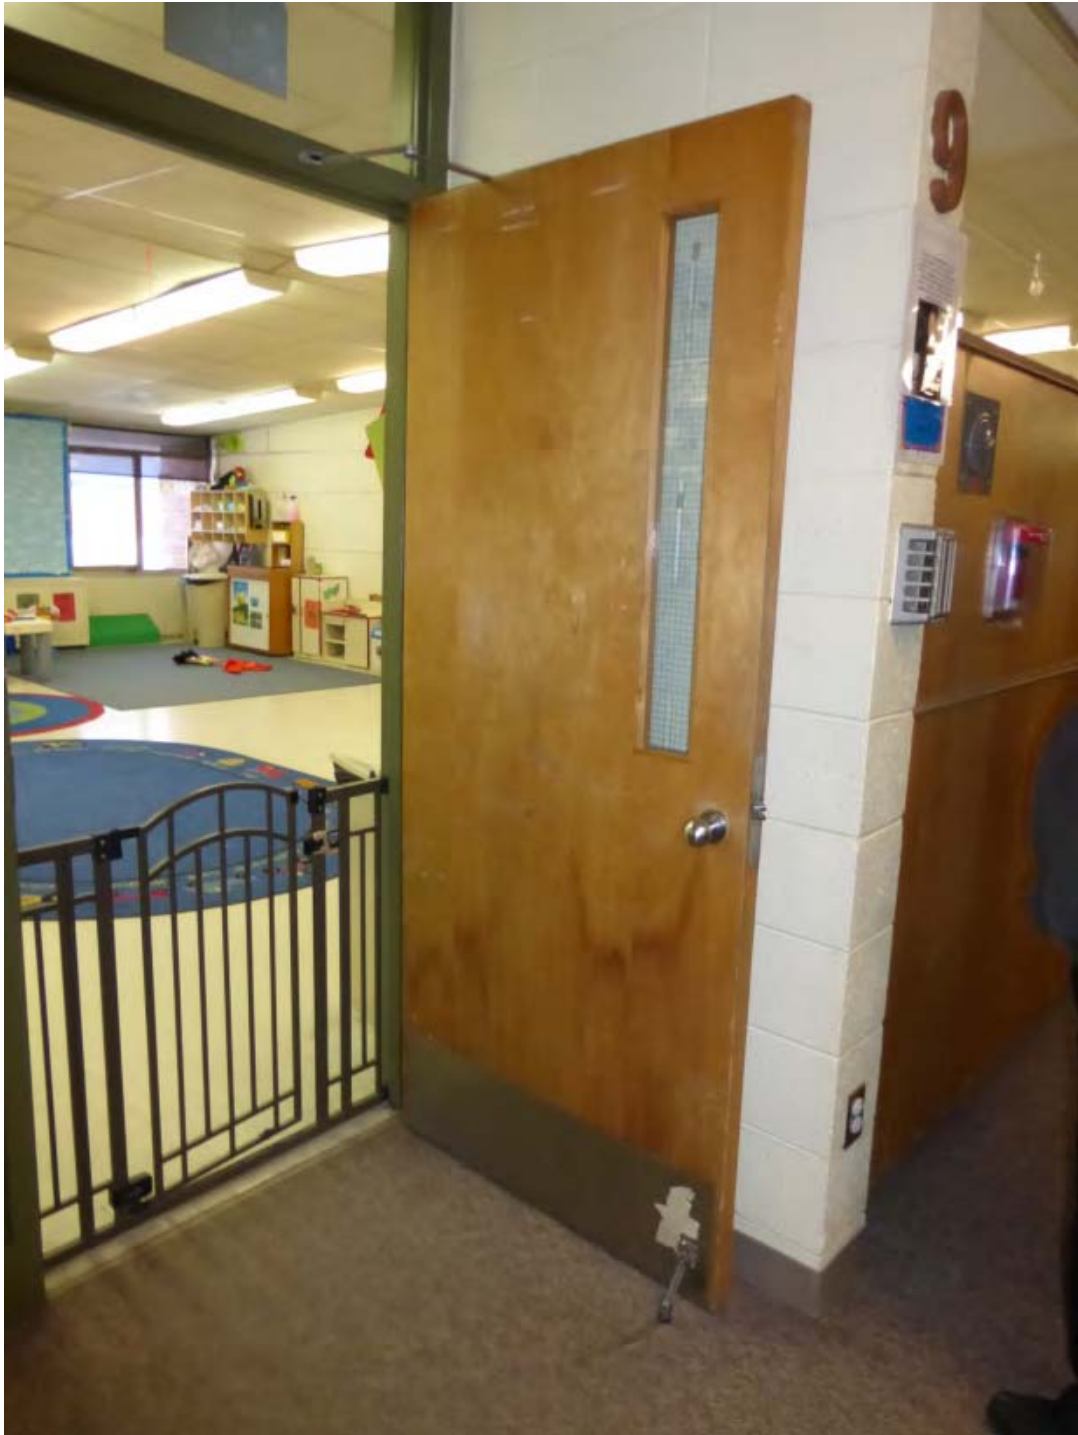
<b>Subtotal - Building Exterior</b>																			<b>\$ 1,128,059</b>
<b>BUILDING INTERIOR</b>																			
BI-1	Original Hollow Metal, Wood Doors and Frames	Entire Building	BI-1	4	3	1	8		Deteriorated, nonfunctional and do not meet current code requirements.	Replace with wood doors and hollow metal frames (Dutch style doors at classrooms).	42	EA	\$ 2,350.00	\$ 98,700					\$ 148,840
BI-3	Carpet	Corridors		3	3	1	7		Carpet reaching life expectancy.	Replace carpet and resilient base.	9,950	SF	\$ 7.00	\$ 69,650					\$ 105,032
BI-4	Casework Cabinets	Classrooms, Work Room, Staff Lounge and Kiva.	BI-3A BI-3B	4	5	2	11		Poor condition.	Replace cabinets.	270	LF	\$ 300.00	\$ 81,000					\$ 122,148
BI-4	Lay-in Acoustical Ceilings	Corridors and Kiva	BI-4	4	3	1	8		Poor condition.	Replace acoustical ceilings, grid and lighting.	6,550	SF	\$ 5.75	\$ 37,663	\$ 1.00	\$ 6,550	\$ 4.00	\$ 26,200	\$ 106,182
BI-5	Accordion Folding Doors	Classrooms	BI-5	4	5	1	10		Poor condition, do not function well.	Replace with dutch style doors in HM frames.	7	EA	\$ 2,350.00	\$ 16,450		\$ -			\$ 24,807

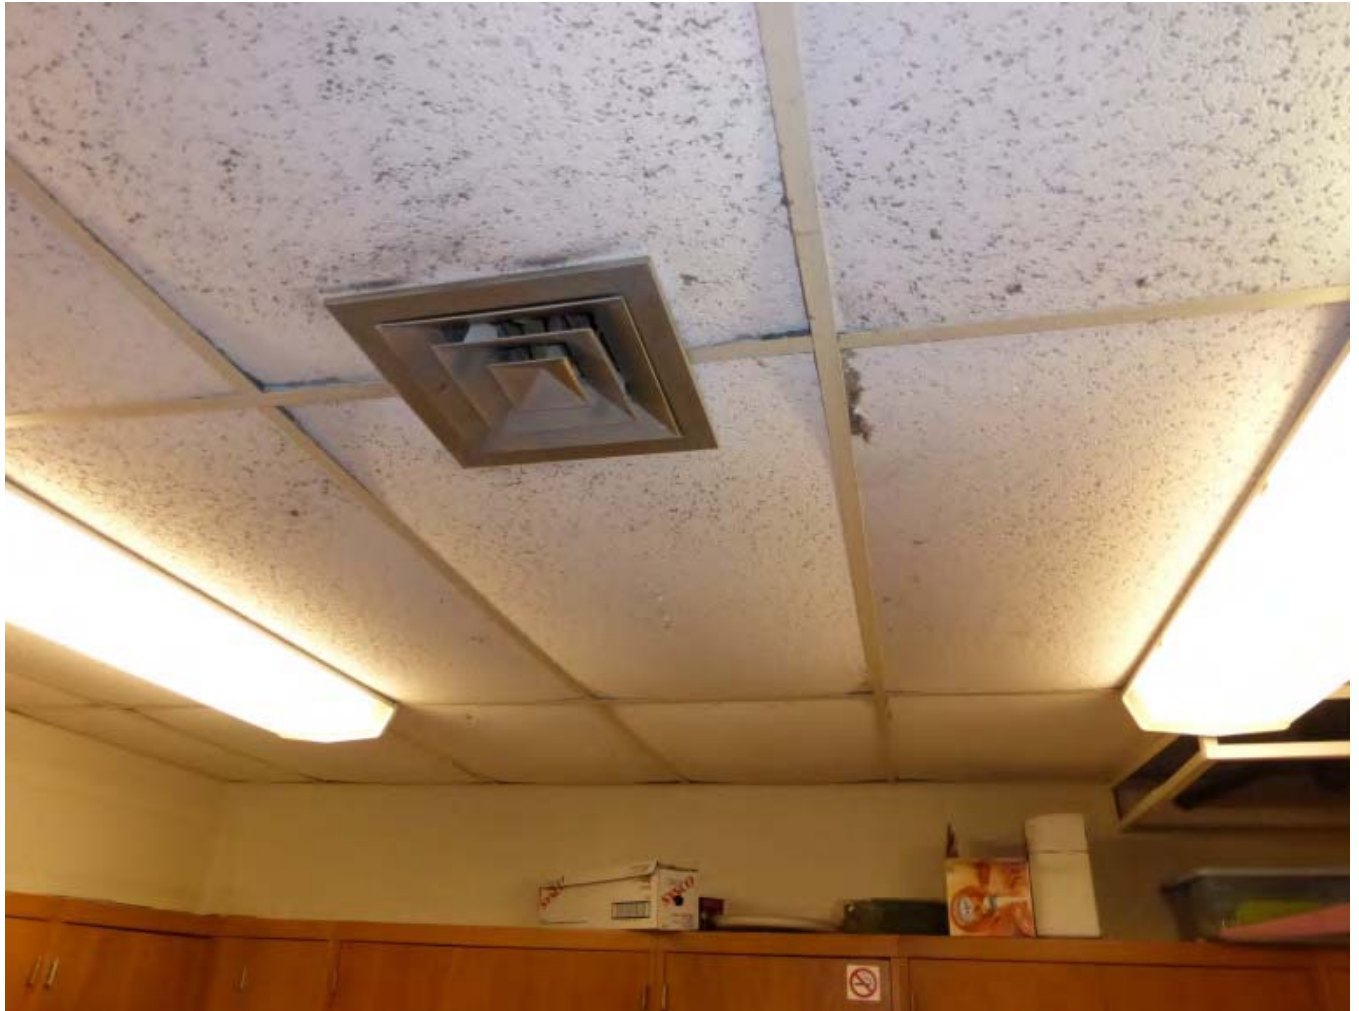
BI-6	Lay-in Acoustical Ceilings	Classrooms and Office Area	BI-6	4	3	1	8		Poor condition.	Replace acoustical ceilings, grid and lighting.	10,700	SF	\$ 5.75	\$ 61,525	\$ 1.00	\$ 10,700	\$ 9.00	\$ 96,300	\$ 254,136
BI-7	Coat Racks	Corridors	BI-7	4	5	1	10		Insufficient space to hang coats and store foot gear. Lack of lockers contributes to reported lice problems.	Add lockers.	192	LF	\$ 500.00	\$ 96,000					\$ 144,768
BI-8	Resilient Tile	Classrooms	BI-8						Fair to poor condition.	Replace resilient floor and base.	9,280	SF	\$ 4.75	\$ 44,080					\$ 66,473
BI-9	Room Security	Head End Room	--	1	1	1	3		Room door is not secure.	Recore door lock.	1	EA	\$ 75.00	\$ 75					\$ 113
<b>Subtotal - Building Interior</b>																			<b>\$ 972,498</b>
<b>ACCESSIBILITY IMPROVEMENT/BUILDING CODE</b>																			
AB-1	Toilet Rooms	Children Toilets	AB-1	1	4	2			Toilet fixtures are not sized to accommodate small children and do not meet current accessibility requirements.	Provide new plumbing fixtures, lighting, floor/wall/ceiling finishes, stalls and automatic door operators.	960	SF	\$ 40.00	\$ 38,400	\$ 35.00	\$ 33,600	\$ 4.20	\$ 4,032	\$ 114,656

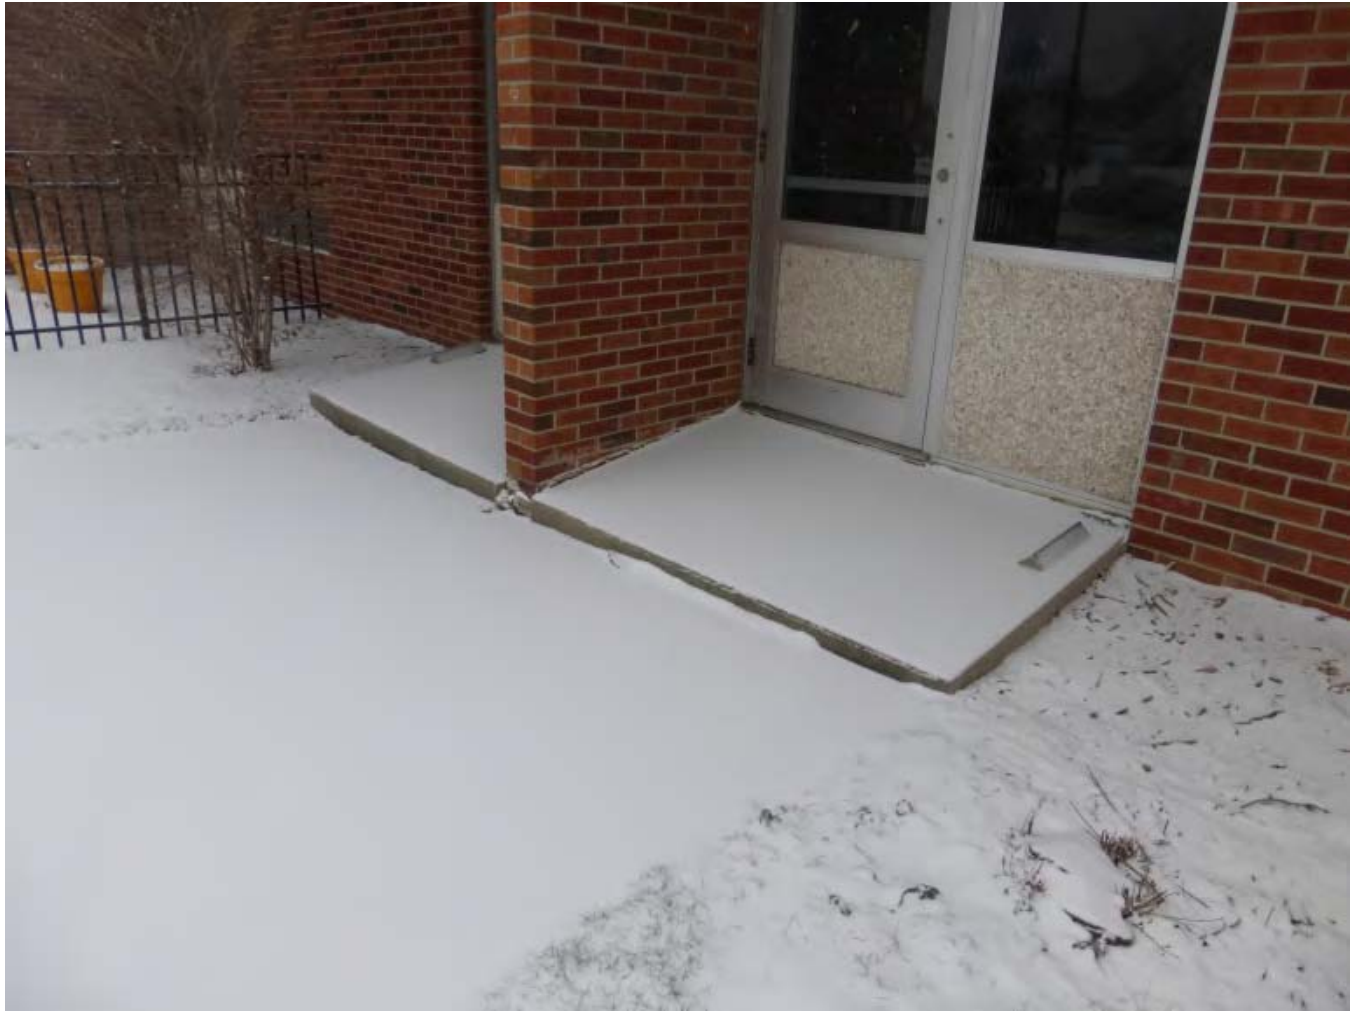
AB-2	Exit Door Concrete Slabs	Classrooms	AB-2	1	4	2			Slab slope exceeds 1/4"/FT. maximum as required by building and BF code.	Replace concrete slabs at exit doors.	120	SF	\$ 115.00	\$ 13,800					\$ 20,810
<b>Subtotal - Accessibility Improvements/Building Code</b>																			<b>\$ 135,467</b>
<b>MECHANICAL SYSTEMS</b>																			
MS-1	Building Controls	Entire Building	MS-1	2	2	1	5		Existing pneumatic controls are outdated.	Provide new DDC controls throughout.	25,000	SF			\$ 3.30	\$ 82,500			\$ 124,410
MS-2	Boiler	Boiler Room	--	1	1	1	3		Existing boiler is in poor condition; +48 years old.	Install two (2) new boilers, controls, combustion intake, stacks, etc.; approximately 1,000 MBH each.	1	LS			\$ 190,000.00	\$ 190,000			\$ 286,520

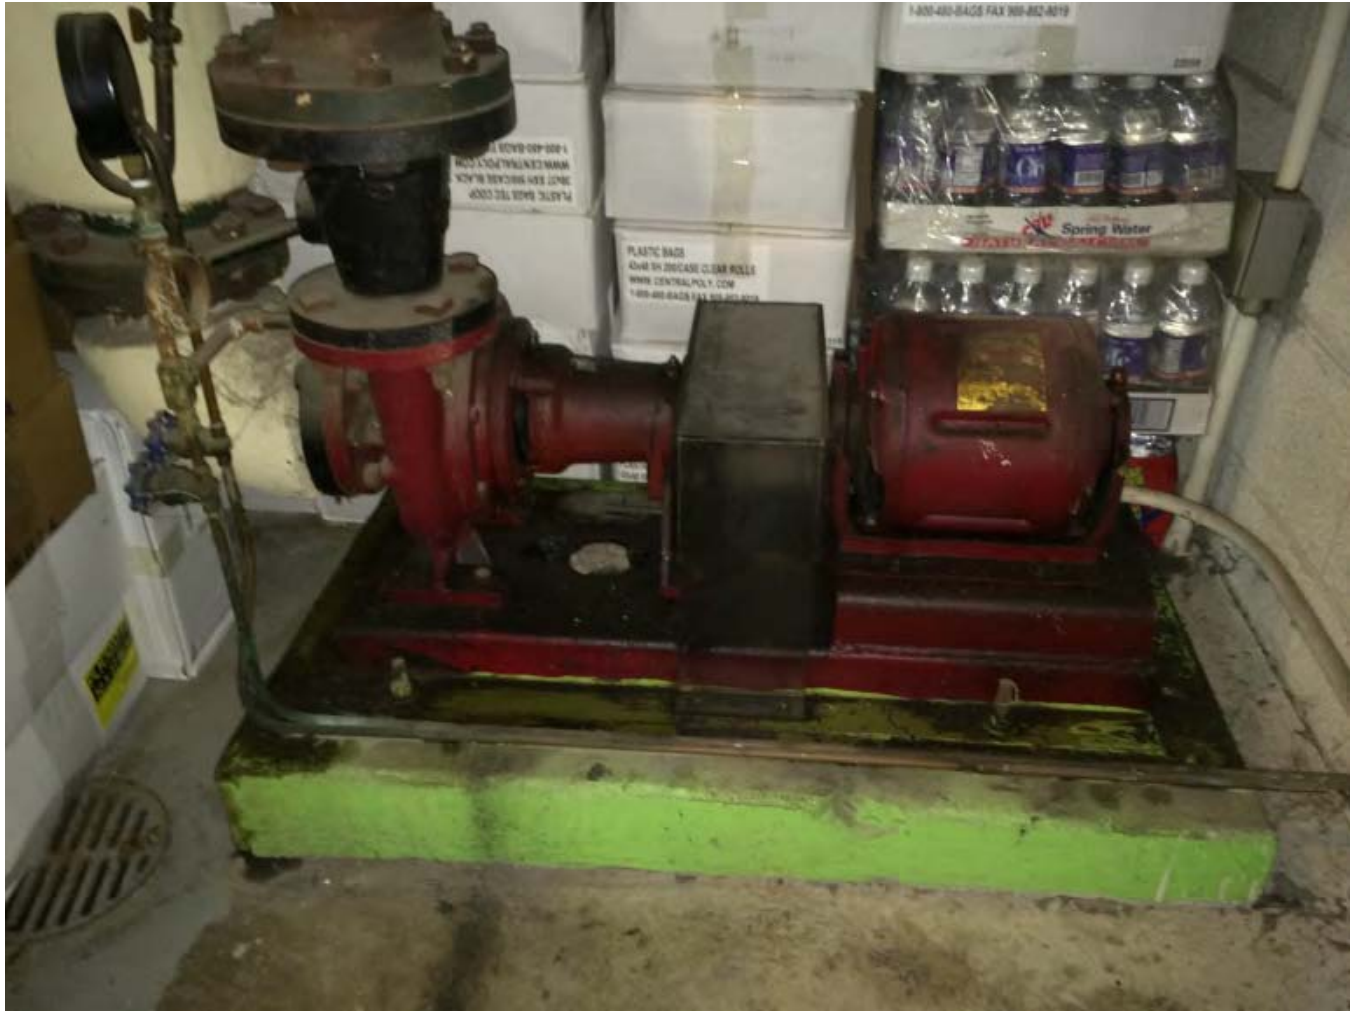
No.	Item/Description	Location	Photo No.	Cons.	Need	Freq.	Score	Energy	Notes	Action	Qty.	Unit	Architectural		Mechanical		Electrical		2014 Project Cost
													Unit Cost	Subtotal	Unit Cost	Subtotal	Unit Cost	Subtotal	
MS-3	HWH Pipe	Entire Building	MS-3	3	3	1	7		Existing pipe is in poor condition.	Replace with like and kind.	250	LF			\$ 5.25	\$ 1,313			\$ 1,979
MS-4	HWH Pumps	Boiler Room	--	3	3	1	7		Existing HWH pumps are in fair to poor condition.	Replace with like and kind; approximate 120 GPM at 40 TDH.	2	EA			\$ 15,600.00	\$ 31,200			\$ 47,050
MS-5	Pipe Insulation	Entire Building		4	4	1	9		Sections of missing insulation.	Install new insulation and labels.	100	LF			\$ 8.55	\$ 855			\$ 1,289
MS-6	Horizontal UV - Heating and Ventilating Only	Entire Building	MS-6	3	3	1	7		Horizontal unit ventilators are in poor condition. Completely remove 12 units.	Provide perimeter HWH radiant ceiling panels.	250	LF			\$ 71.00	\$ 17,750			\$ 26,767

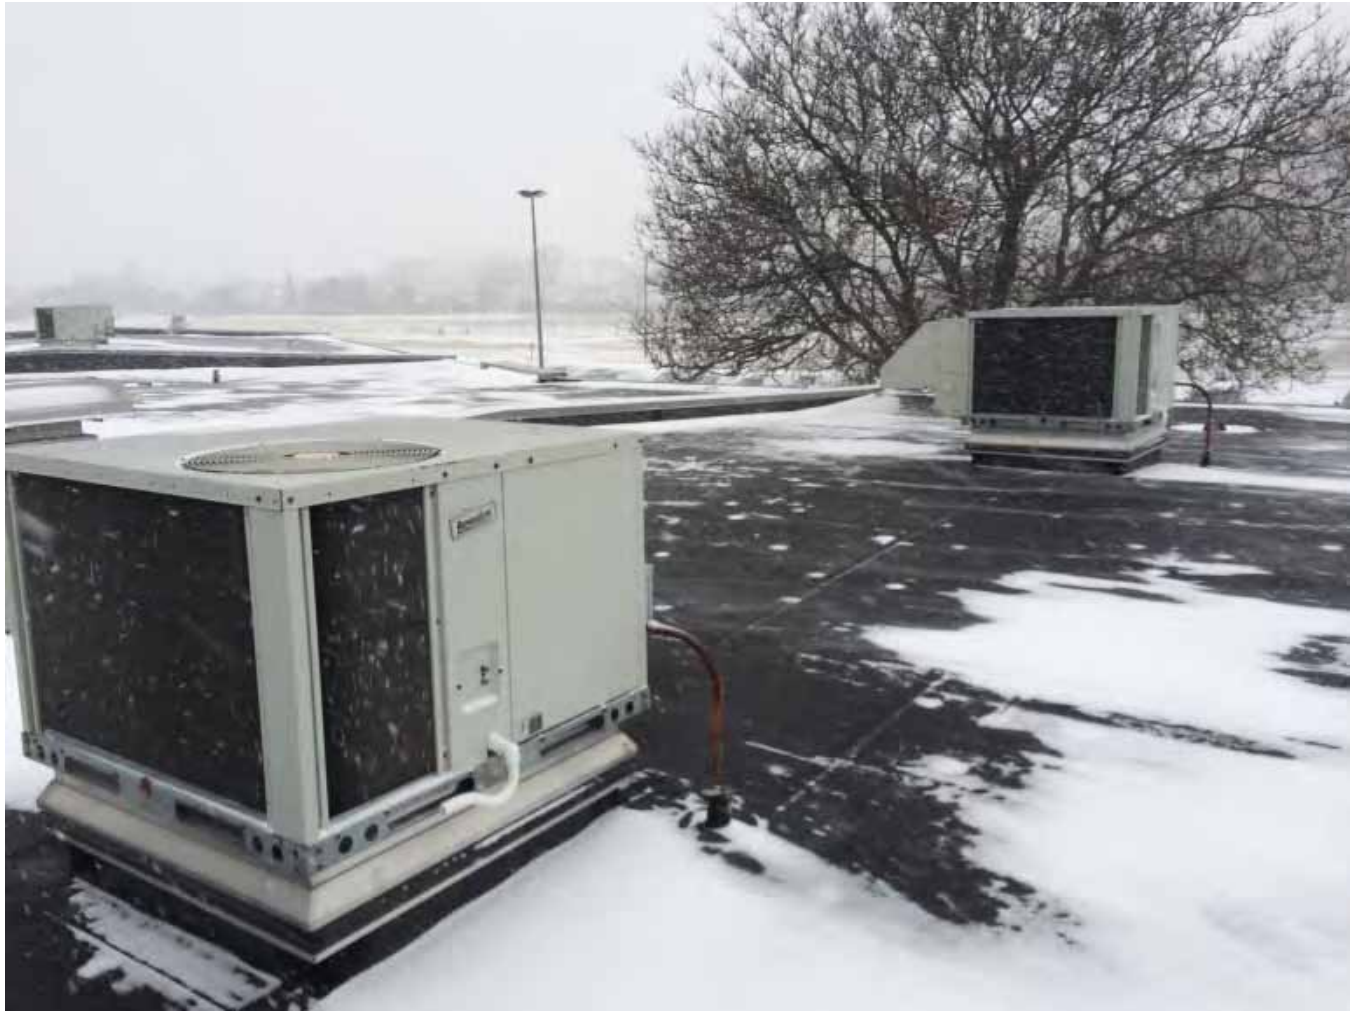
MS-7	Infant Room Rooftop Units	Roof	MS-7	5	5	1	11		Existing rooftop units are beyond their useful life.	Install new DX rooftop units; approximately 3-tons each.	2	EA			\$ 15,000.00	\$ 30,000	\$ 5,455.00	\$ 10,910	\$ 61,692
MS-8	Office HVAC	Fan Room 110	MS-8	3	3	2	8		Original HVAC units are in fair to poor condition.	Provide new indoor HVAC; approximate 7.5-ton unit; lower thru roof opening.	1	LS			\$ 27,000.00	\$ 27,000	\$ 6,535.00	\$ 6,535	\$ 50,571
MS-9	Classroom HVAC Units	Roof	MS-9	4	4	2	10		Ten rooftop units are beyond their useful life; cooling only.	Replace with like and kind; 3-tons. Add HWH coil to ductwork.	10	EA			\$ 20,000.00	\$ 200,000	\$ 5,455.00	\$ 54,550	\$ 383,861
MS-10	LMC Center HVAC	Roof	MS-10	4	4	1	9		Three existing rooftop units are beyond their useful life; cooling only.	Replace with like and kind; 3-tons each.	3	EA			\$ 15,000.00	\$ 45,000	\$ 5,455.00	\$ 16,365	\$ 92,538
